# Your Inspection Report

Thursday, October 23, 2025

Smart Choice Inspections LLC  
173 Ridge Road, Suite H1  
Cedar Grove, NJ 07009

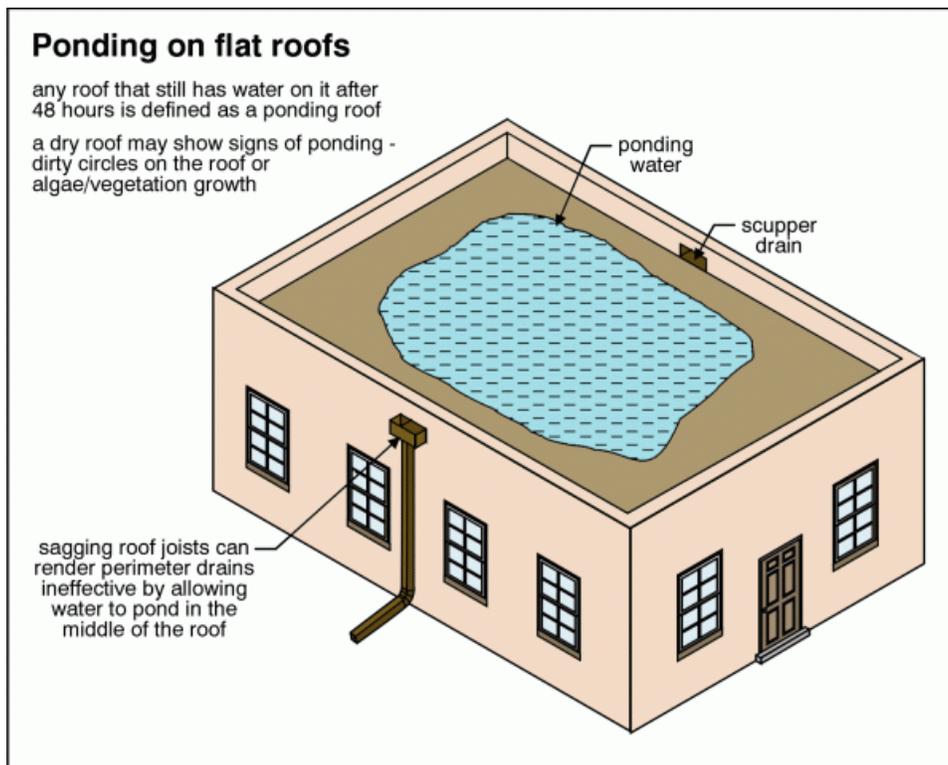
Signs of ponding

4. Ponding

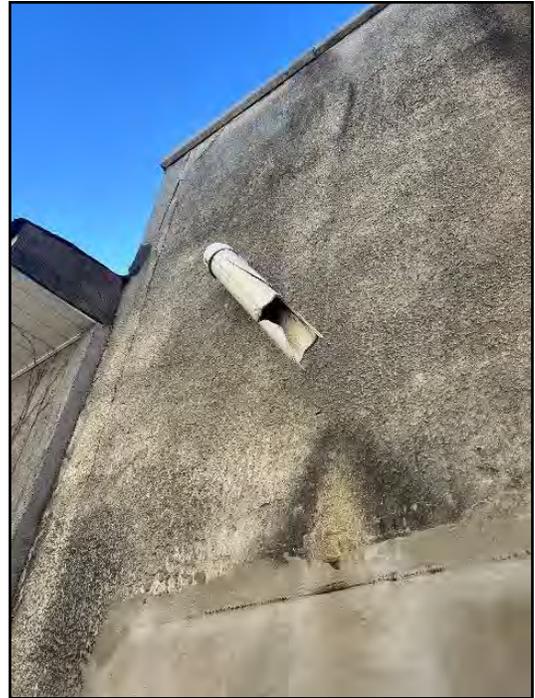
Downspout is causing an excessive amount of moisture issues with siding and foundation parging. Water penetration was observed on the inside which has lead to mold growth and has caused moisture issues to an improperly mounted panel. Recommend fixing downspout arrangement and mitigating moisture issues.

9. Discharge too close to building

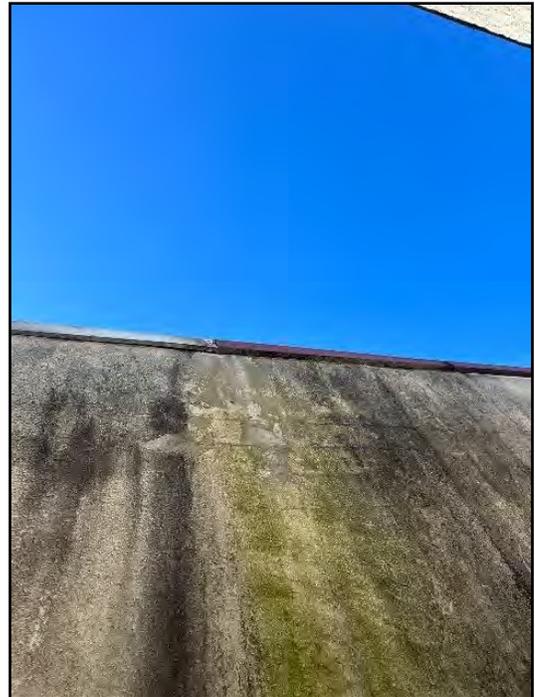
11. Moisture penetration

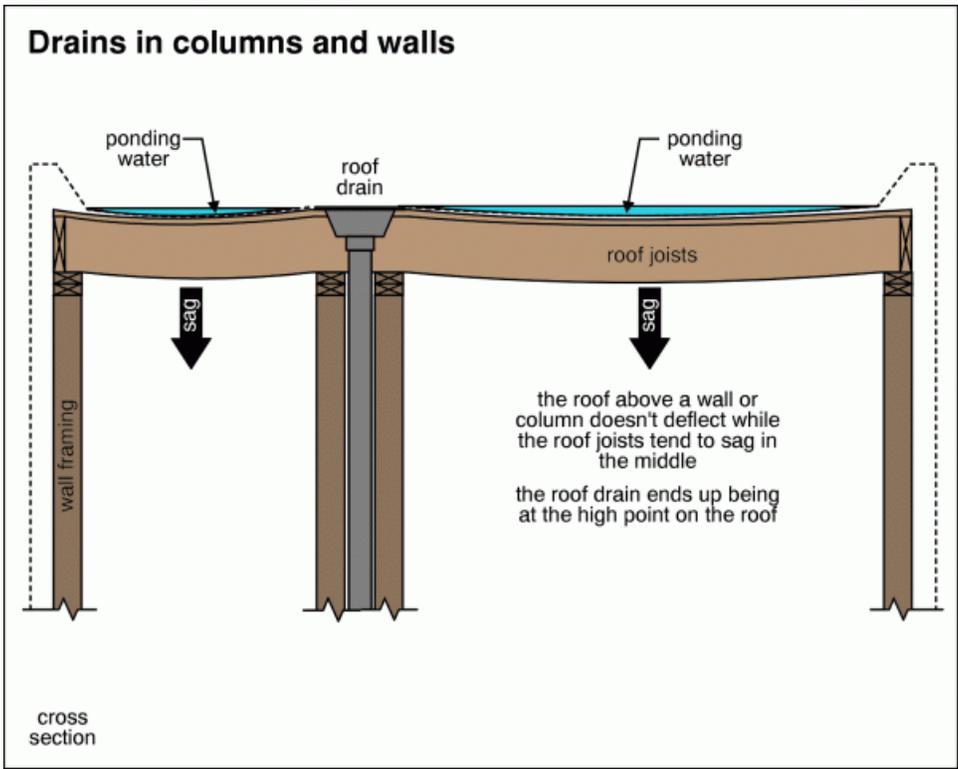
14. Drains not at low points

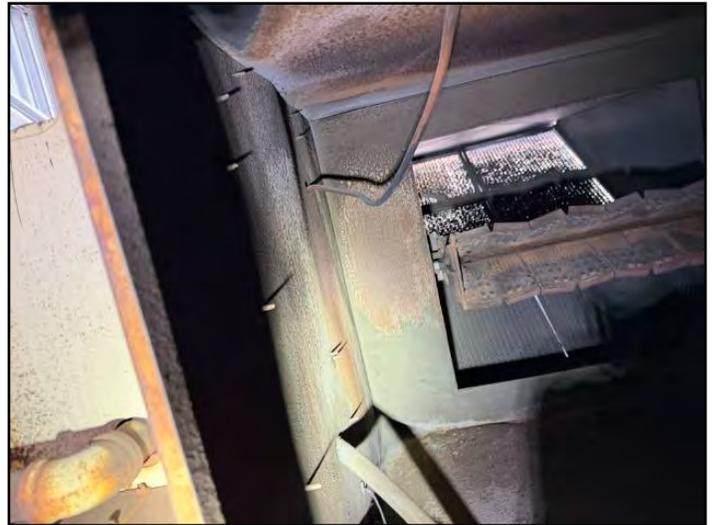
The furnace appears to be heavily corroded, and a structure has been built over it to prevent rain from entering the unit. This furnace is not used to heat the building but rather to provide heat and speed up the paint-drying process. The unit is over 20-30 years. If the paint booth will remain in the building after purchase, replacement of this furnace is highly recommended.

35. Rust

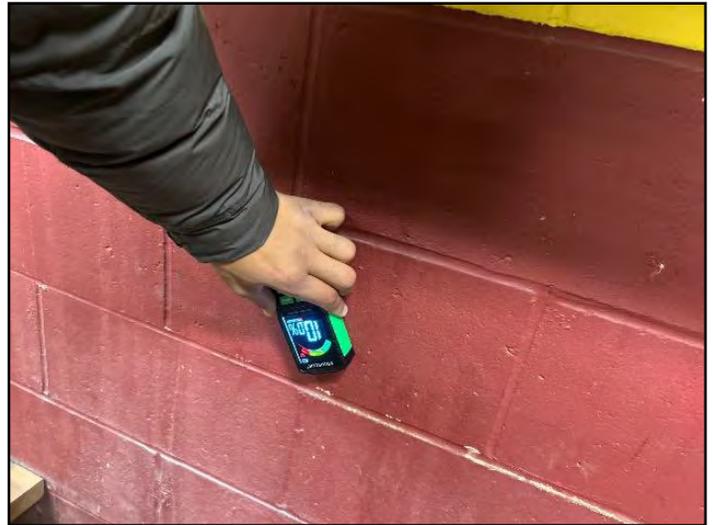
Moisture was detected in the masonry block wall, and visible water stains were also observed.

It is suspected that the water is originating from an improperly discharged downspout connected to the flat roof gutter system.

39. Active water leak detected

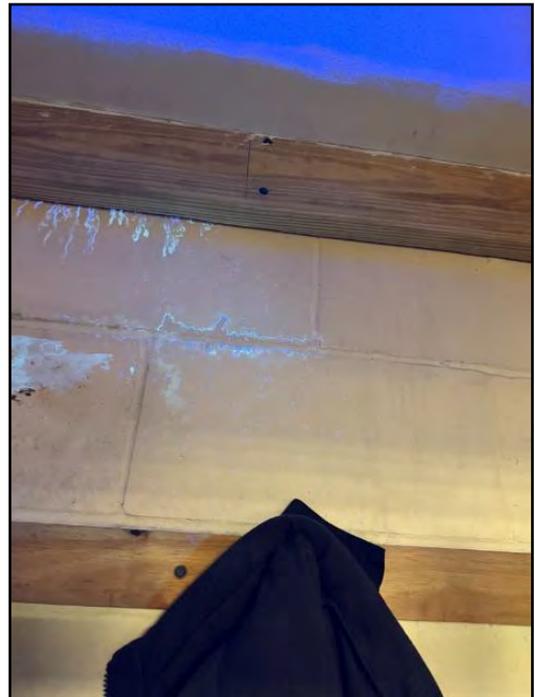
41. Active water leak detected

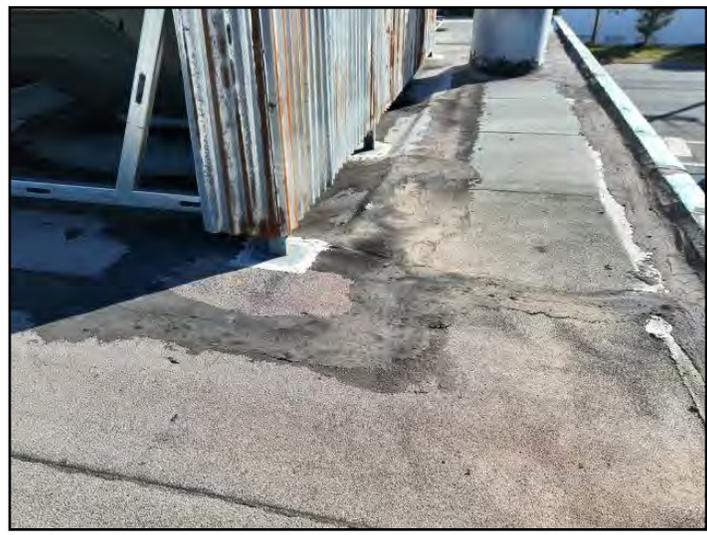
64. Patched

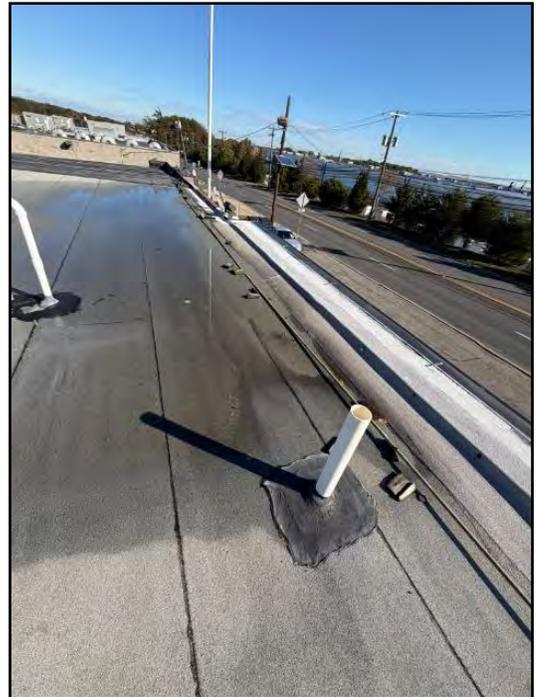
68. Ponding

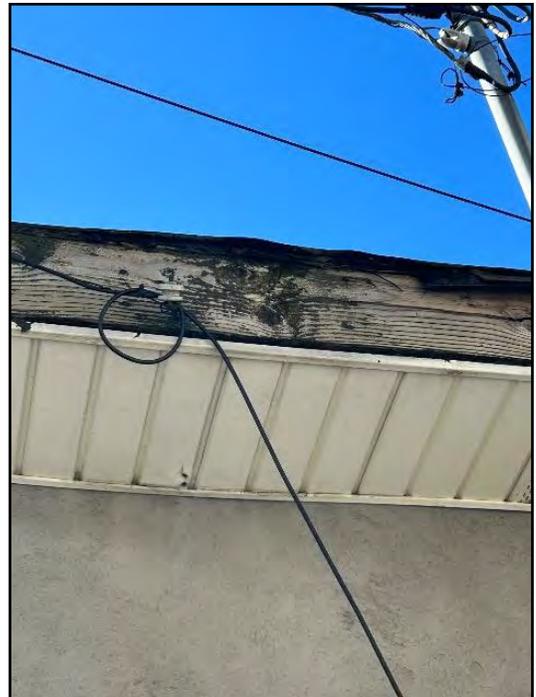
70. Multiple layers

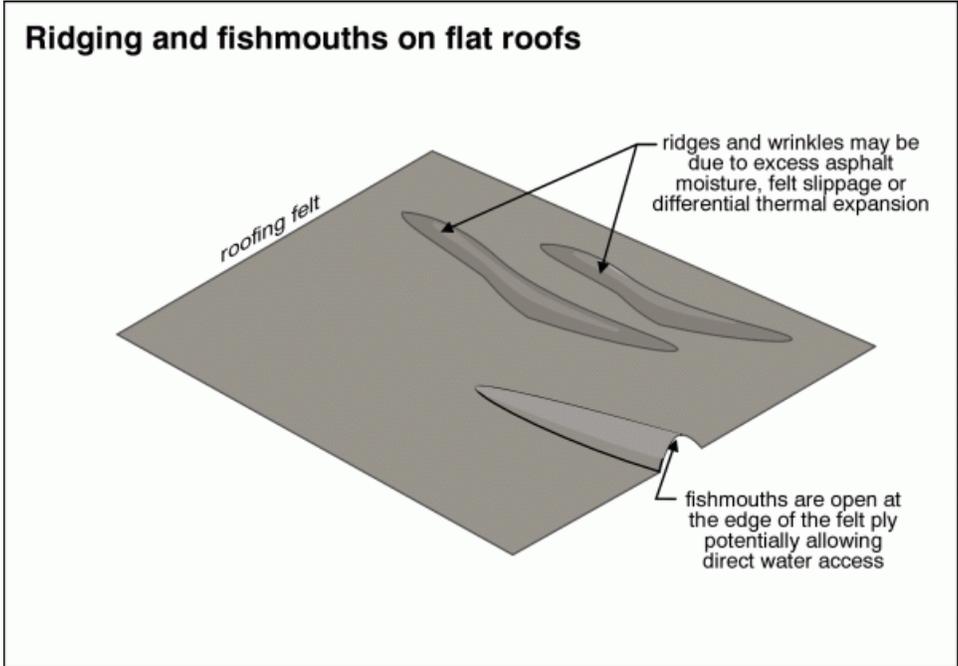
71. Wrinkles, ridges, fishmouths

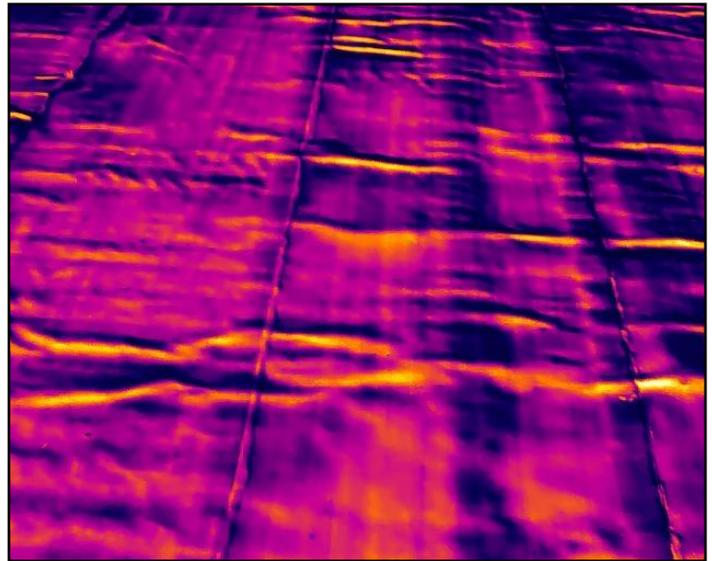
72. Wrinkles, ridges, fishmouths

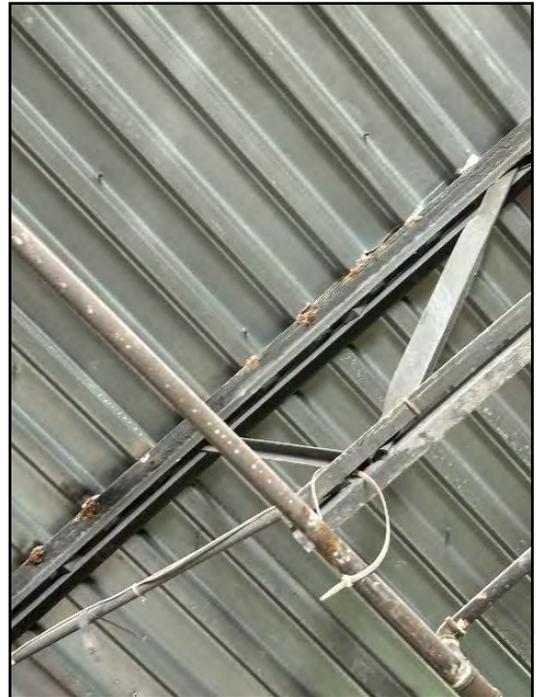
77. Rust

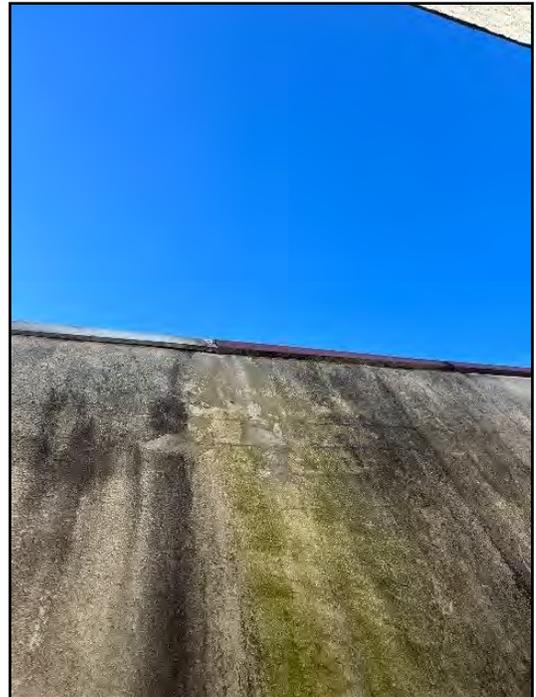
Downspout is causing an excessive amount of moisture issues with siding and foundation parging. Water penetration was observed on the inside which has lead to mold growth and has caused moisture issues to an improperly mounted panel. Recommend fixing downspout arrangement and mitigating moisture issues.

89. Moisture penetration

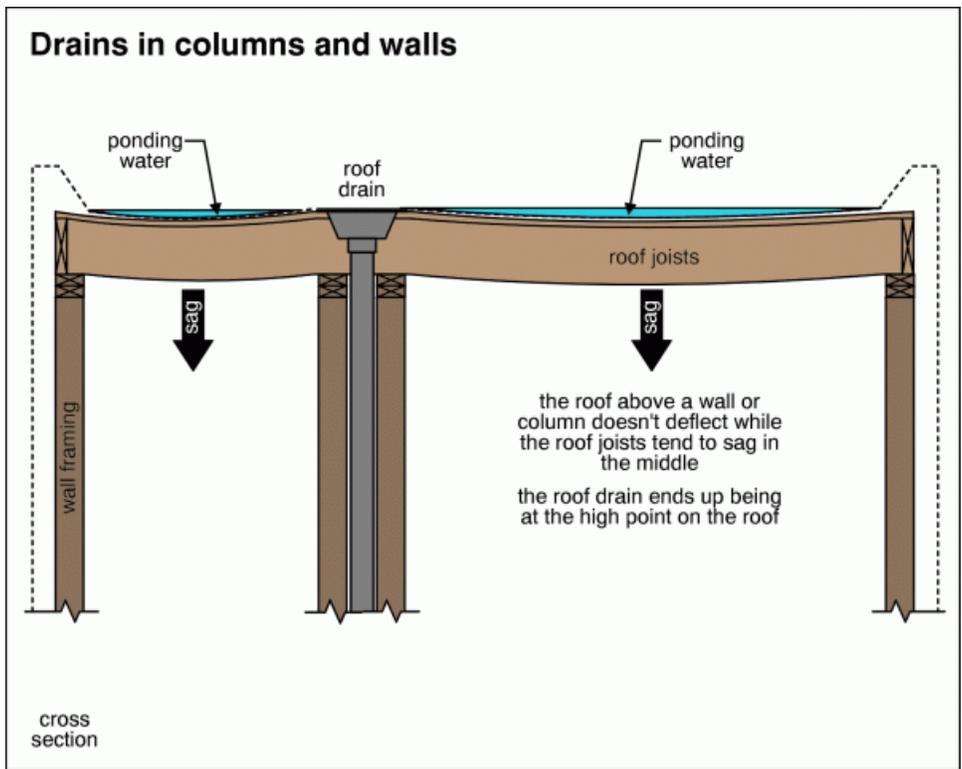
92. Drains not at low points

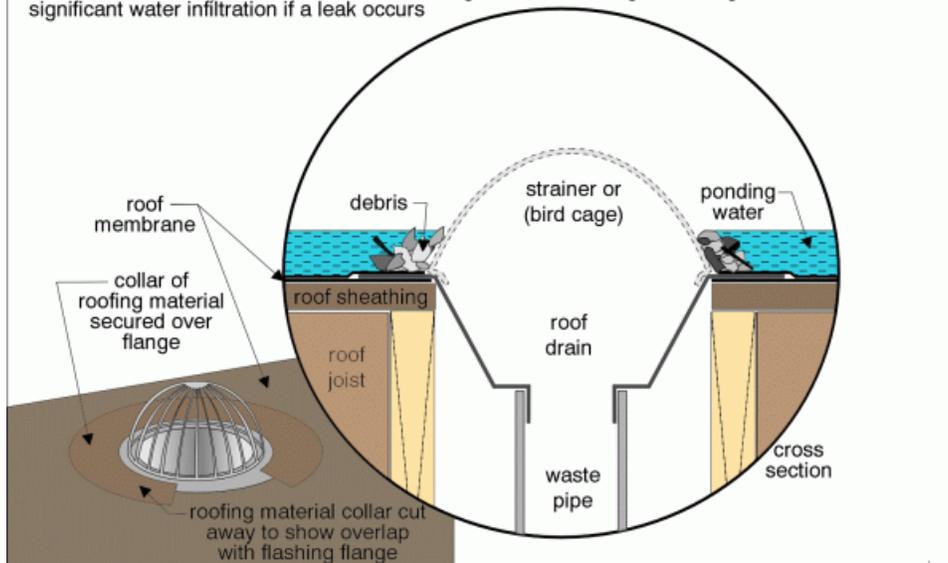
94. Strainer missing

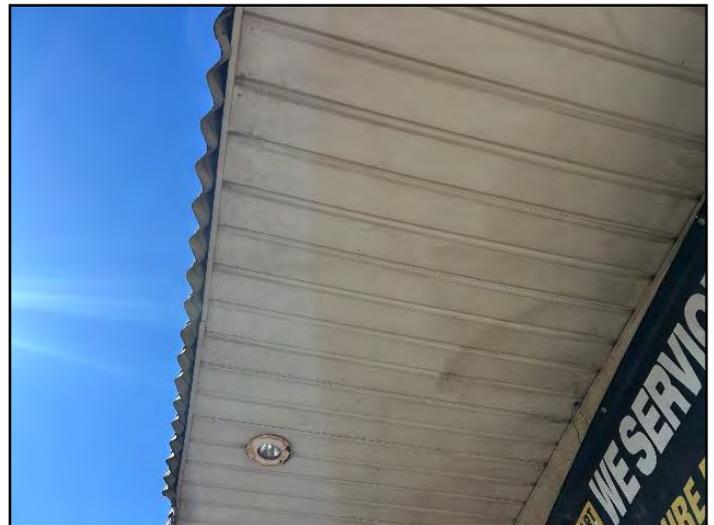
97. Buckled soffit covers

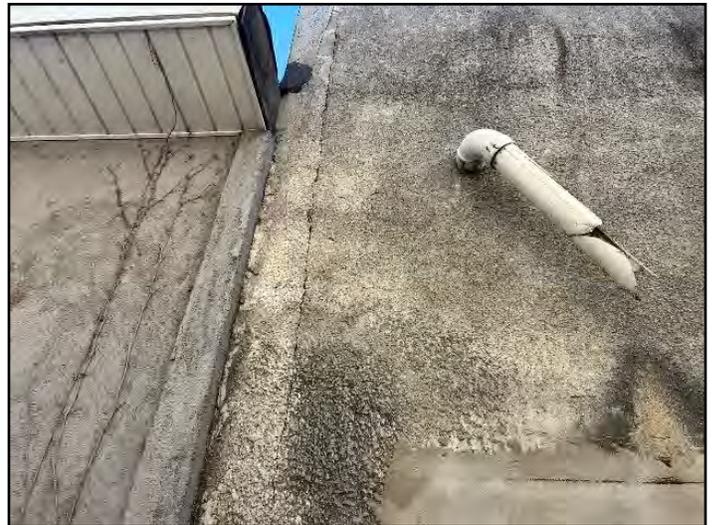
102. Moisture penetration

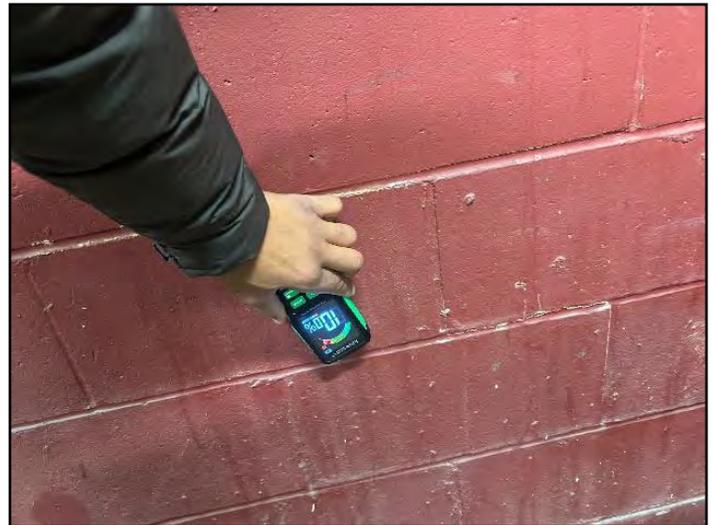
106. Moisture penetration

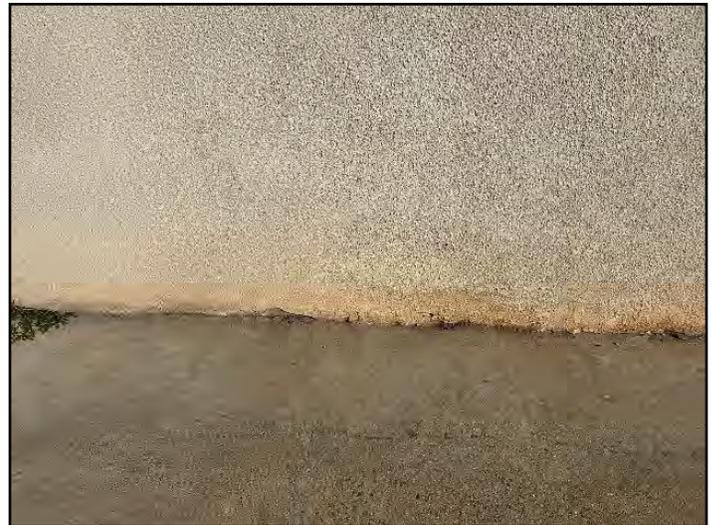
109. Moisture penetration

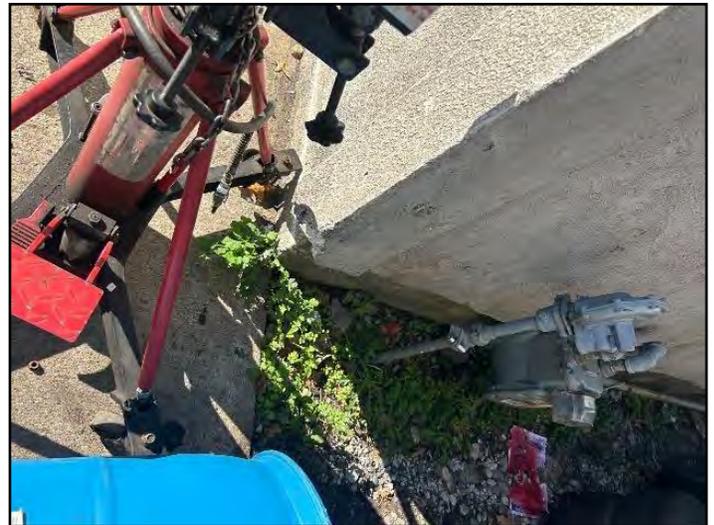
112. Mechanical damage

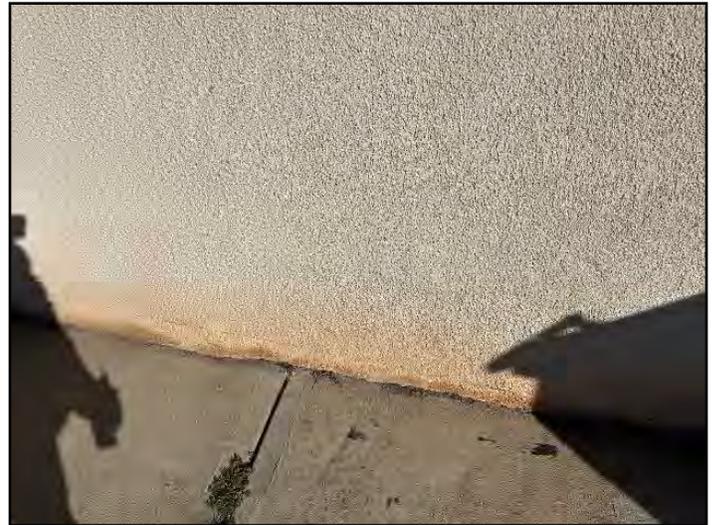
113. Mechanical damage

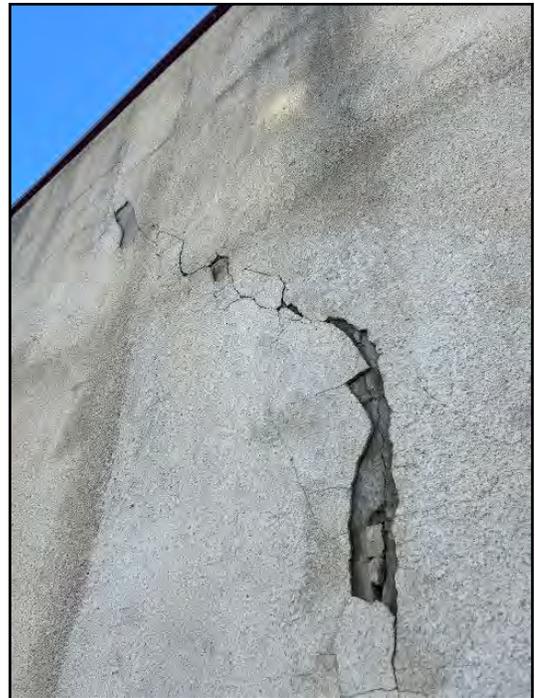
115. Mechanical damage

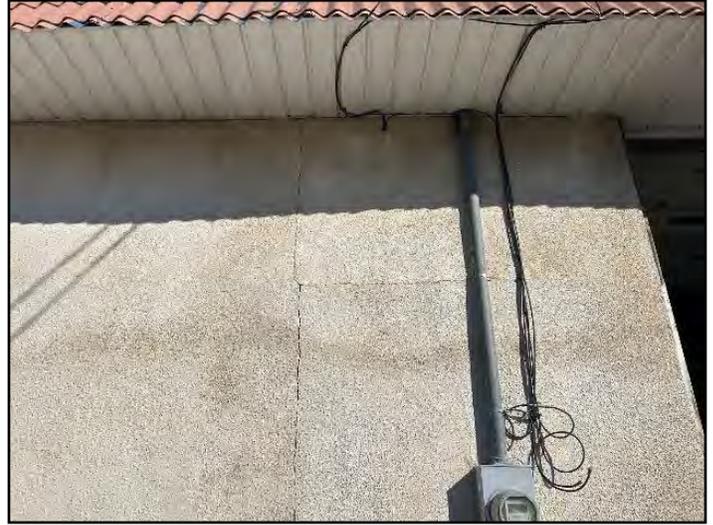
124. Cracked

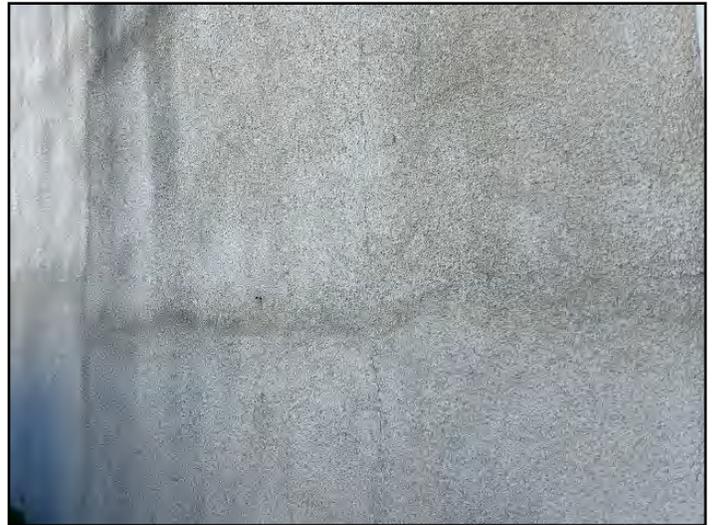
127. Cracked

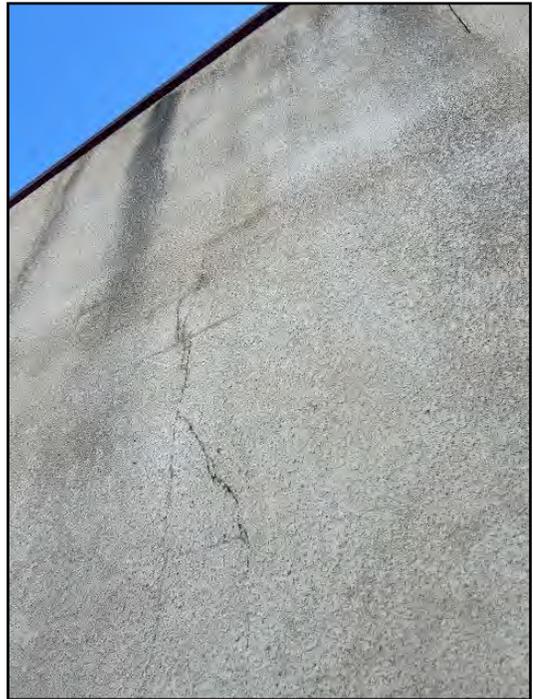
129. Cracked

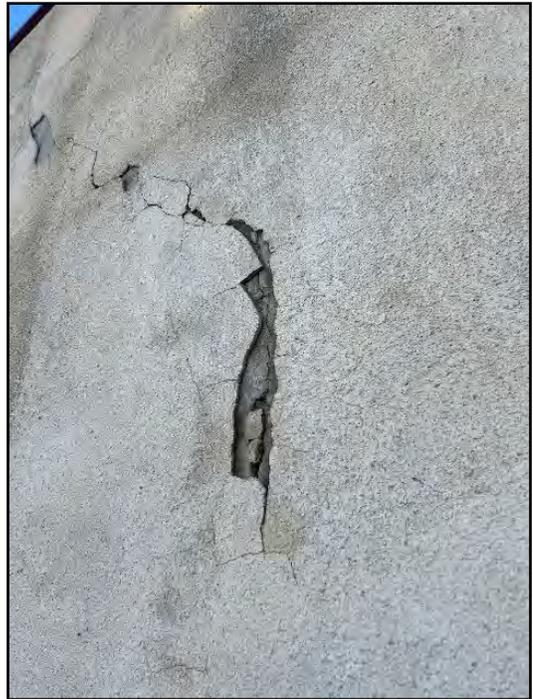
131. Cracked

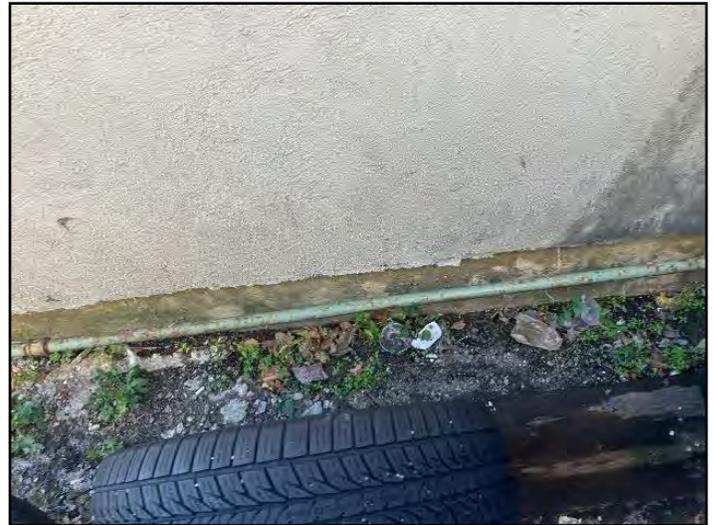
134. Crumbling

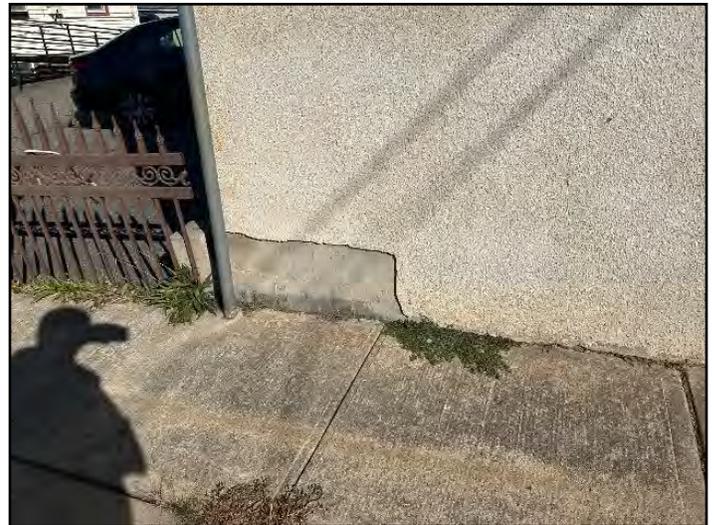
136. Crumbling

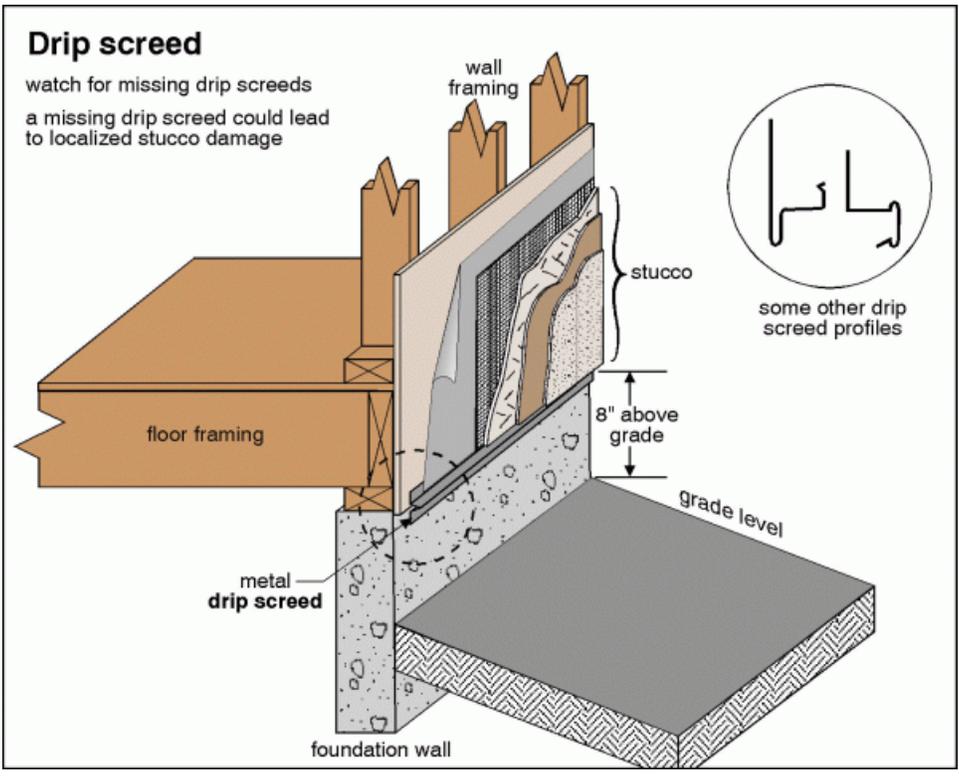
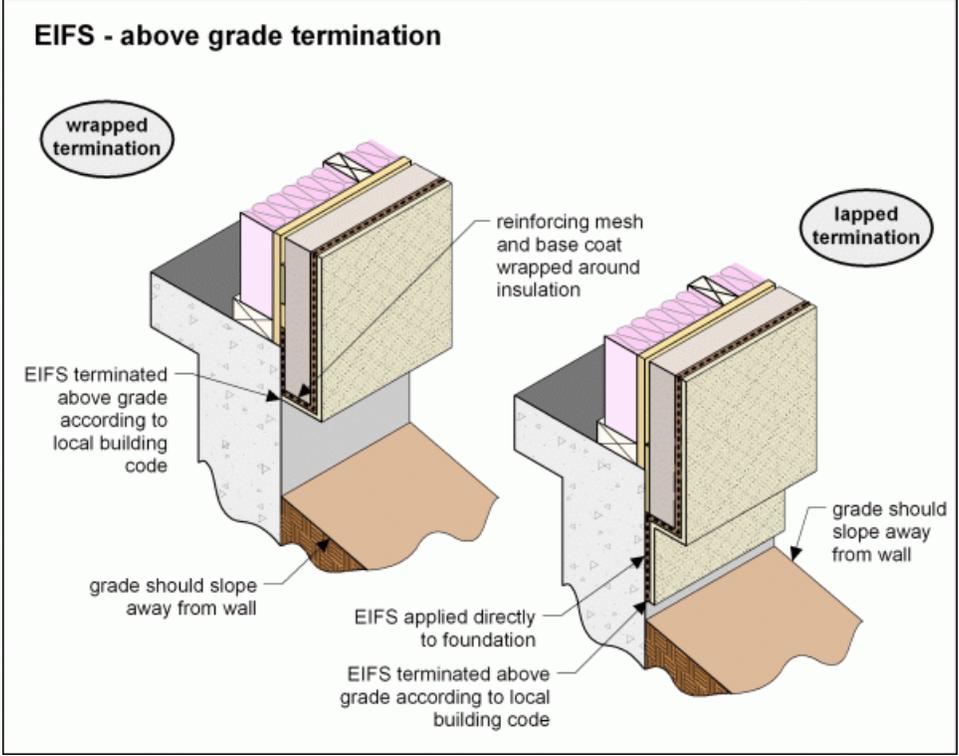
**137.** *Too close to grade*

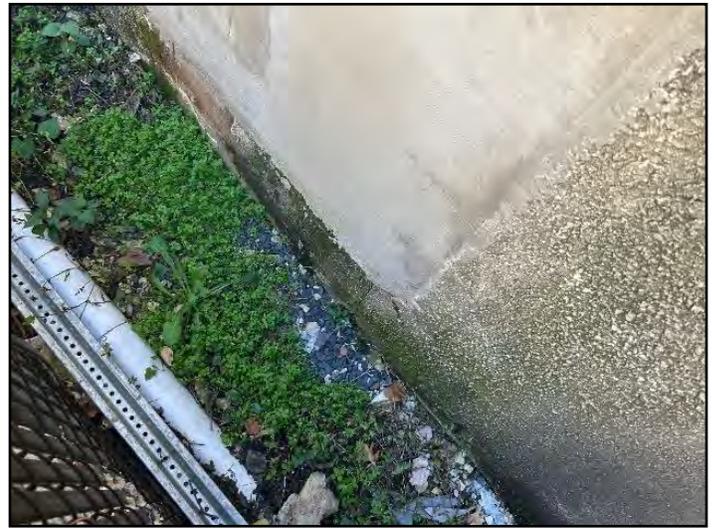
143. Patched

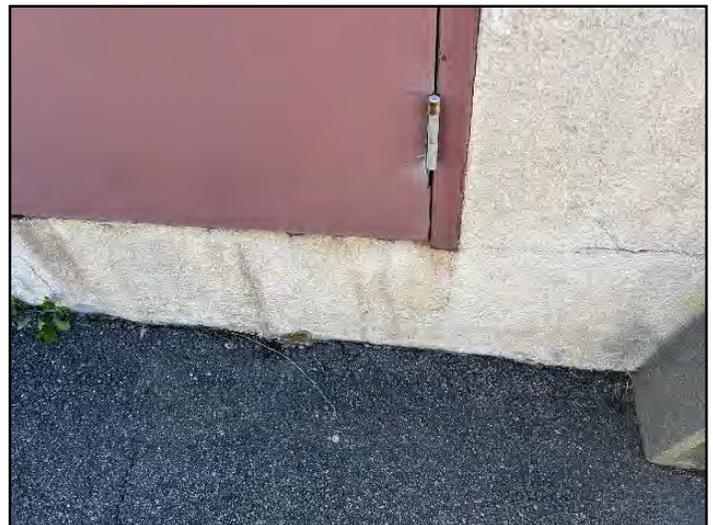
146. Rust

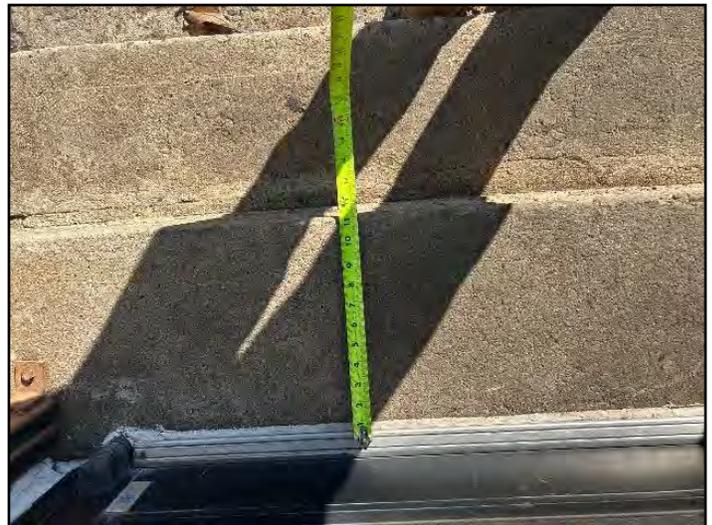
151. Landings missing or undersized

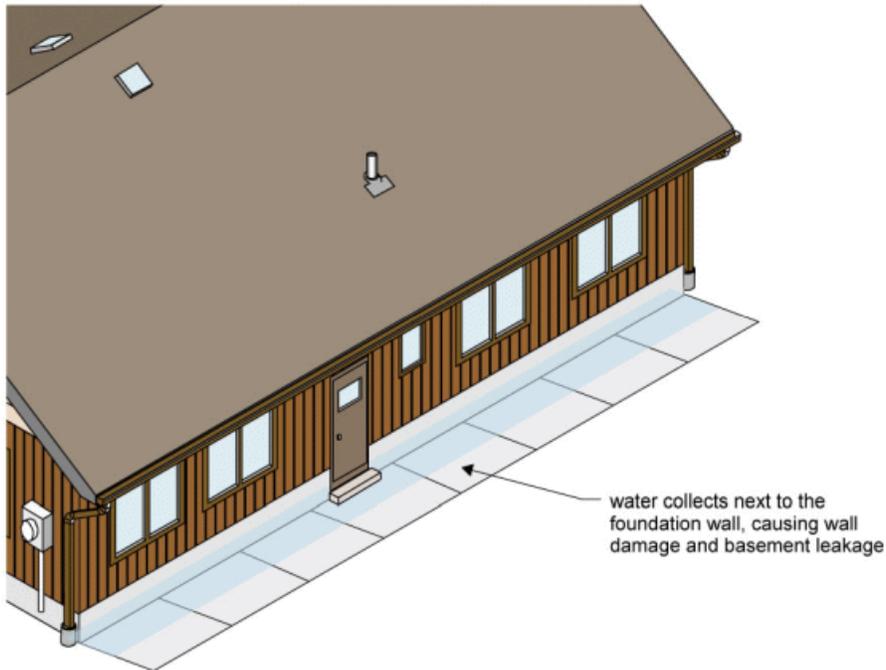
Walk/patio sloping towards house

158. Improper slope or drainage

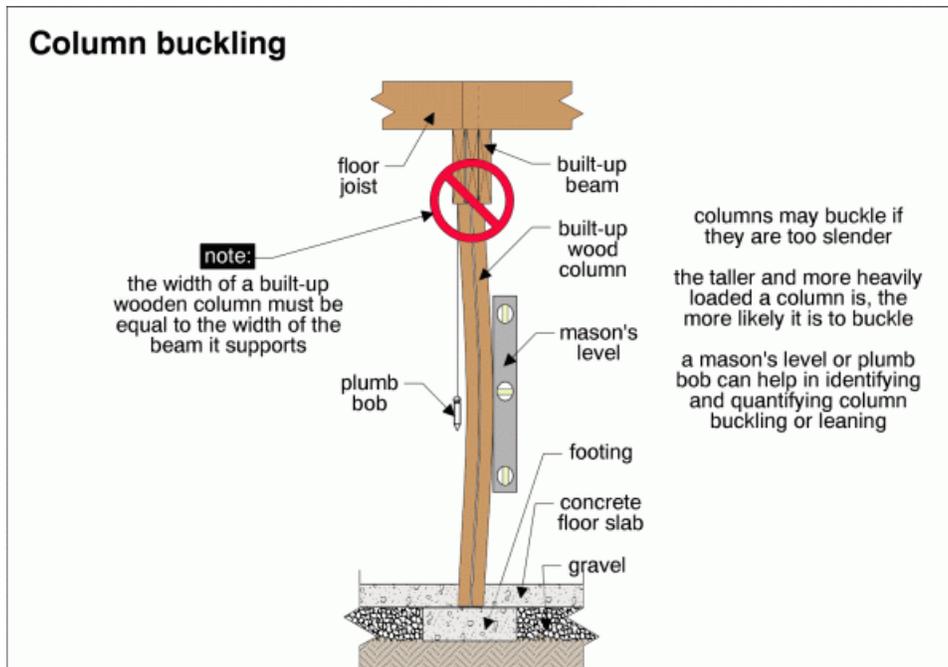
167. Buckling

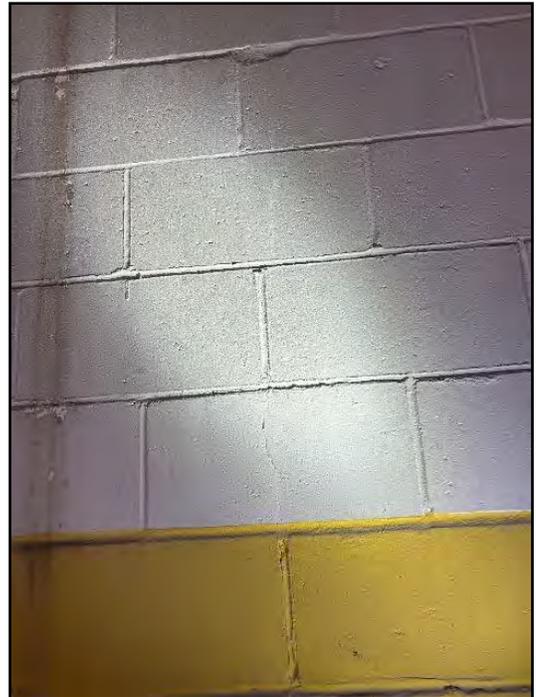
173. Typical minor cracks

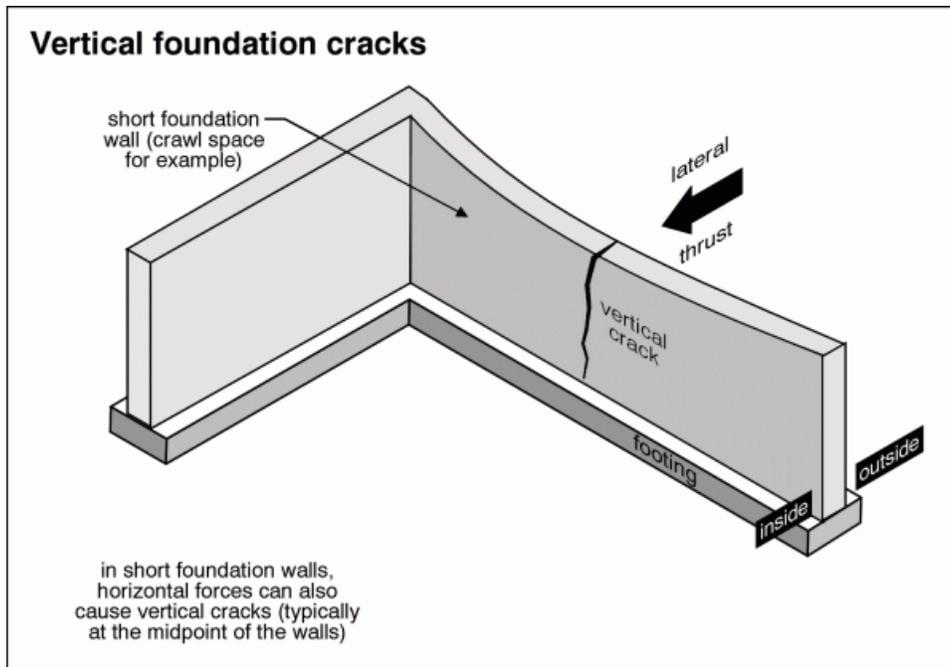
174. Cracked

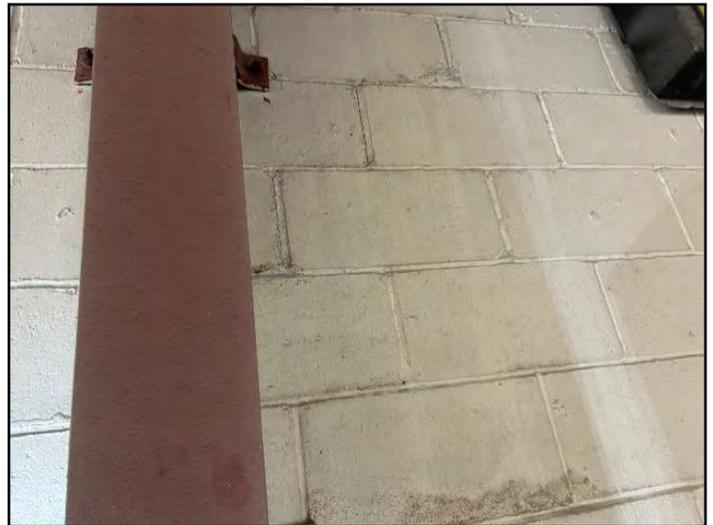
177. Cracked

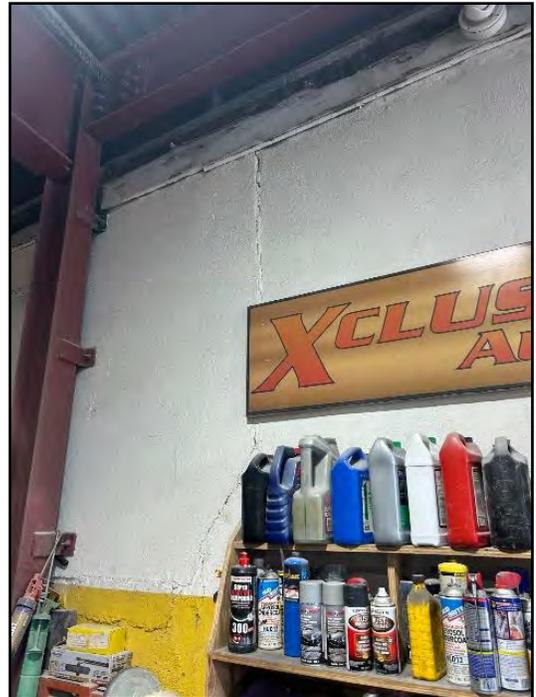
187. Cracked

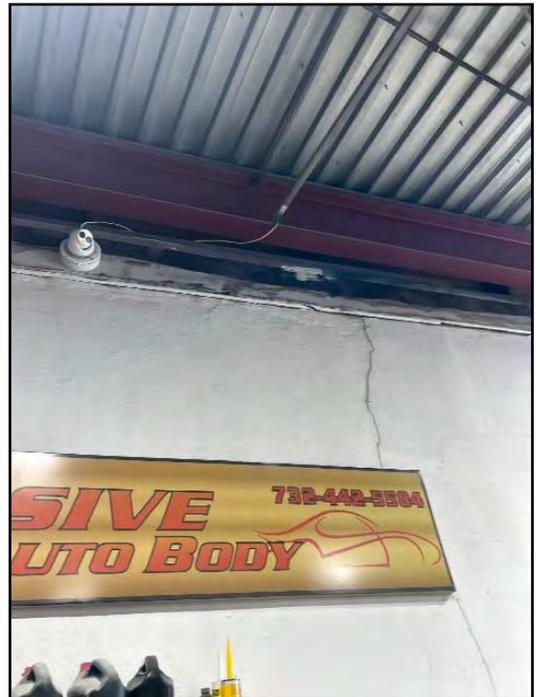
189. Cracked

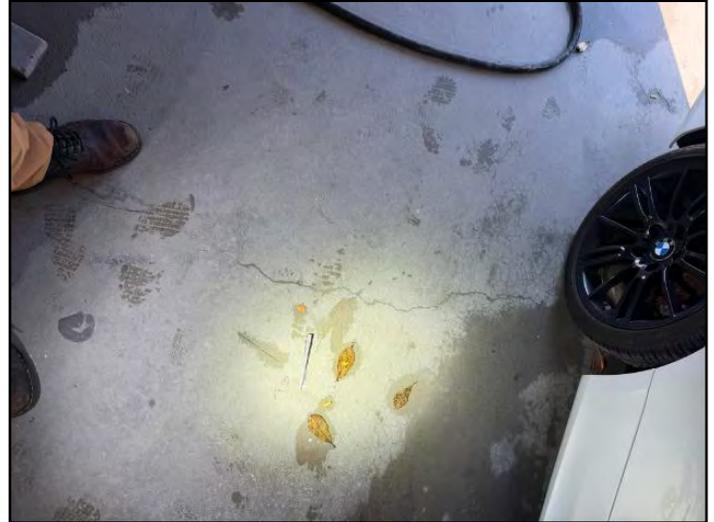
196. Cracked

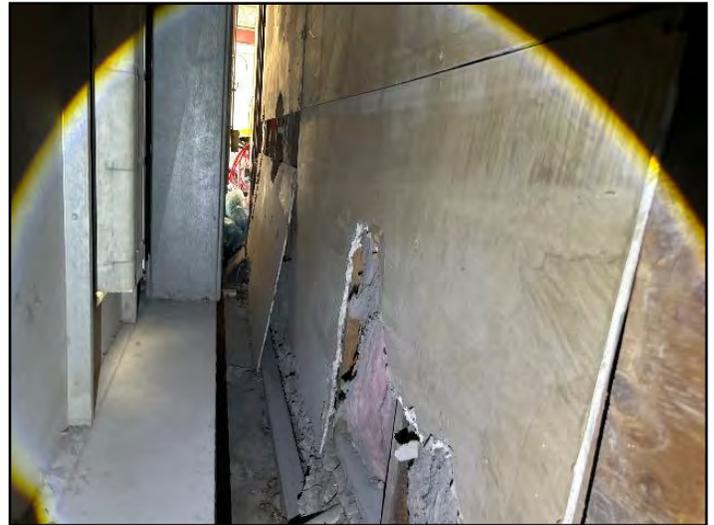
200. Spalling

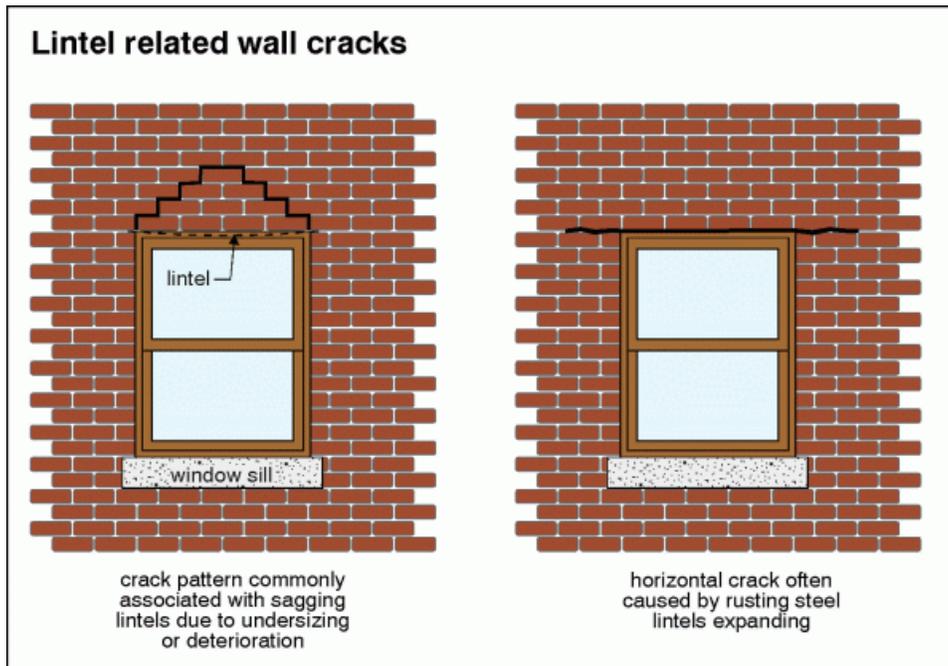
Structural cracks have begun to form on foundation wall due to sagging lintel. Recommend addressing the cracks and replacing lintel.

210. Lintels sagging

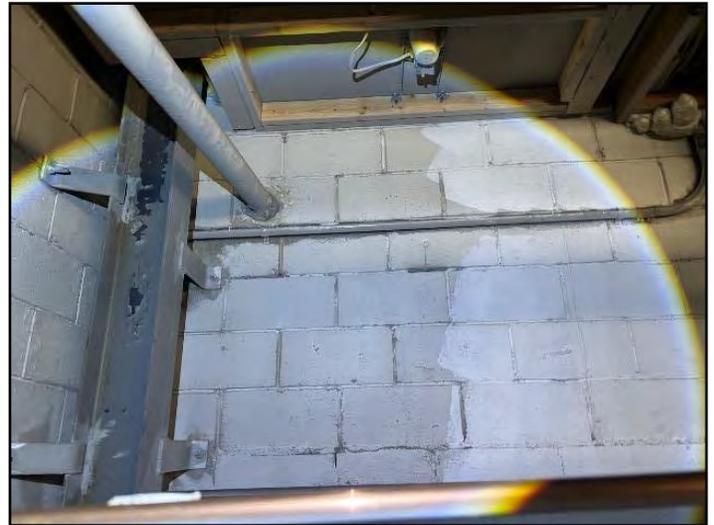
216. Mortar deteriorating

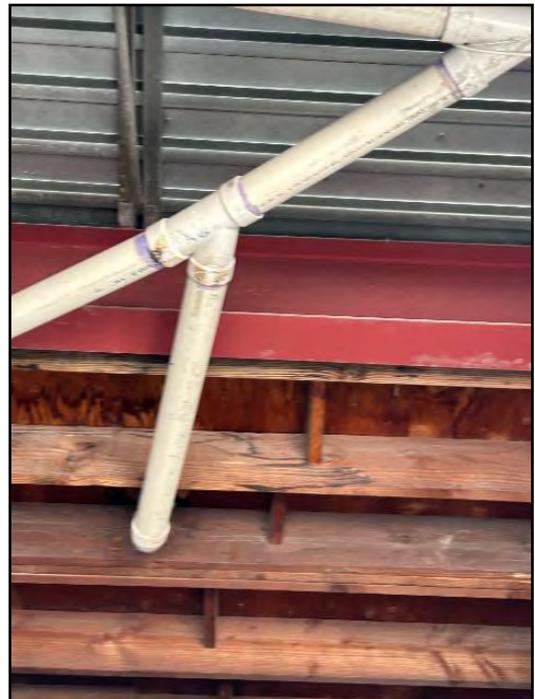
220. Water stains

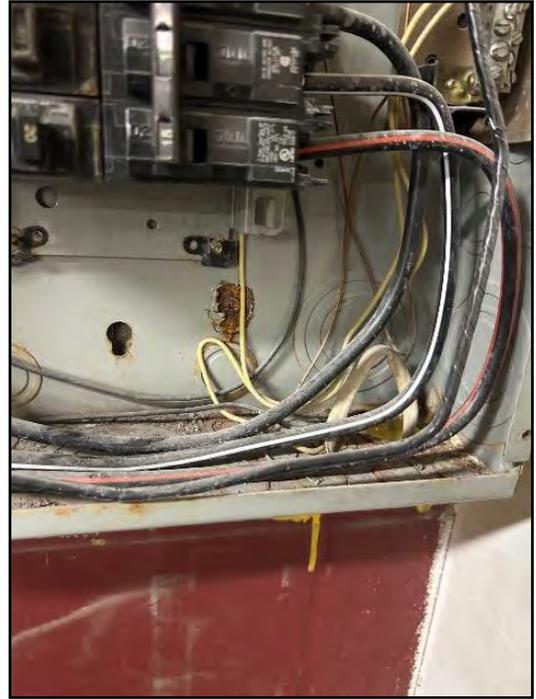
Corroded components observed during inspection of three phase distribution panel. Recommend hiring a licensed electrician to replace distribution panel. Also recommend for moisture issue in regards to downspout to be mitigated to ensure that this area does not remain an issue for future panels. Safety and fire hazard.

226. Rust or water in panel

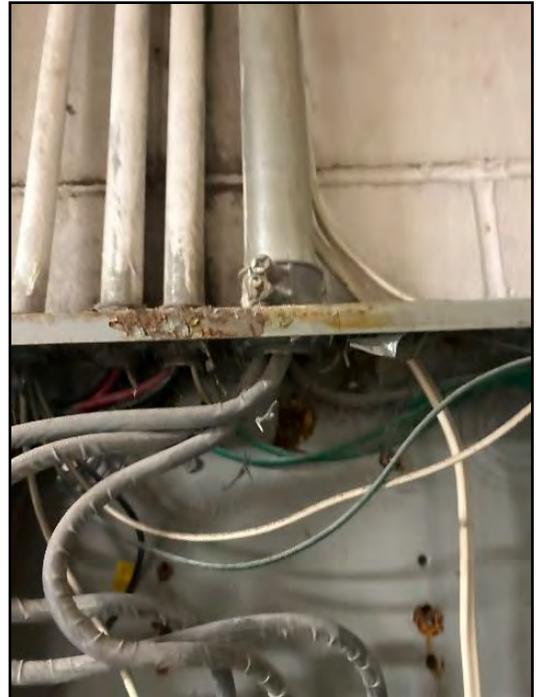
228. Rust or water in panel

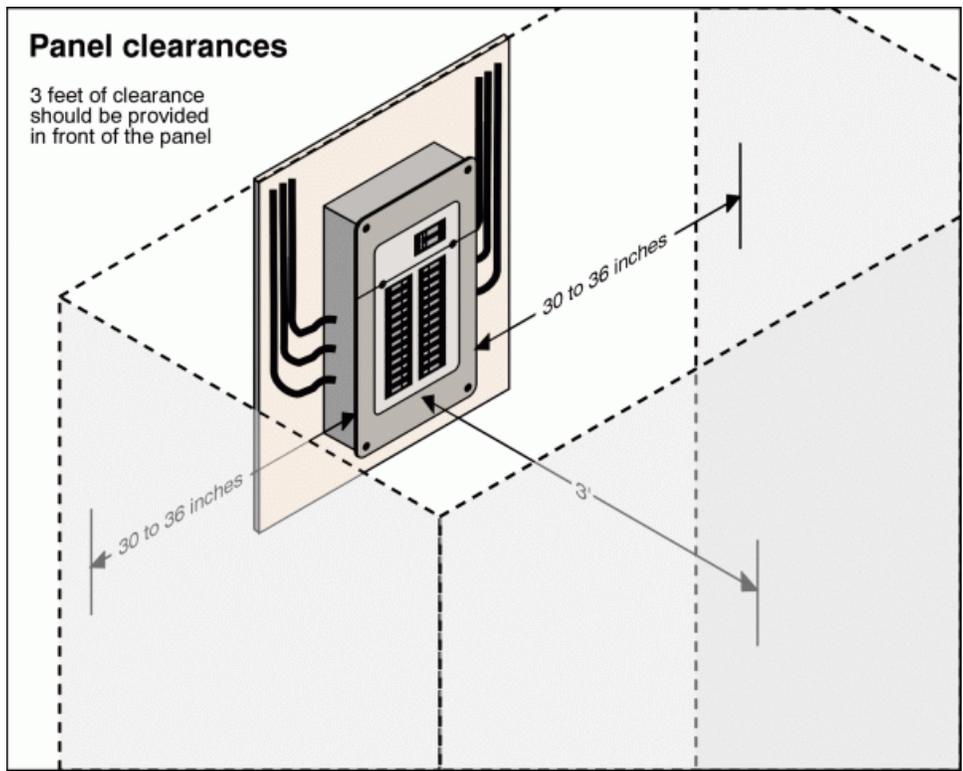
234. Poor access

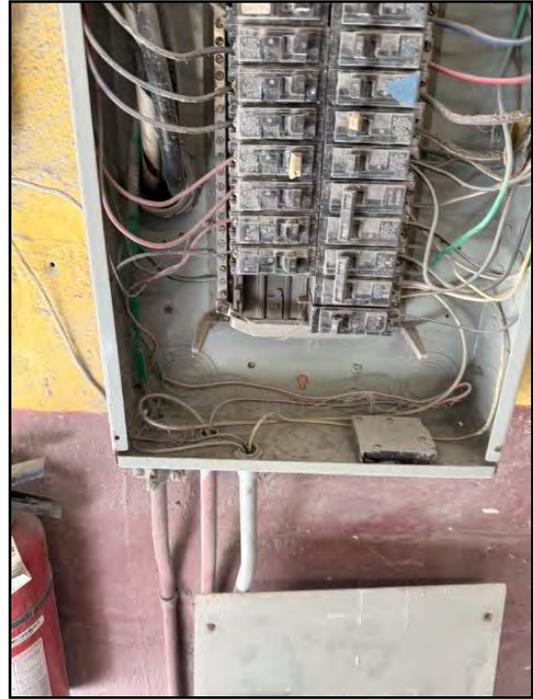
This can pose a potential hazard by obstructing proper airflow or causing unintended electrical contact. It is recommended to have the panel cleaned by a qualified professional to ensure safe operation.

240. Debris was observed inside the panel
