# Your Inspection Report

Thursday, October 23, 2025

Smart Choice Inspections LLC  
173 Ridge Road, Suite H1  
Cedar Grove, NJ 07009

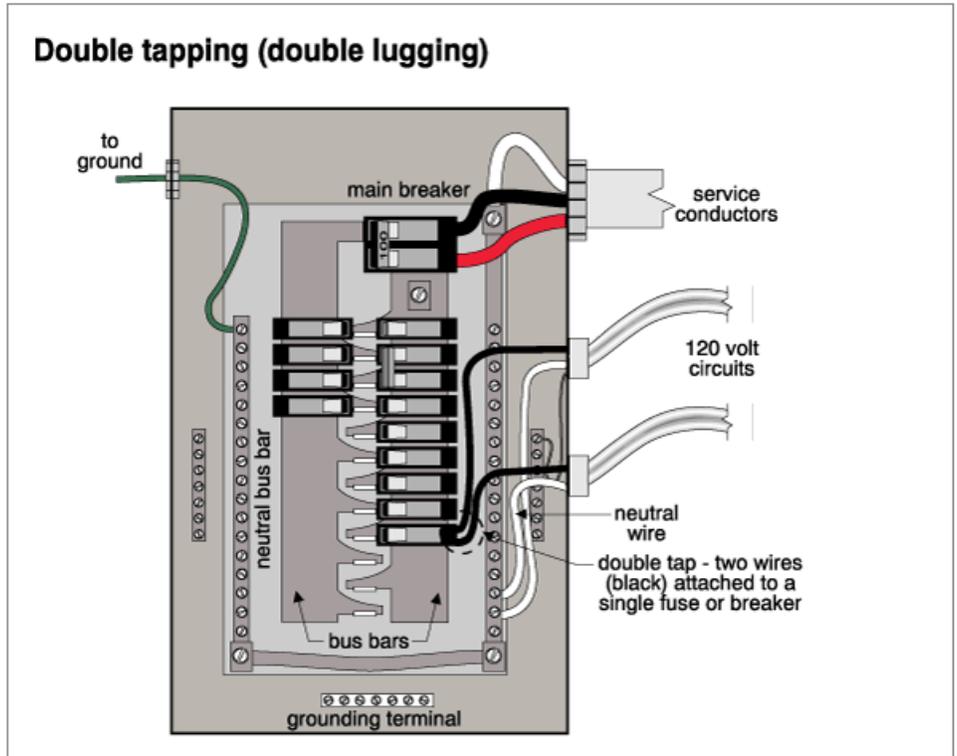
243. Double taps

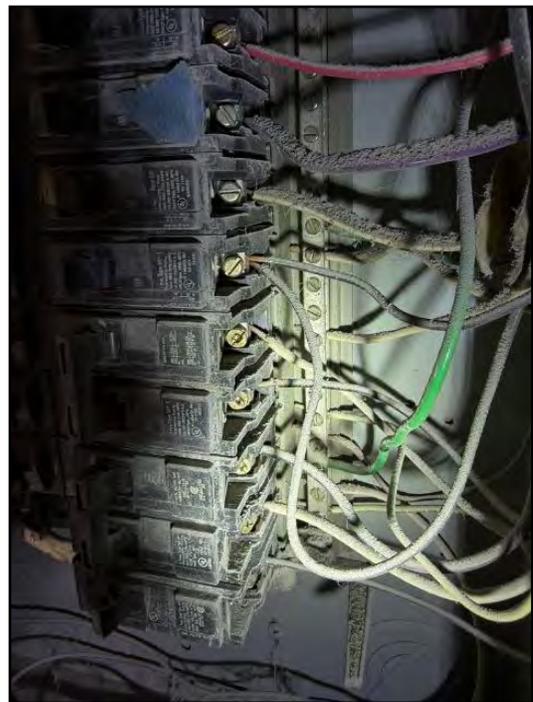
244. Double taps

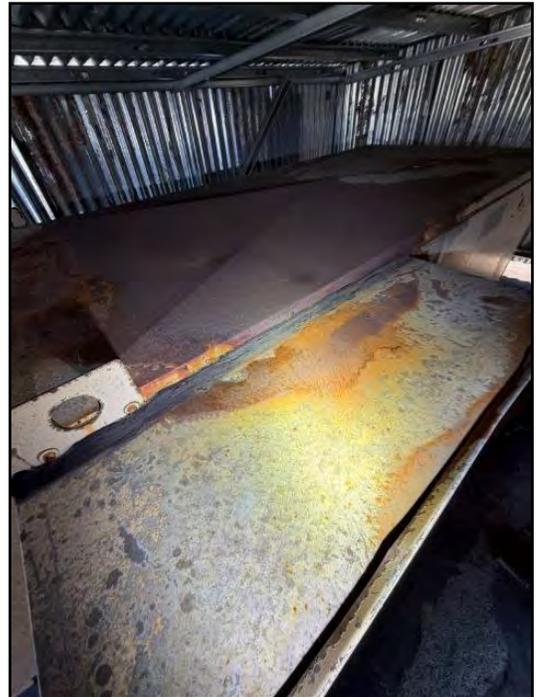
255. Rust

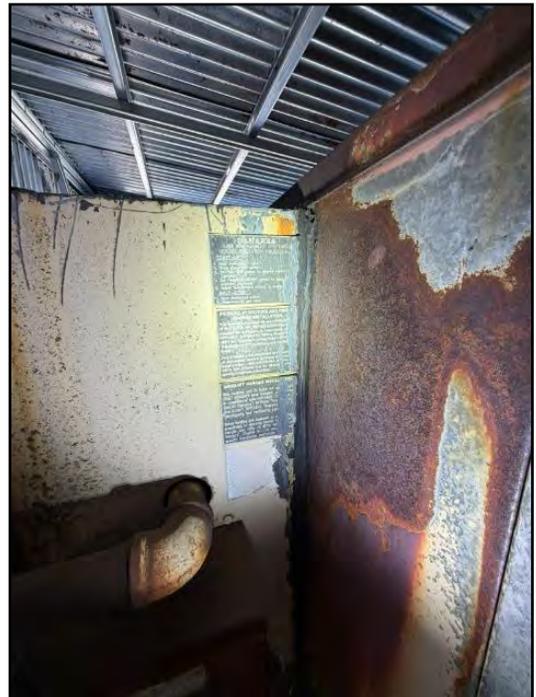
257. Rust

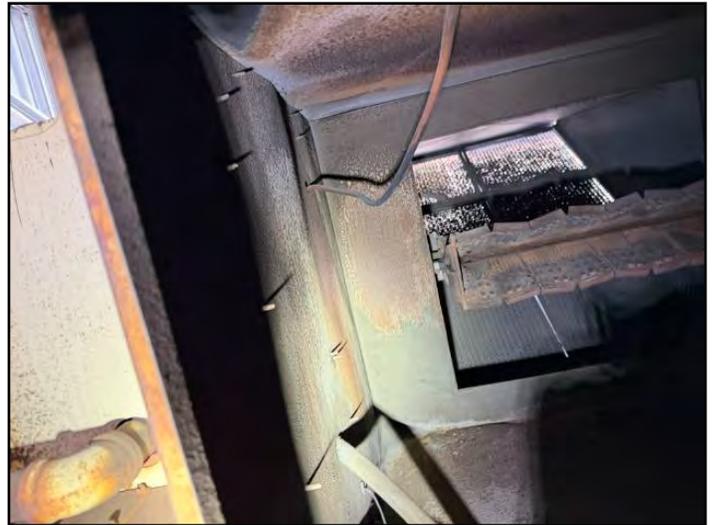
259. Rust

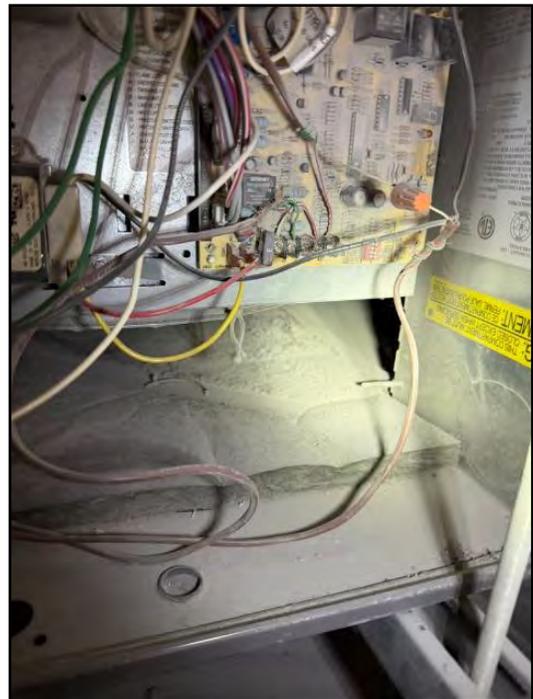
262. Dirty

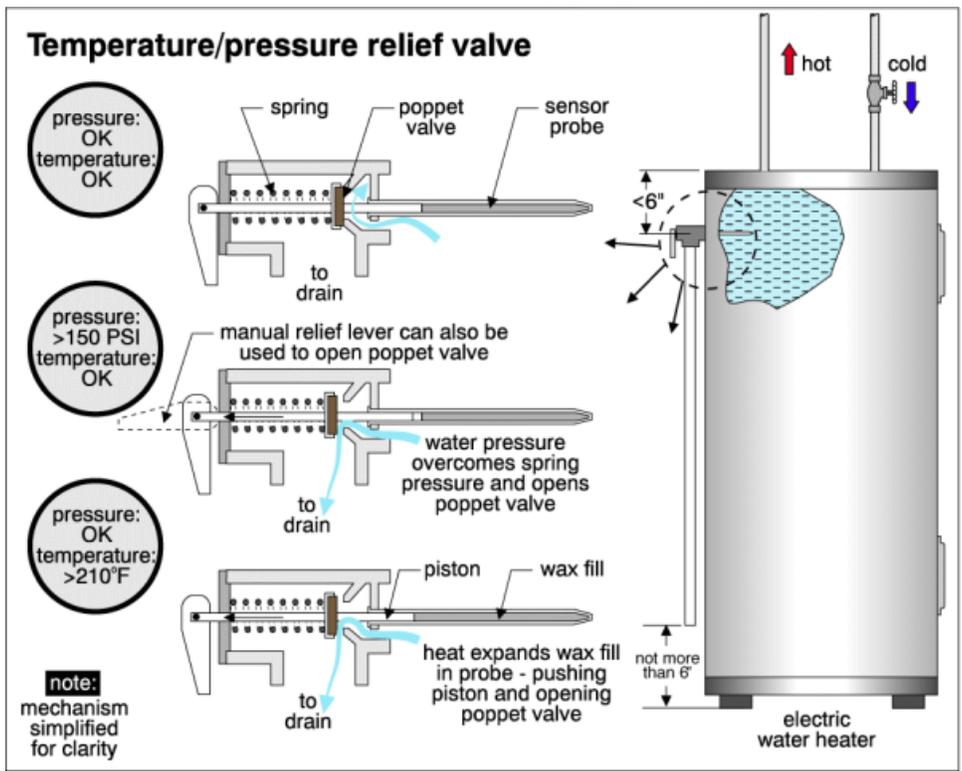
277. Discharge tube missing

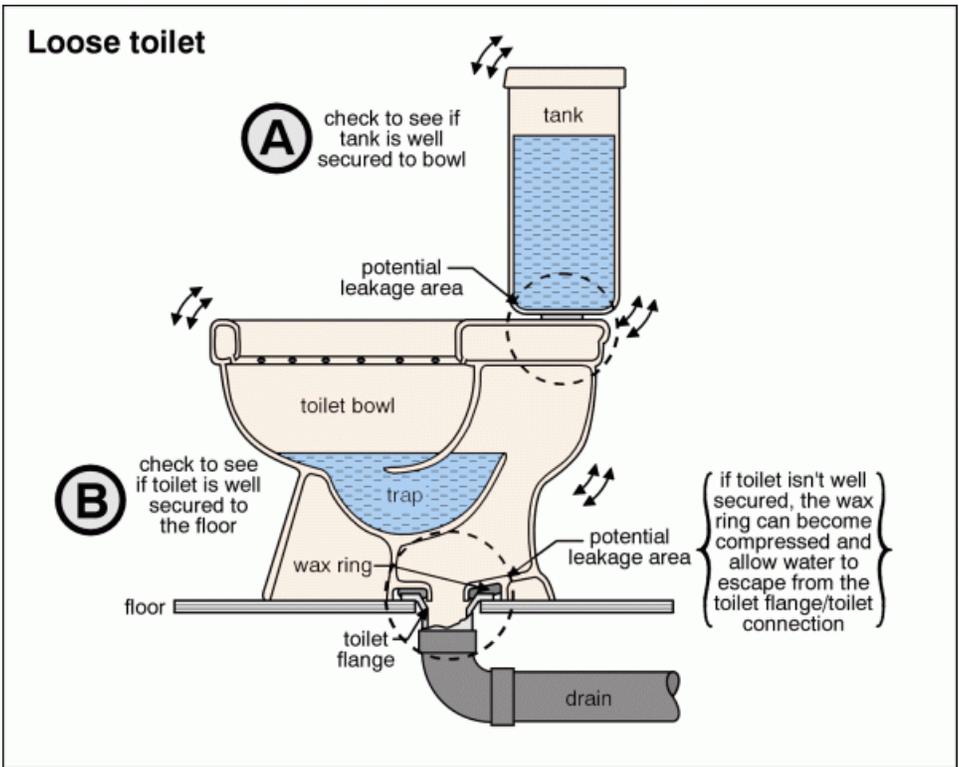
280. Loose

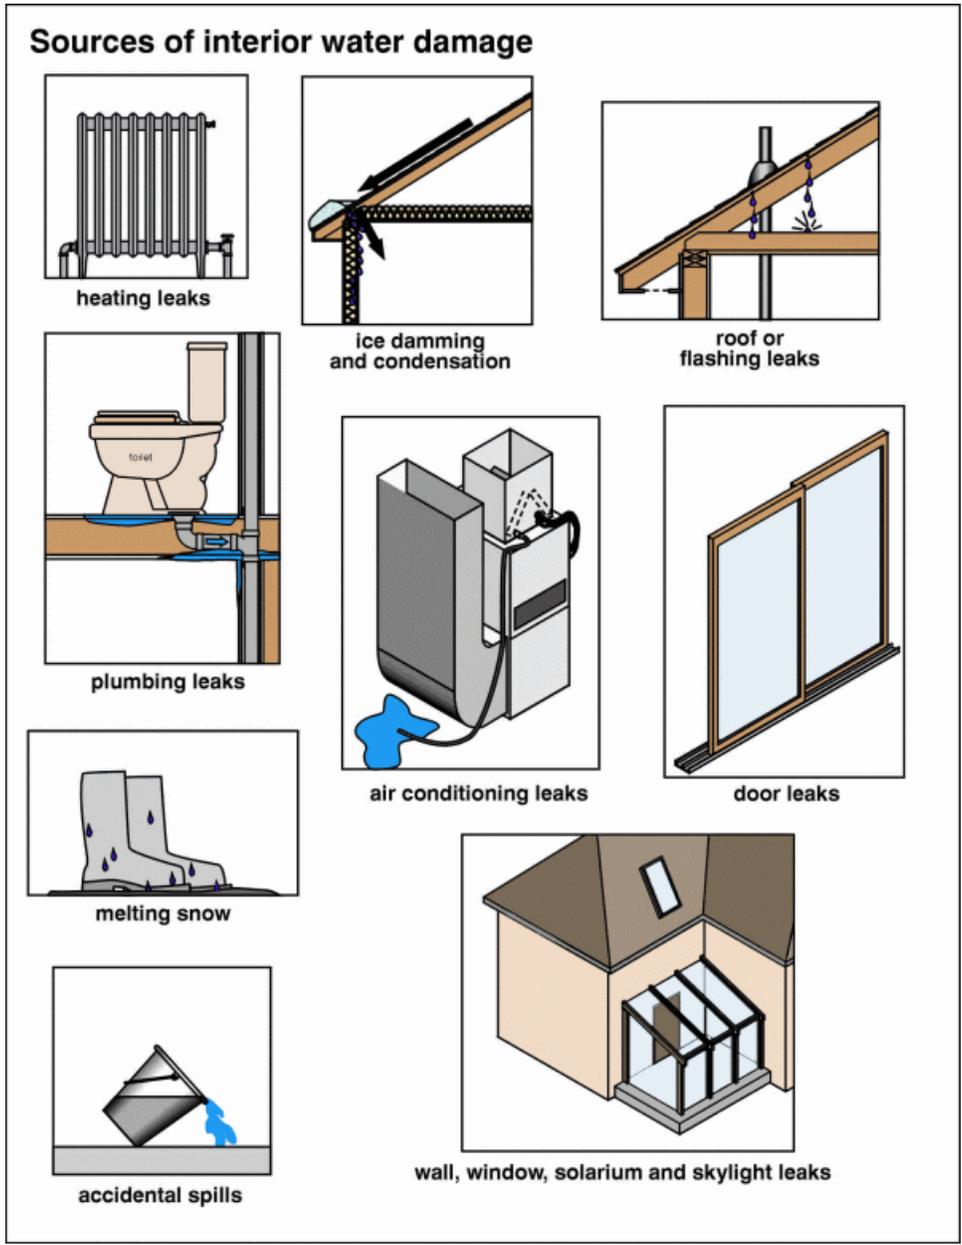
281. Water damage

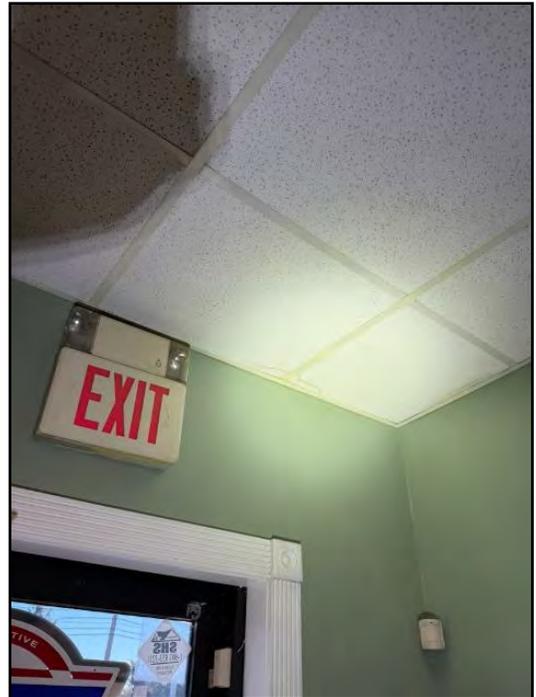
282. Water damage

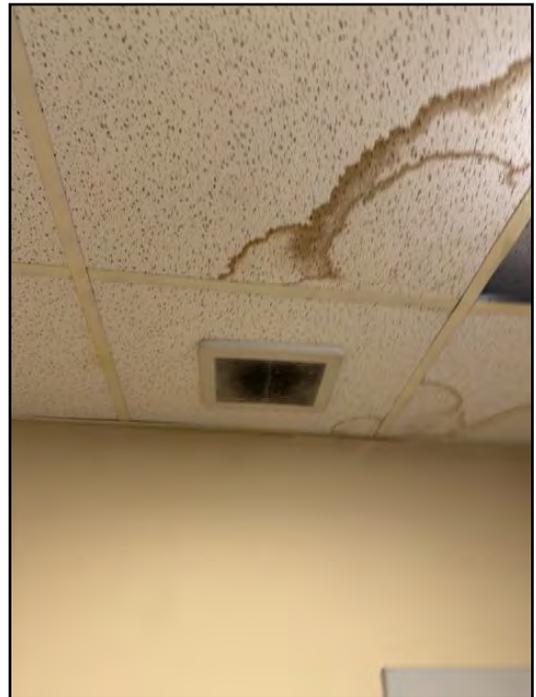
284. Water damage

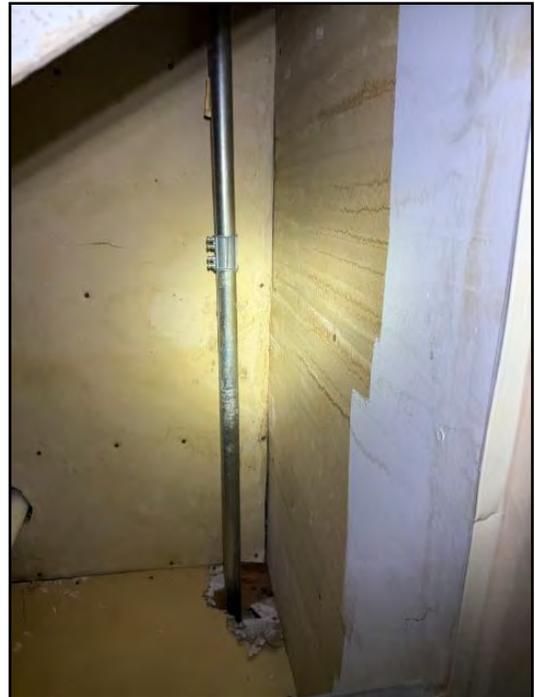
286. Water damage

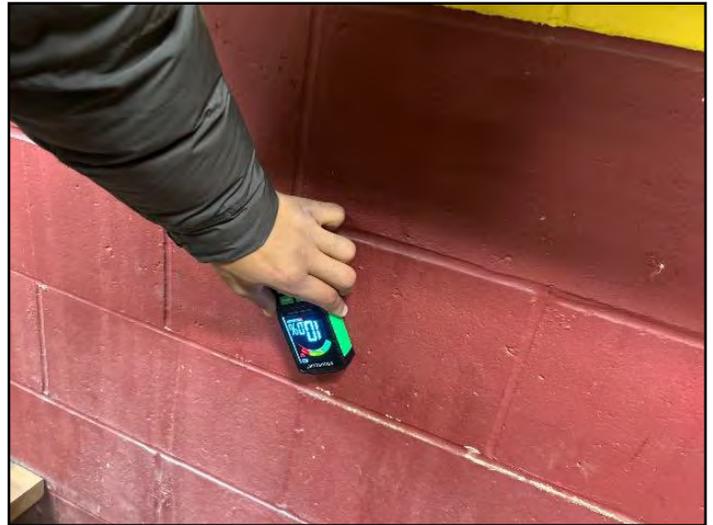
290. Active water leak detected

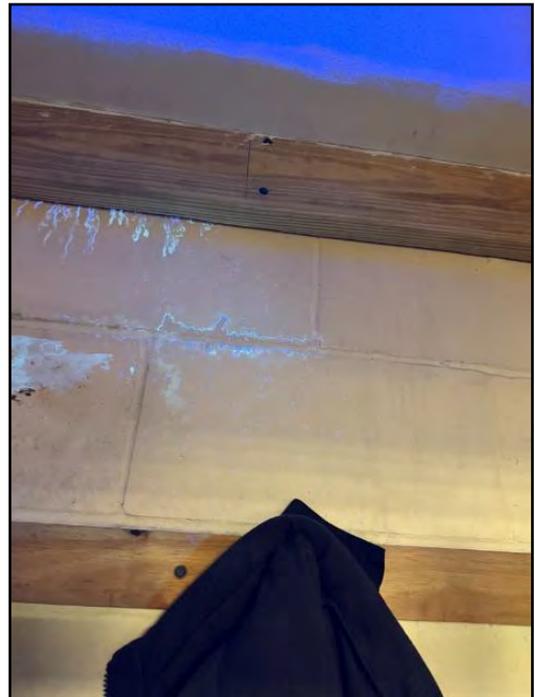
292. Active water leak detected

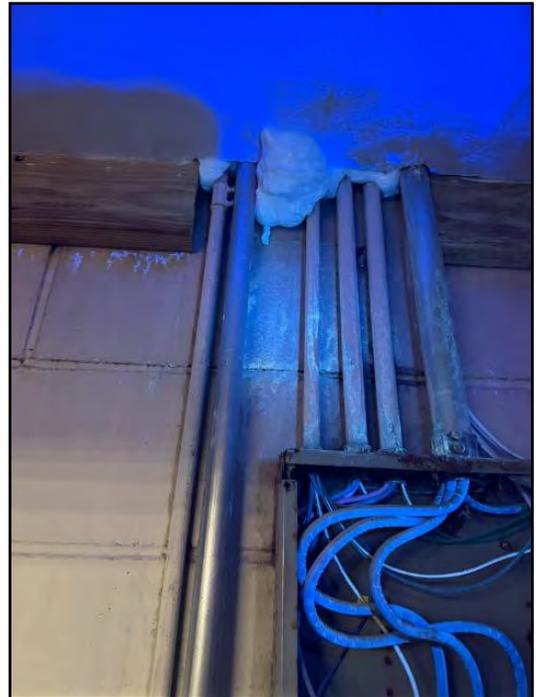
294. Active water leak detected

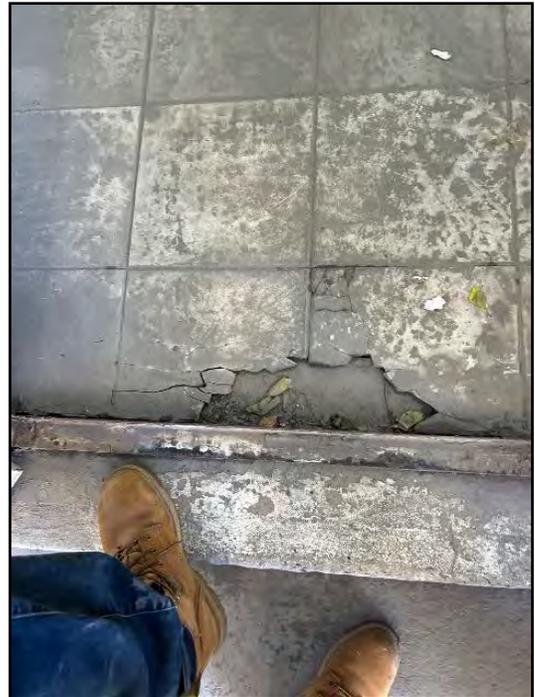
297. Tiles broken
