# Your Inspection Report

Thursday, October 23, 2025

Smart Choice Inspections LLC  
173 Ridge Road, Suite H1  
Cedar Grove, NJ 07009

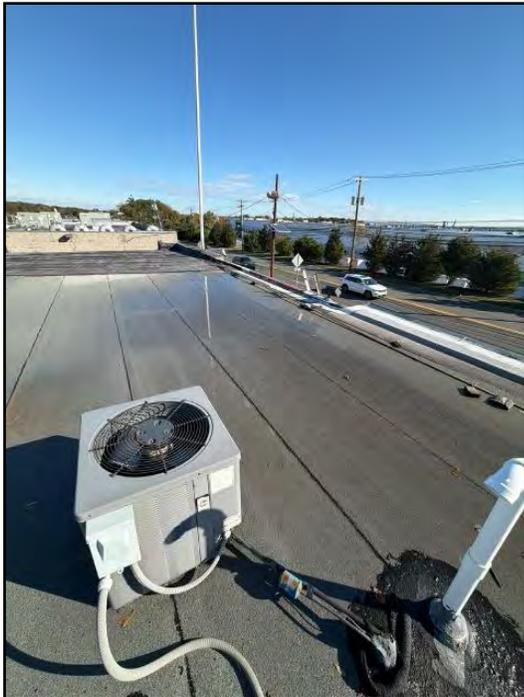
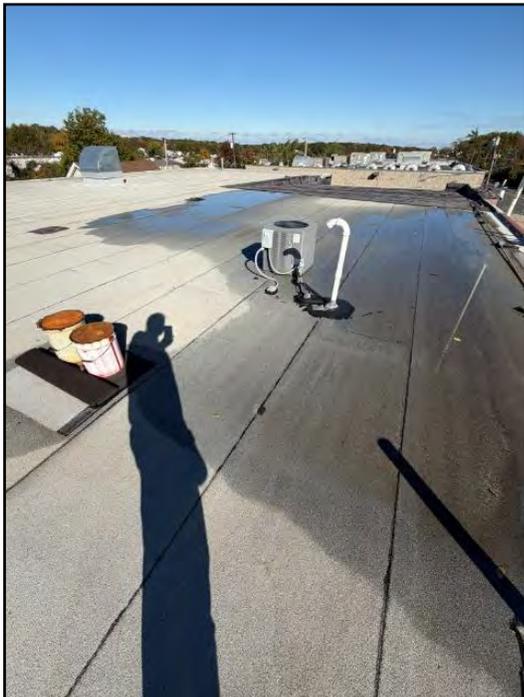
Signs of ponding

Implication(s): Chance of water damage to structure, finishes and contents

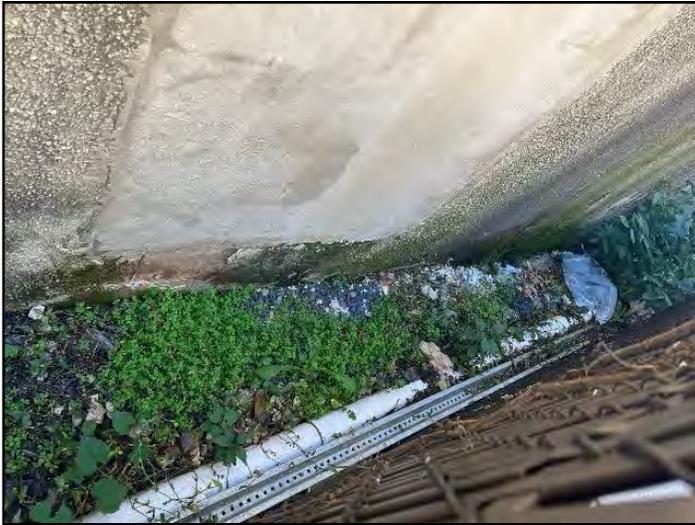
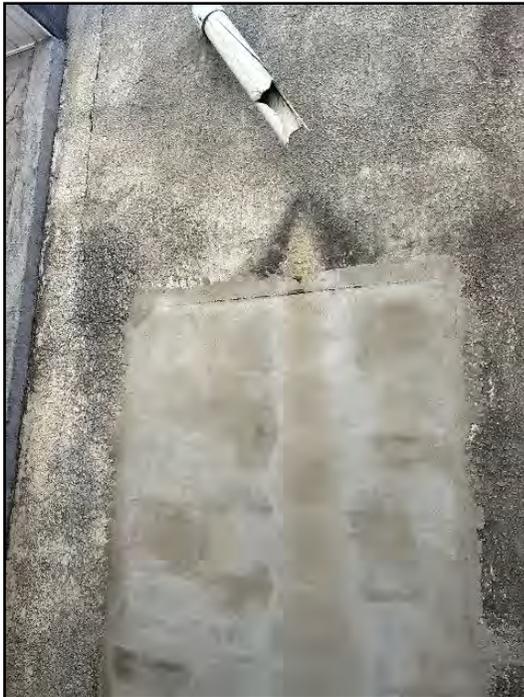
Downspout is causing an excessive amount of moisture issues with siding and foundation parging. Water penetration was observed on the inside which has lead to mold growth and has caused moisture issues to an improperly mounted panel. Recommend fixing downspout arrangement and mitigating moisture issues.

**Implication(s):** Chance of water damage to structure, finishes and contents

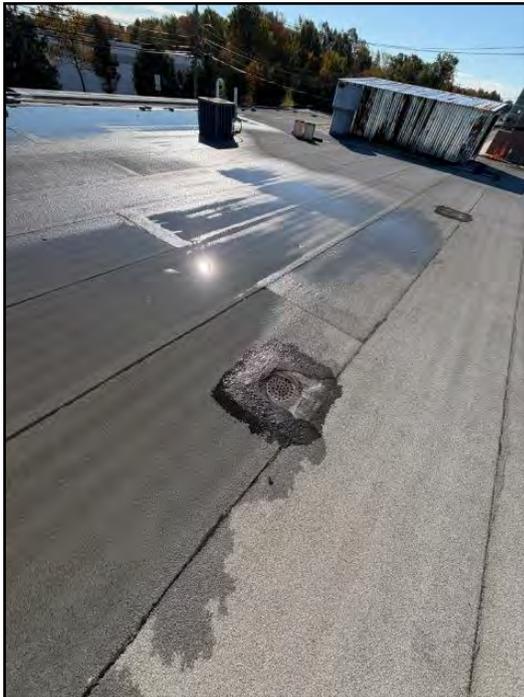
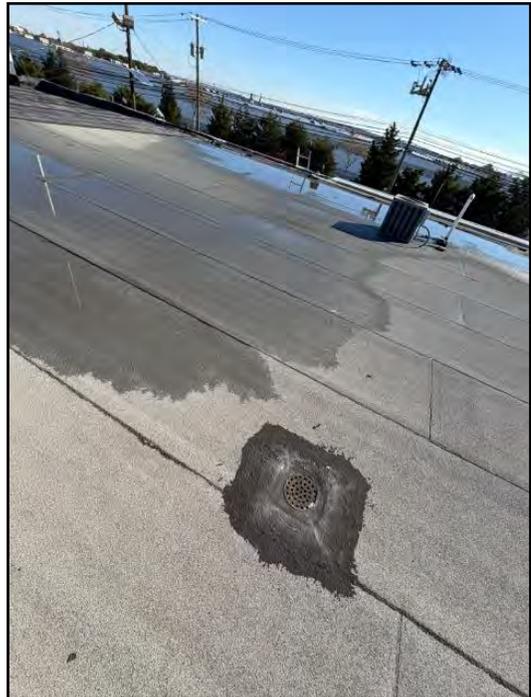
Condition: • [Drains not at low points](#)

Implication(s): Chance of water damage to structure, finishes and contents

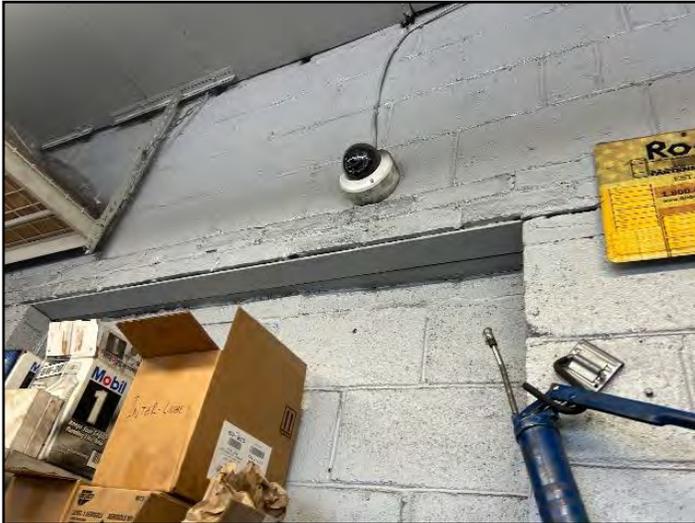
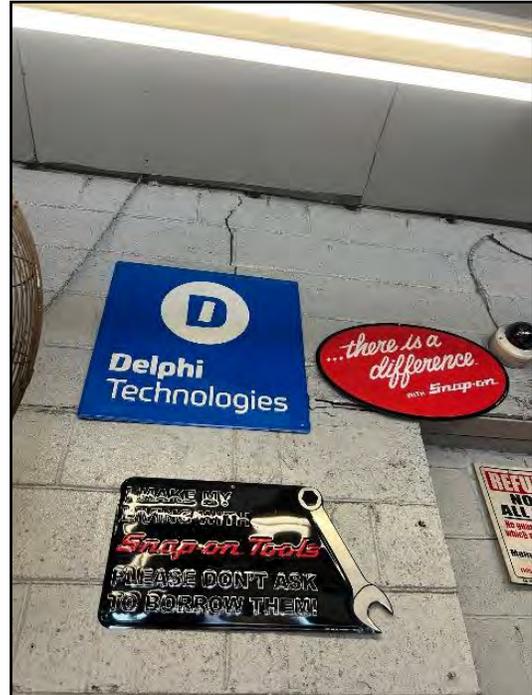
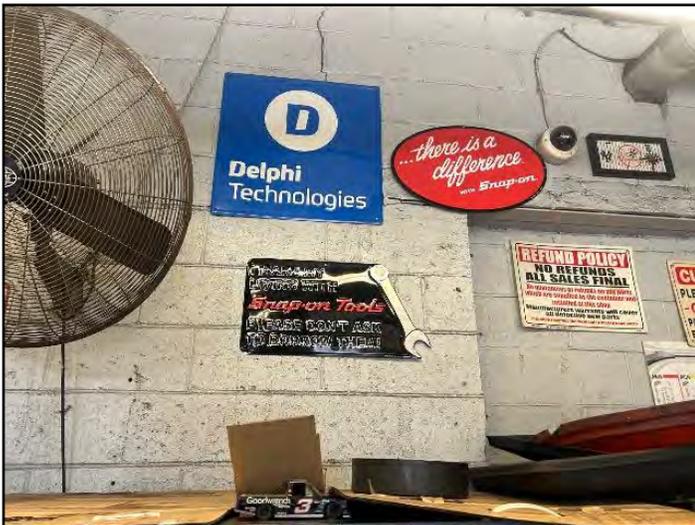
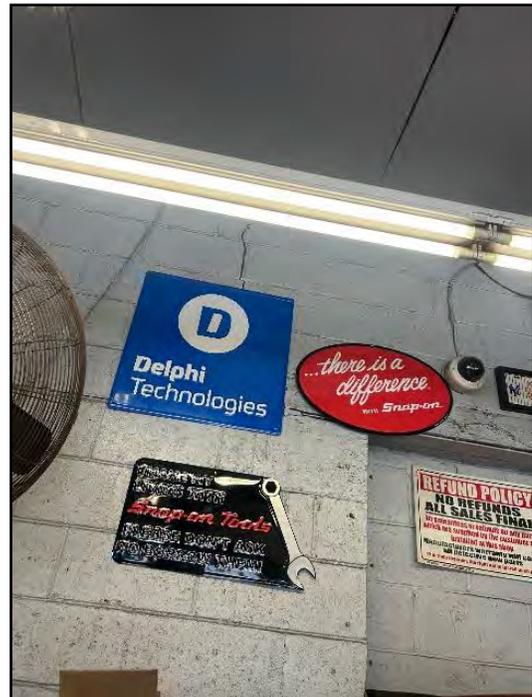
Condition: • [Cracked](#)

Implication(s): Weakened structure

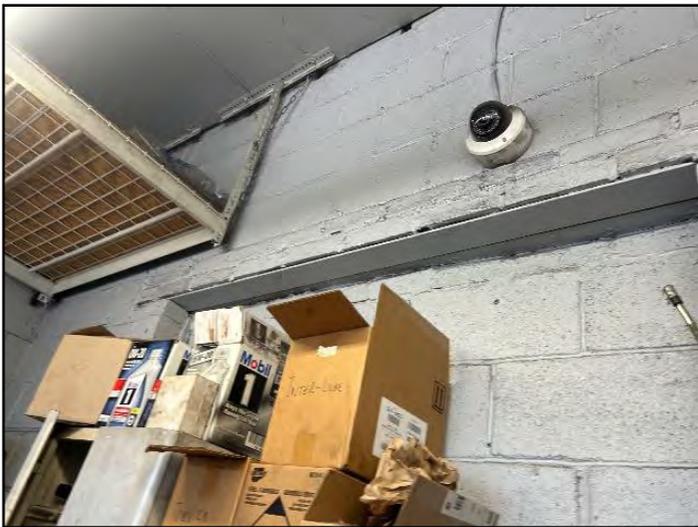
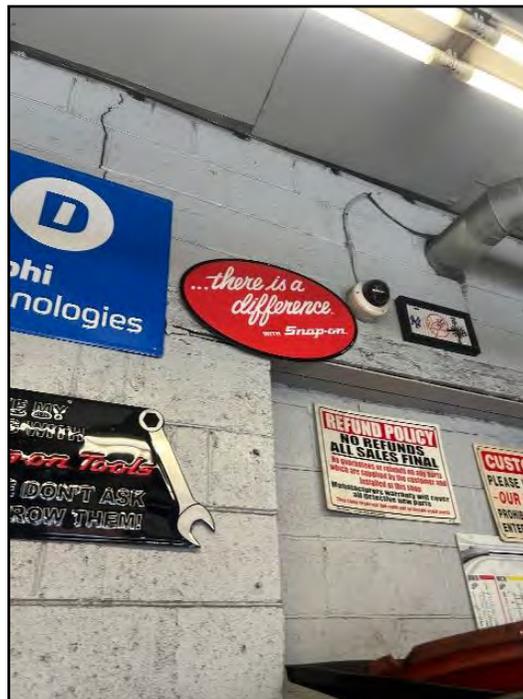
Structural cracks have begun to form on foundation wall due to sagging lintel. Recommend addressing the cracks and replacing lintel.

**Implication(s):** Weakened structure | Chance of structural movement

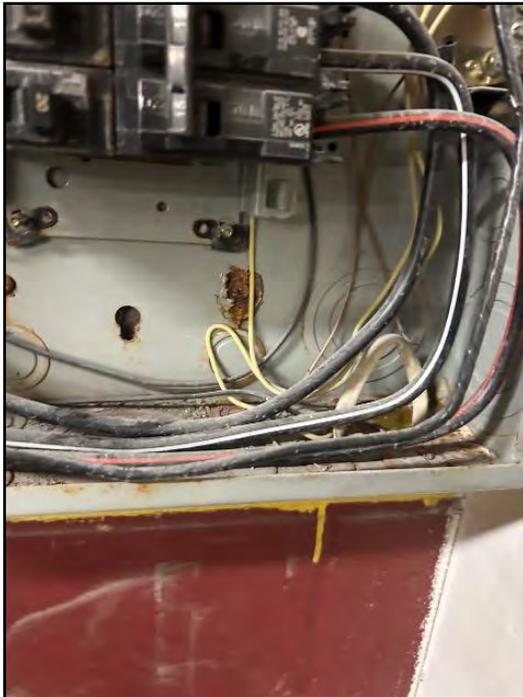
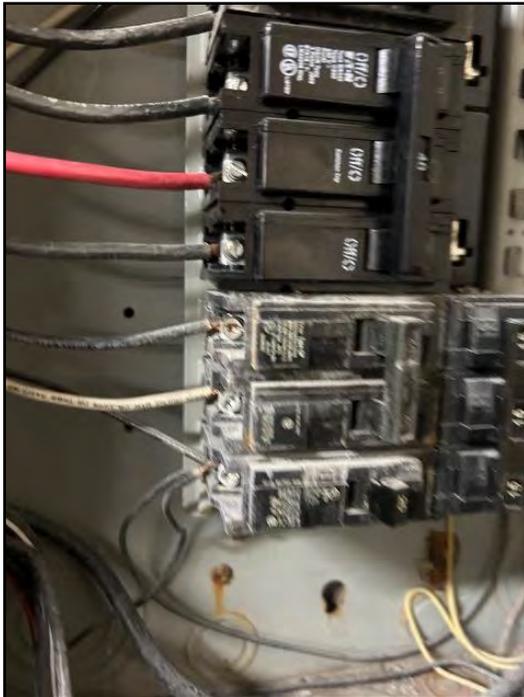
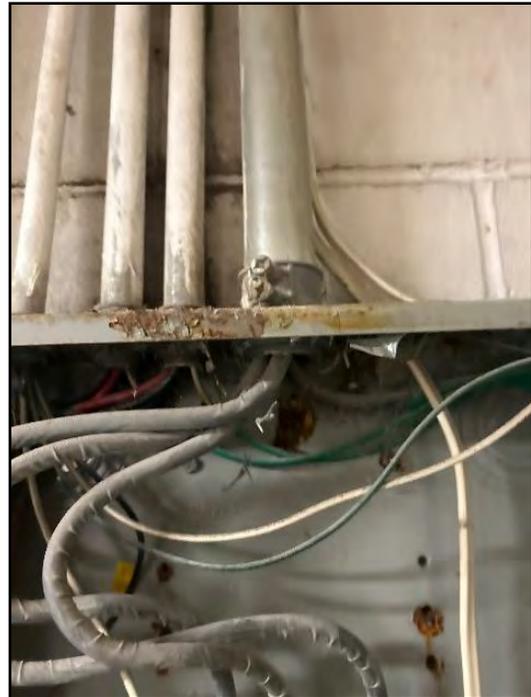
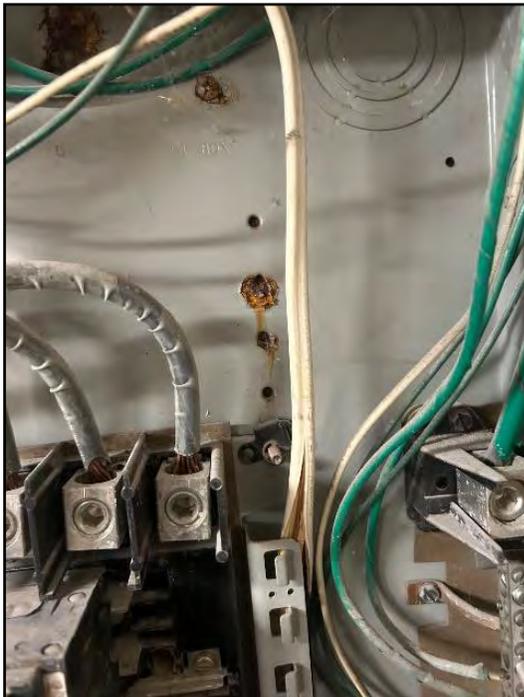
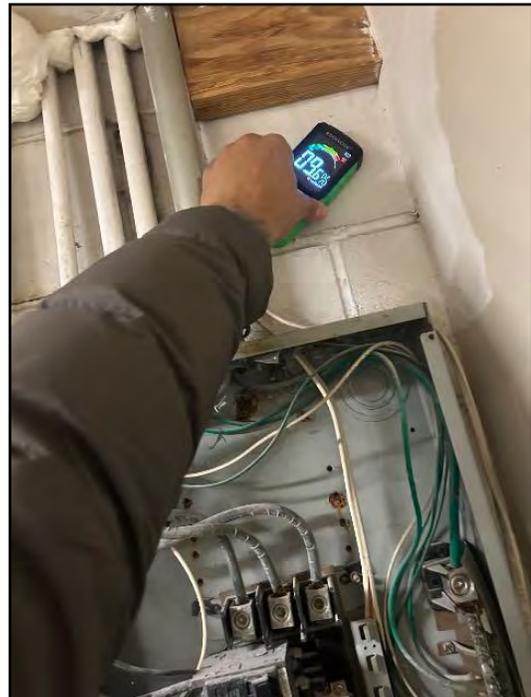
Corroded components observed during inspection of three phase distribution panel. Recommend hiring a licensed electrician to replace distribution panel. Also recommend for moisture issue in regards to downspout to be mitigated to ensure that this area does not remain an issue for future panels. Safety and fire hazard.

**Implication(s):** Electric shock | Fire hazard

**Task:** Replacement

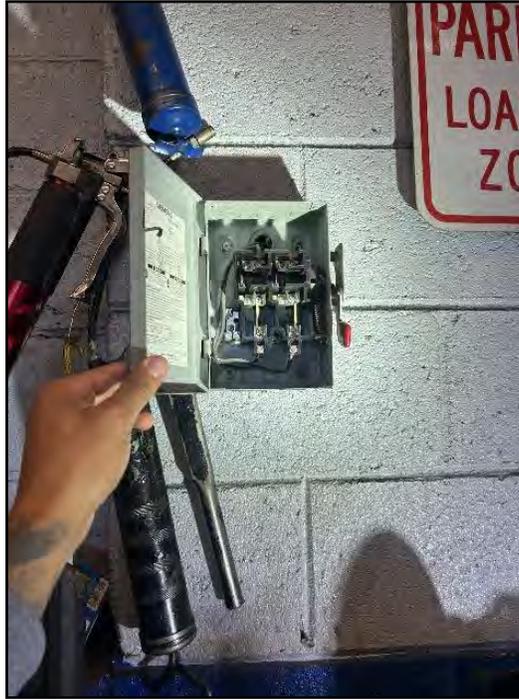
29. No fuses or breakers for subpanel (pony...

Copper wiring was installed in place of the required tube fuses, which eliminates overcurrent protection and creates a significant safety hazard.

**Implication(s):** Electric shock | Fire hazard

**Location:** Auto mechanic shop

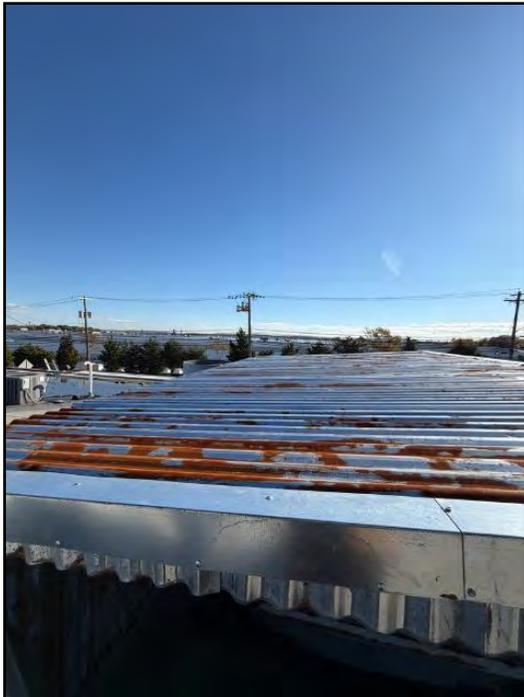
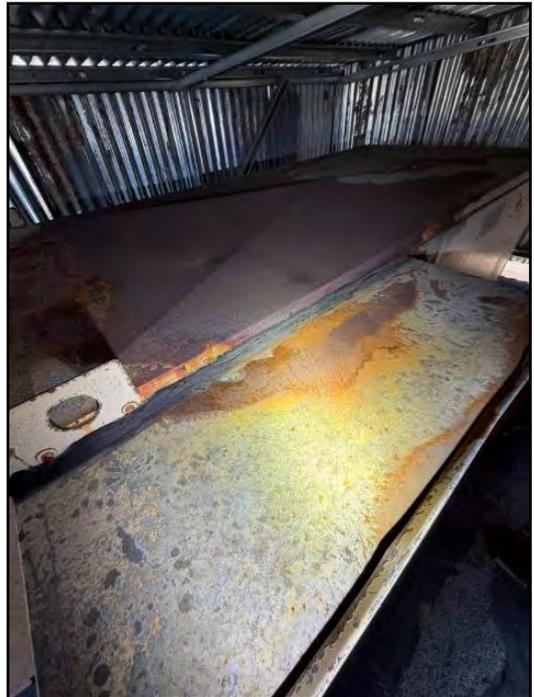
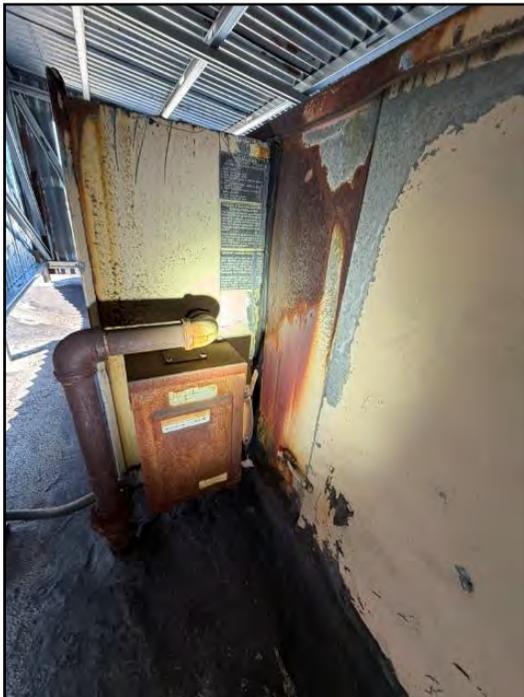
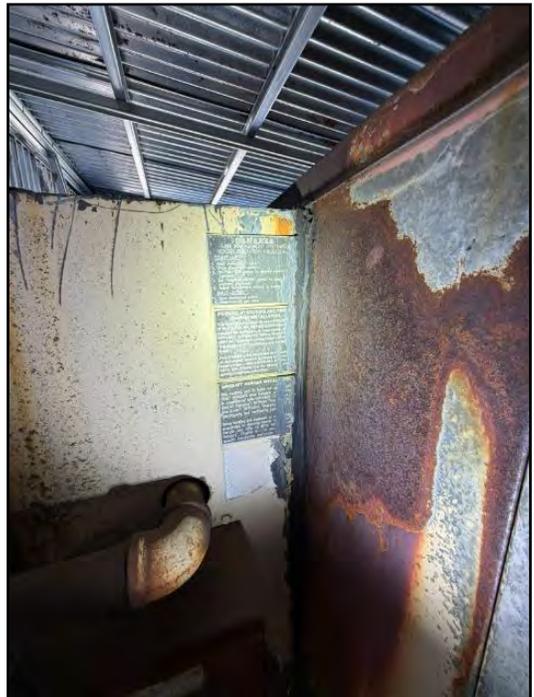
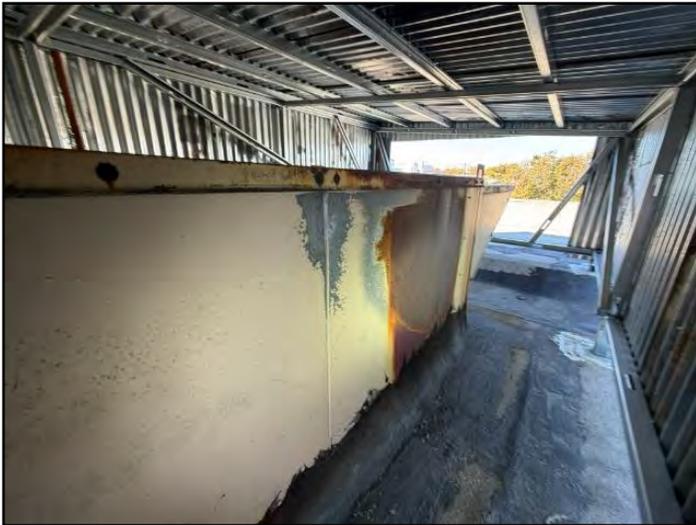
The furnace appears to be heavily corroded, and a structure has been built over it to prevent rain from entering the unit. This furnace is not used to heat the building but rather to provide heat and speed up the paint-drying process. The unit is over 20-30 years. If the paint booth will remain in the building after purchase, replacement of this furnace is highly recommended.

**Implication(s):** Material deterioration | Reduced system life expectancy

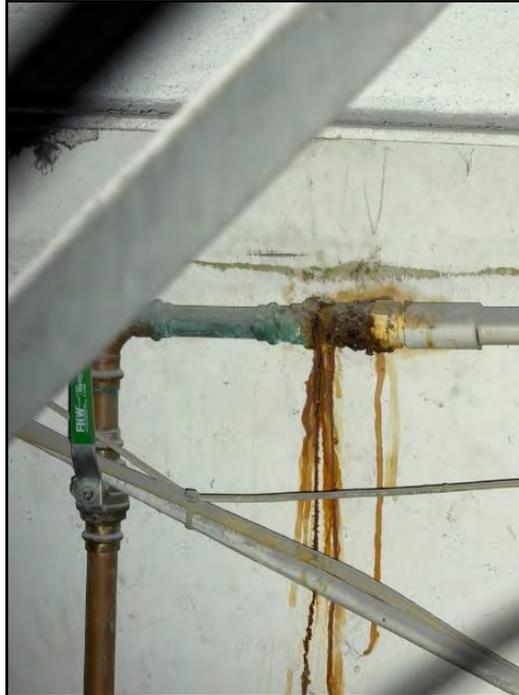
37. Leak

**Condition:** • [Leak](#)

**Implication(s):** Chance of water damage to structure, finishes and contents | System inoperative

**Location:** Seen above office space

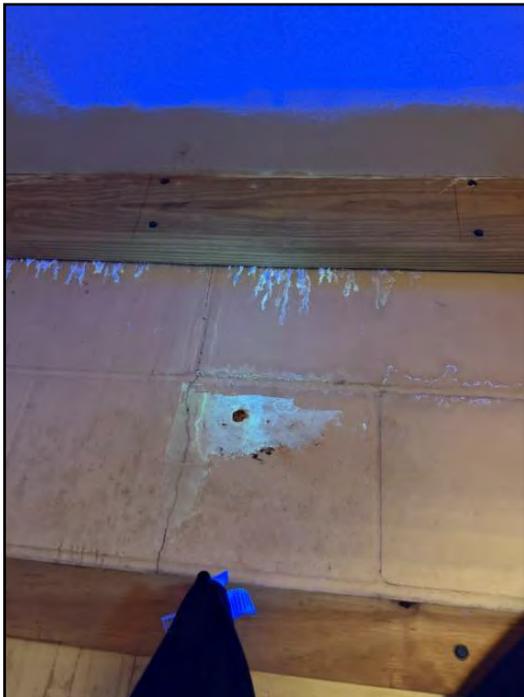
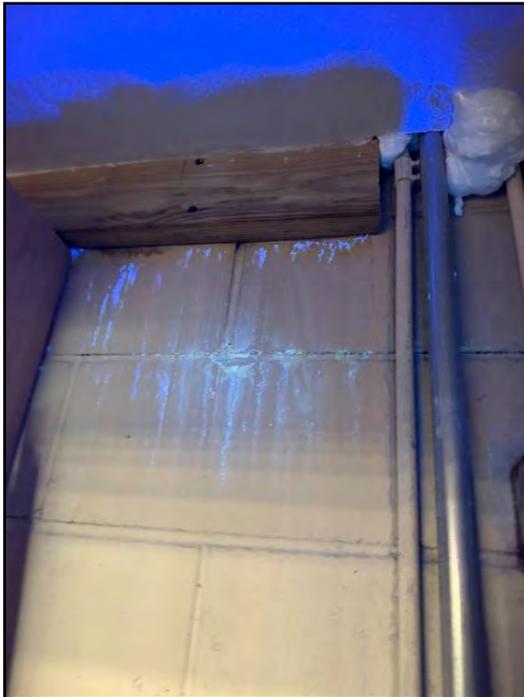
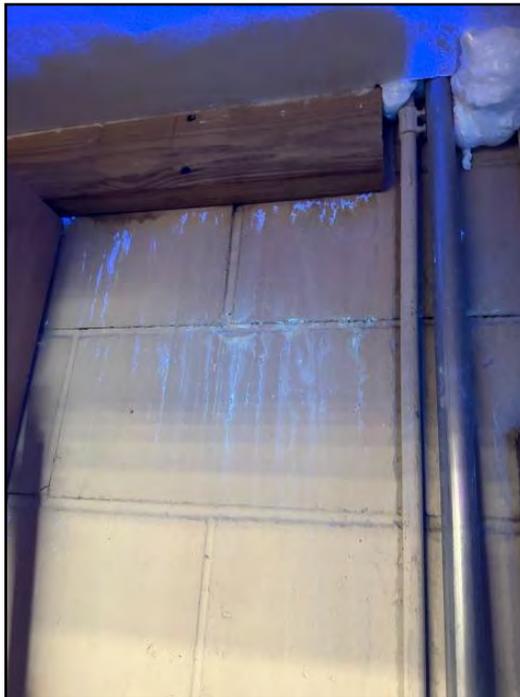
**Condition:** • Active water leak detected

Moisture was detected in the masonry block wall, and visible water stains were also observed.

It is suspected that the water is originating from an improperly discharged downspout connected to the flat roof gutter system.

**Implication(s):** Chance of movement, Rot, Leakage

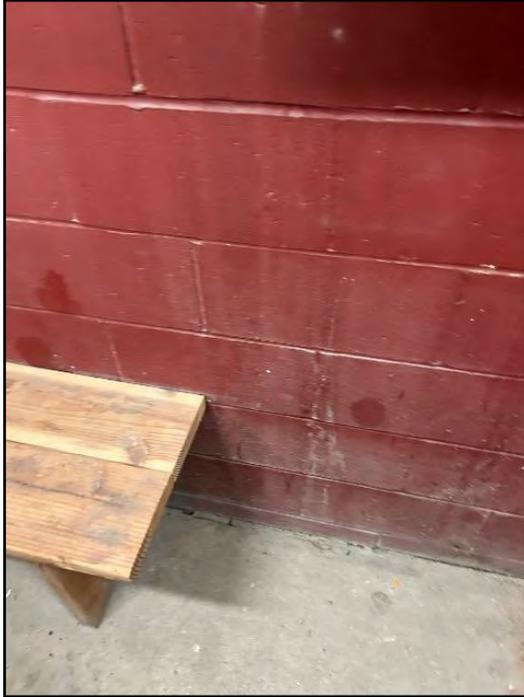
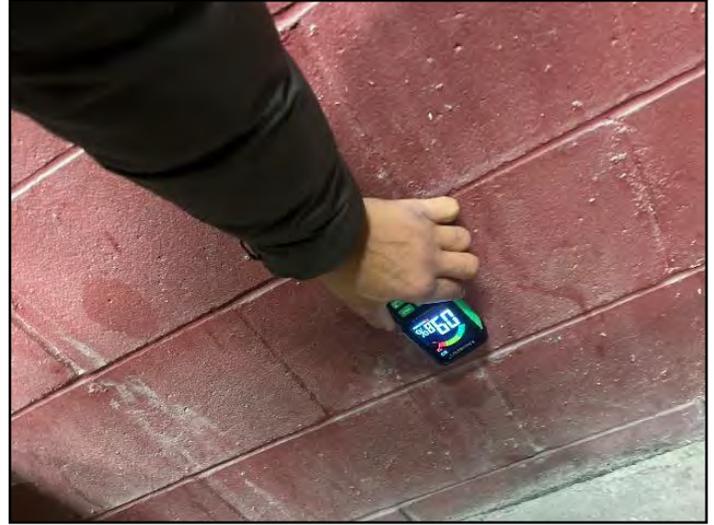
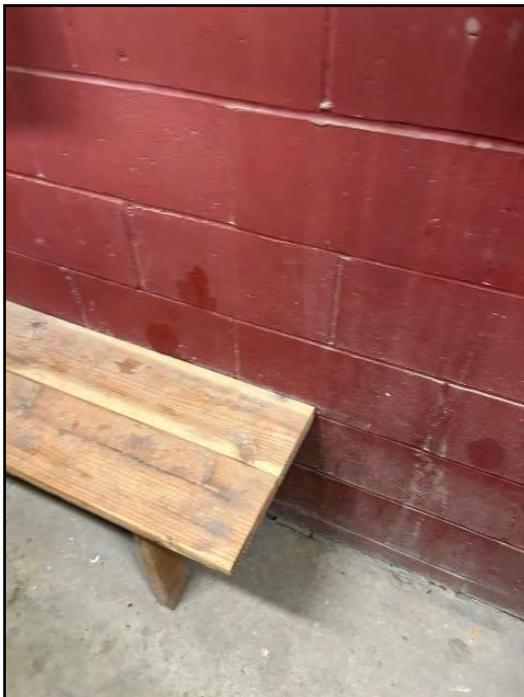
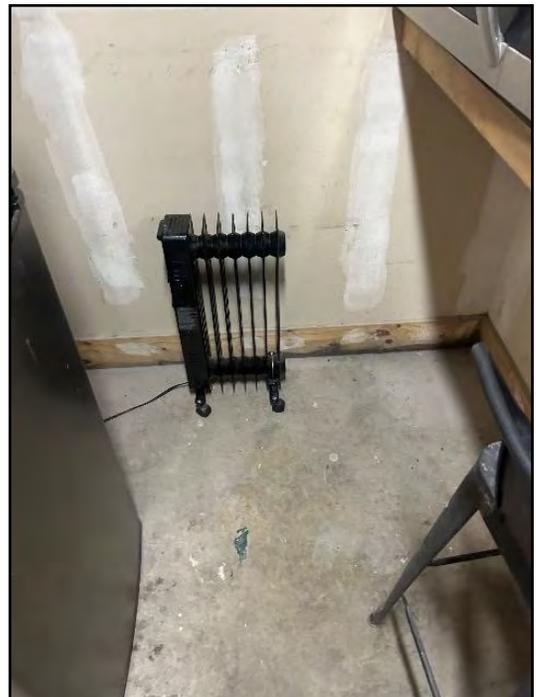
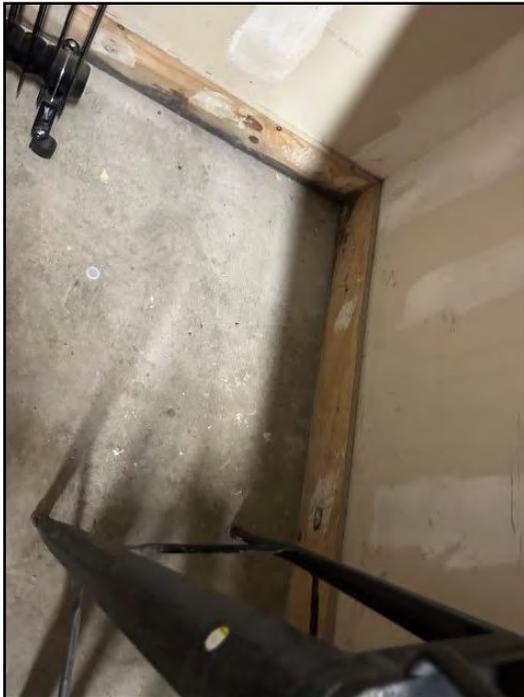
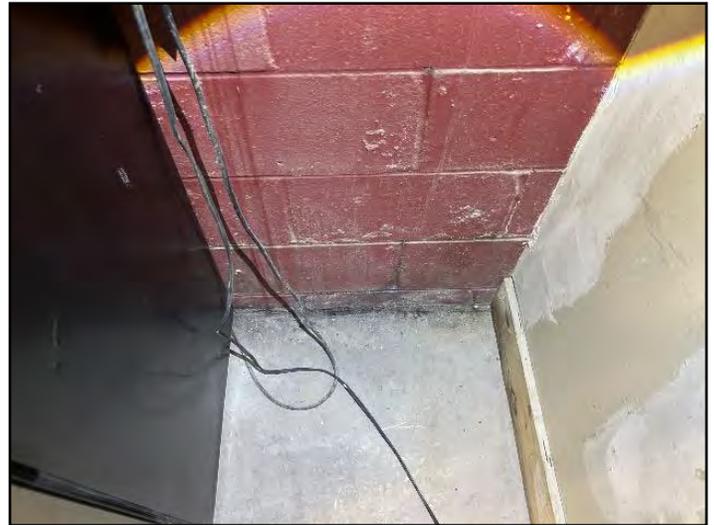
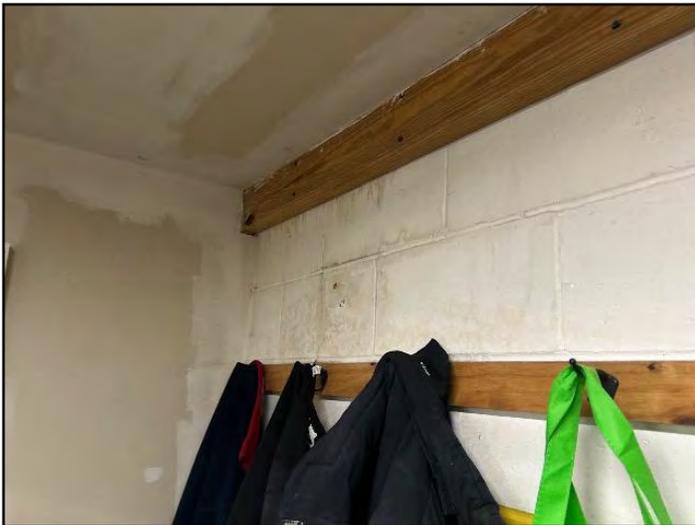
**Condition:** • Mold

**Implication(s):** Health hazard

Location: Kitchenette

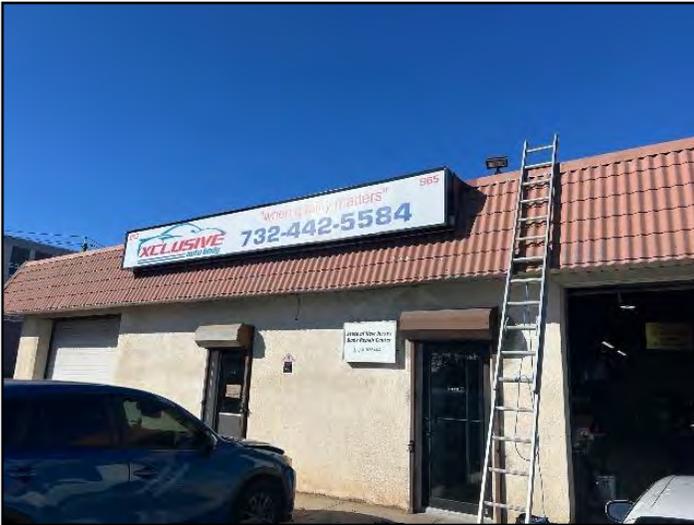
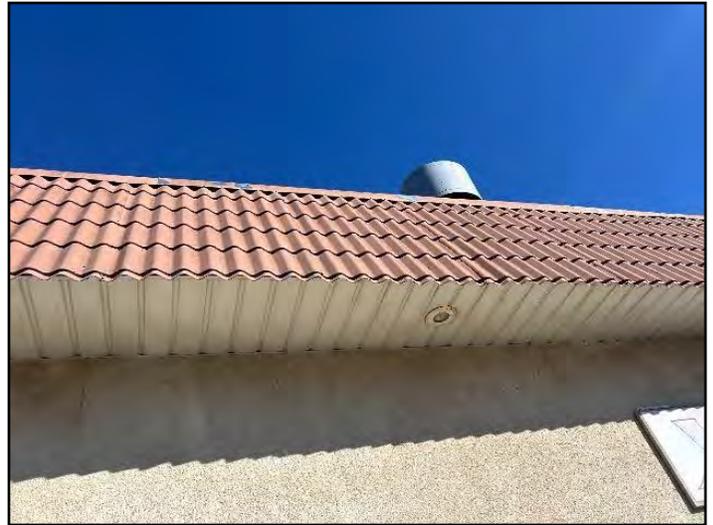
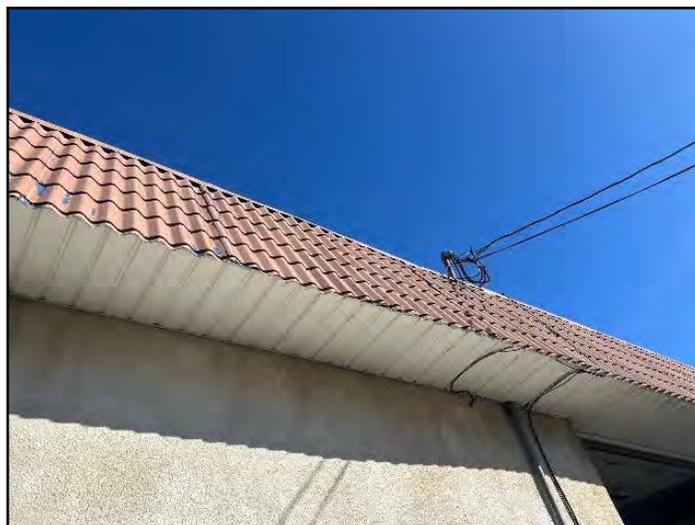
1. Condition: • Paint needed

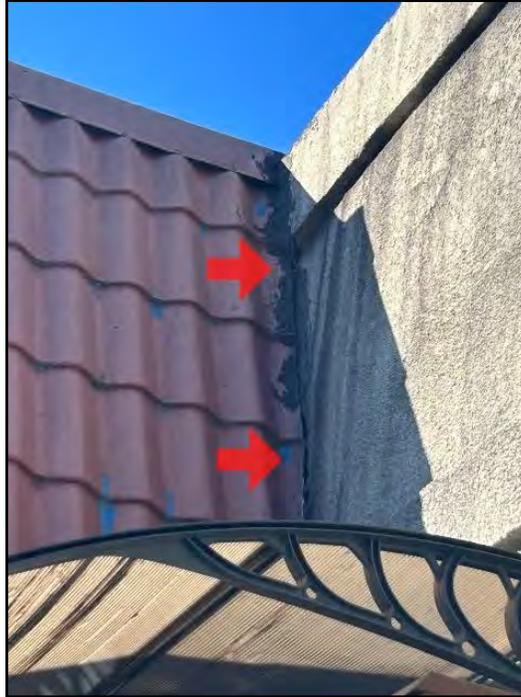
56. Damage, loose, open seams, patched

2. Condition: • [Damage, loose, open seams, patched](#)

Implication(s): Chance of water damage to structure, finishes and contents

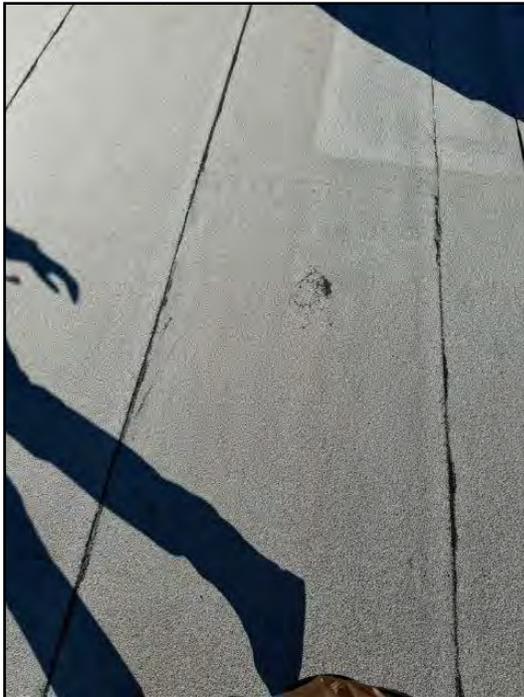
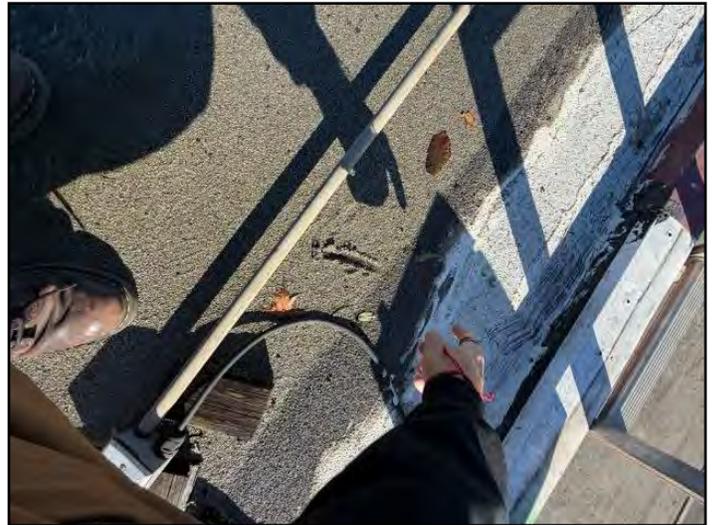
#### **4. Condition:** • [Loss of granules](#)

Excessive granule loss was observed on the roof surface in an area showing signs of ponding. This condition is likely the result of prolonged standing water over the years, which has accelerated the deterioration and loosening of the surface layer. Granules on rolled roofing help protect the underlying material from UV exposure and weathering; once they wear away, the roof becomes more vulnerable to cracking, leaks, and premature failure.

**Implication(s):** Chance of water damage to structure, finishes and contents

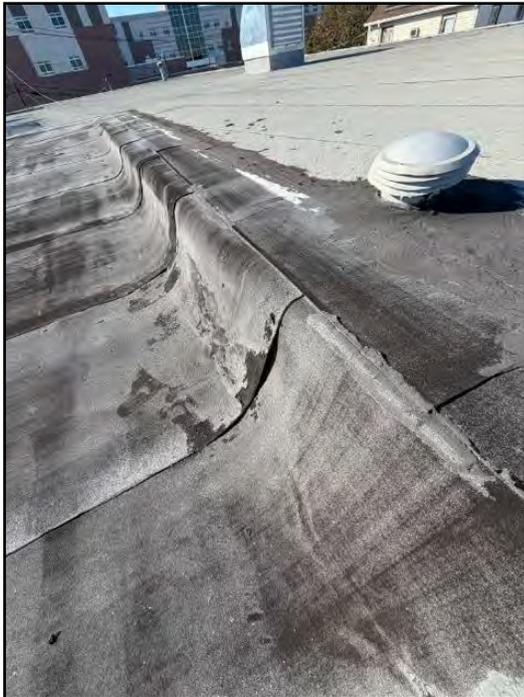
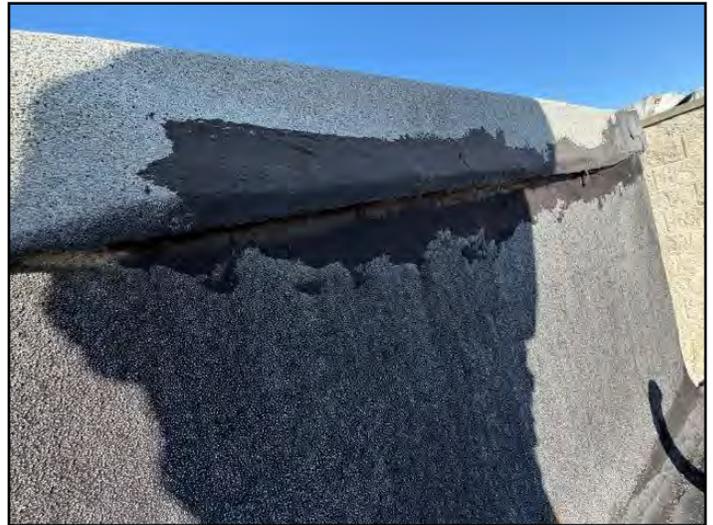
5. Condition: • [Openings at seams or flashings](#)

Implication(s): Chance of water damage to structure, finishes and contents

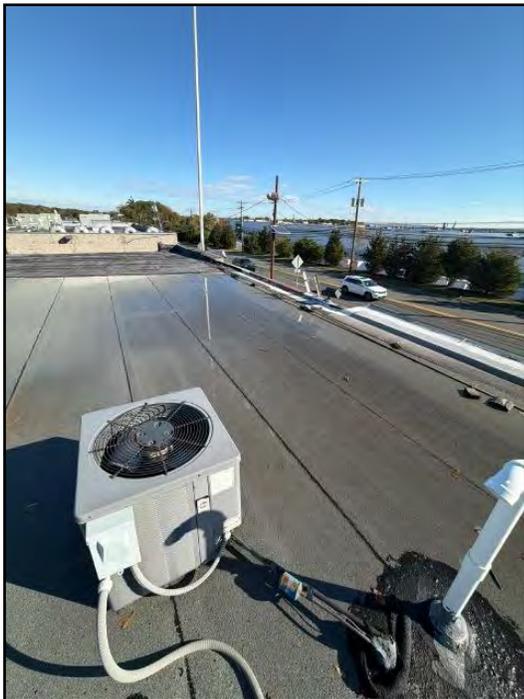
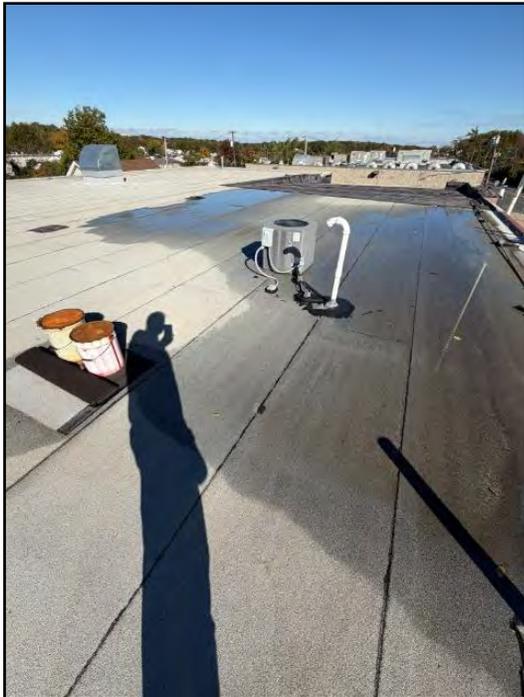
**7. Condition:** • [Ponding](#)

**Implication(s):** Chance of water damage to structure, finishes and contents

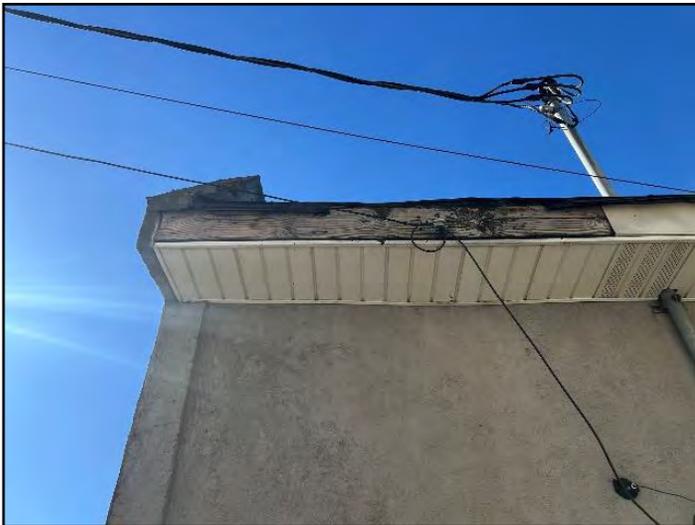
69. Multiple layers

8. Condition: • [Multiple layers](#)

Implication(s): Shortened life expectancy of material

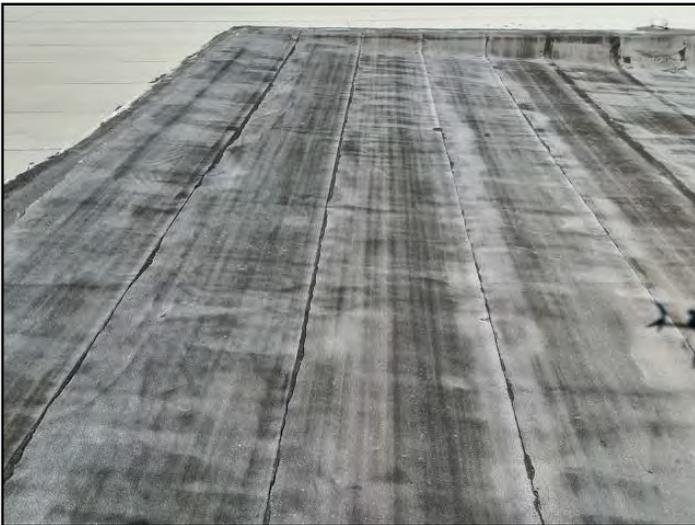
71. Wrinkles, ridges, fishmouths

9. Condition: • Wrinkles, ridges, fishmouths

Implication(s): Chance of water damage to structure, finishes and contents

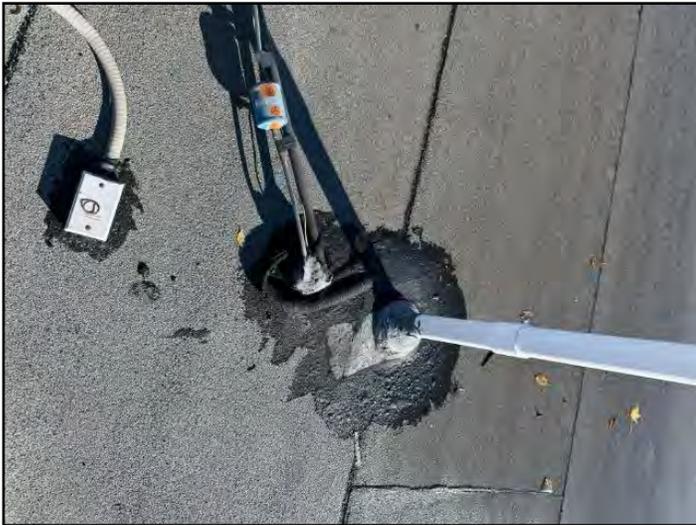
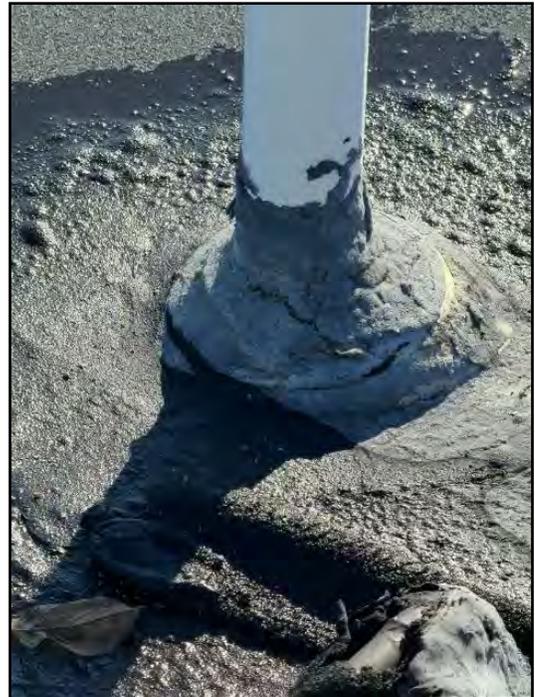
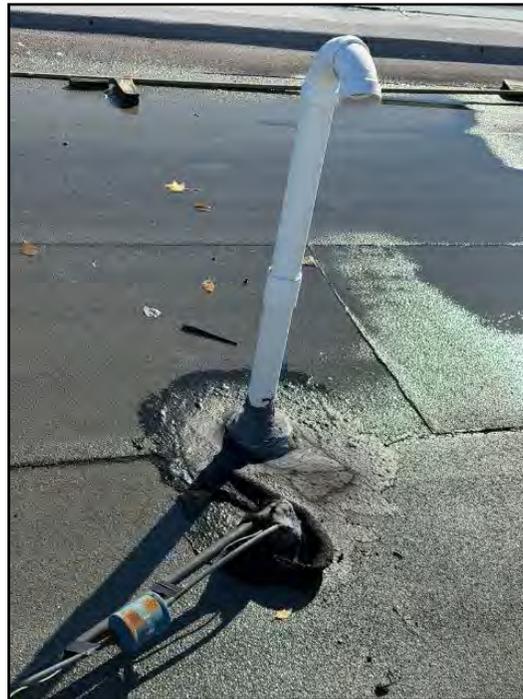
**10. Condition:** • An incorrect type of flashing has been used on flat roof pipe penetrations. It is recommended to install a proper flashing system designed for flat roofing, such as the Firestone QuickSeam Penetration Pocket (MB-P-6) or the Firestone QuickSeam Pipe Flashing (MB-P-5), to ensure a watertight and durable seal around the penetrations.

2. Firestone QuickSeam Pipe Flashing (MB-P-5):

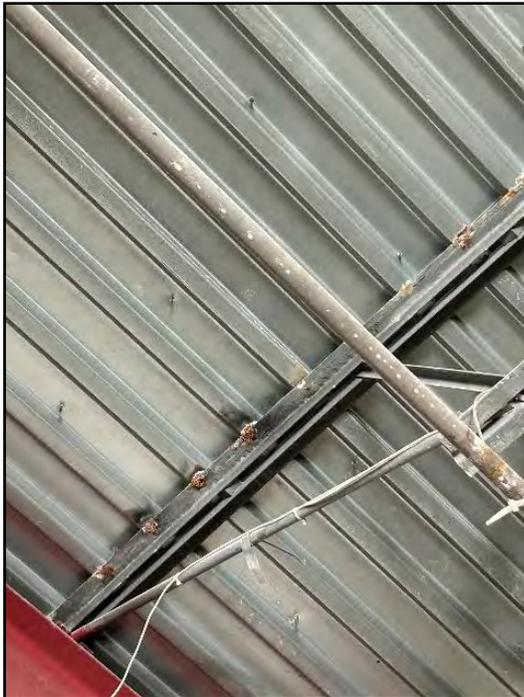
76. Rust

11. Condition: • [Rust](#)

Implication(s): Chance of water damage to structure, finishes and contents

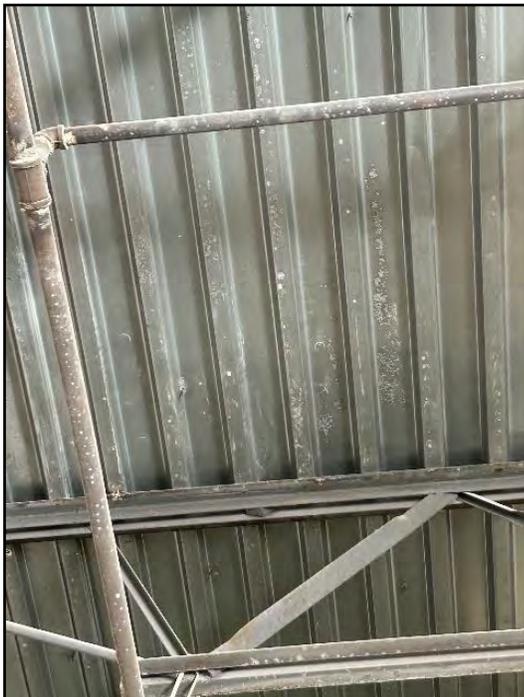
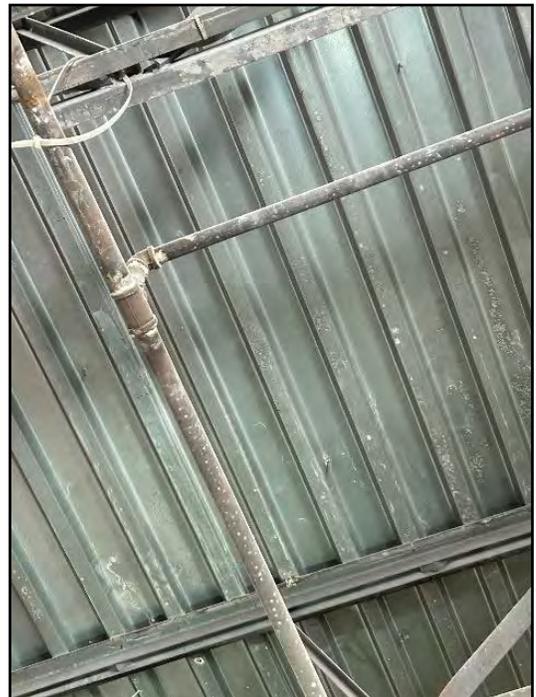
12. Condition: • Water stains

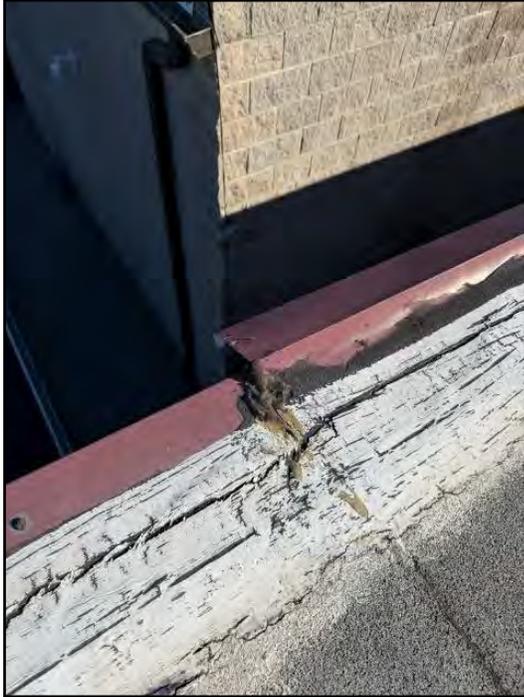
80. Open at seams or ends

13. Condition: • [Open at seams or ends](#)

**Implication(s):** Chance of water damage to structure, finishes and contents

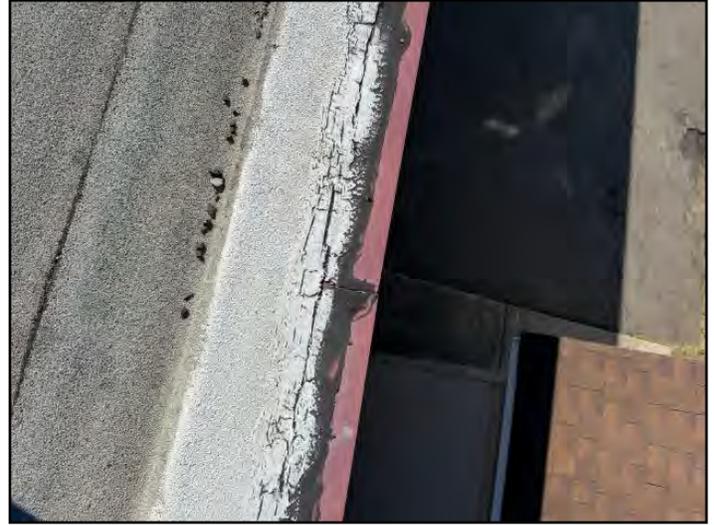
81. Open at seams or ends

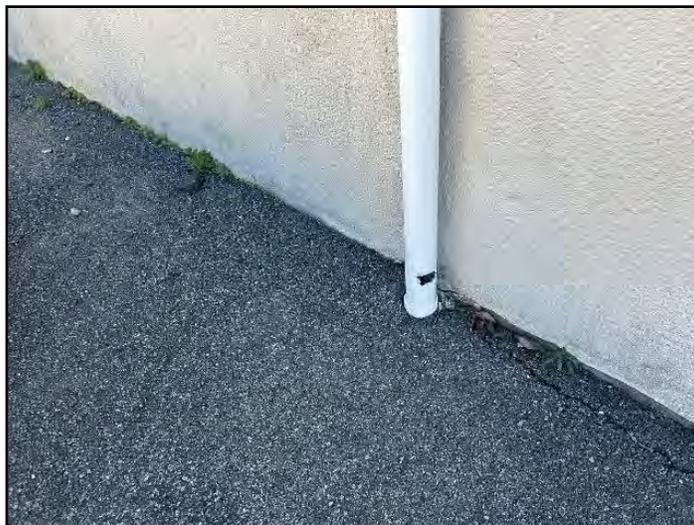
14. Condition: • [Damage](#)

84. Damage

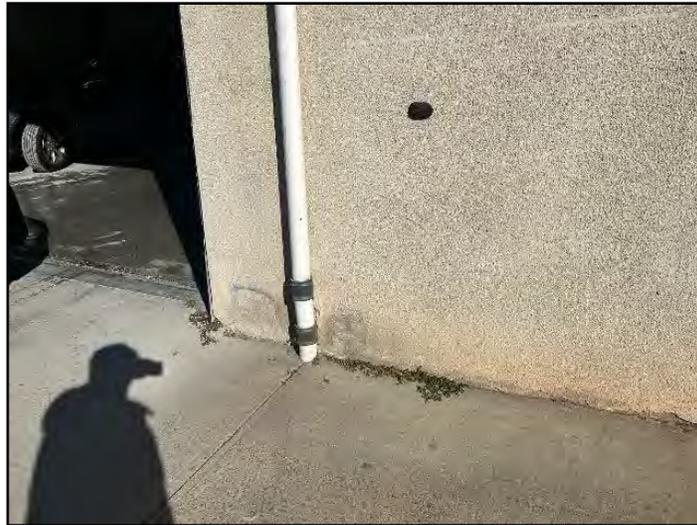
15. Condition: • [Discharge below grade](#)

85. Discharge below grade

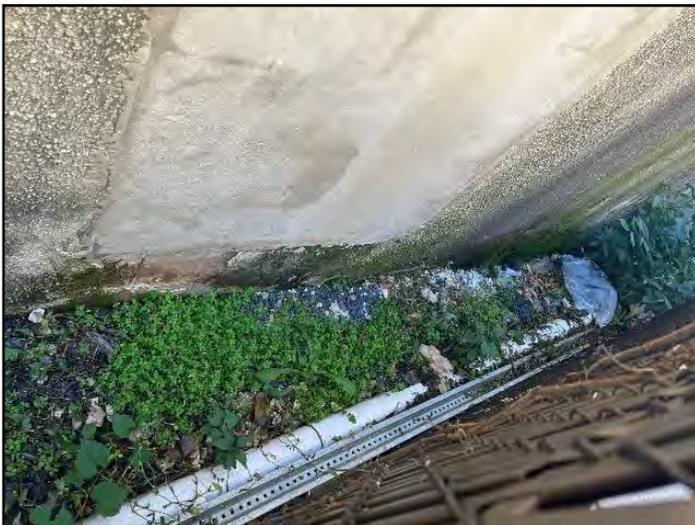
Downspout is causing an excessive amount of moisture issues with siding and foundation parging. Water penetration was observed on the inside which has lead to mold growth and has caused moisture issues to an improperly mounted panel. Recommend fixing downspout arrangement and mitigating moisture issues.

86. Moisture penetration

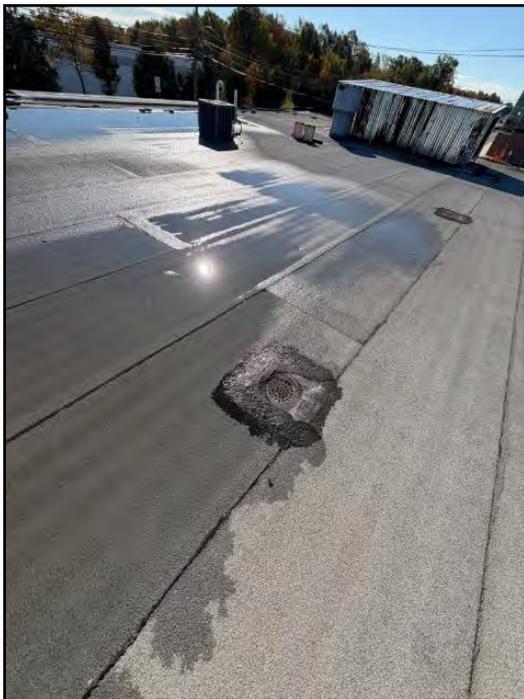
17. Condition: • [Drains not at low points](#)

92. Drains not at low points

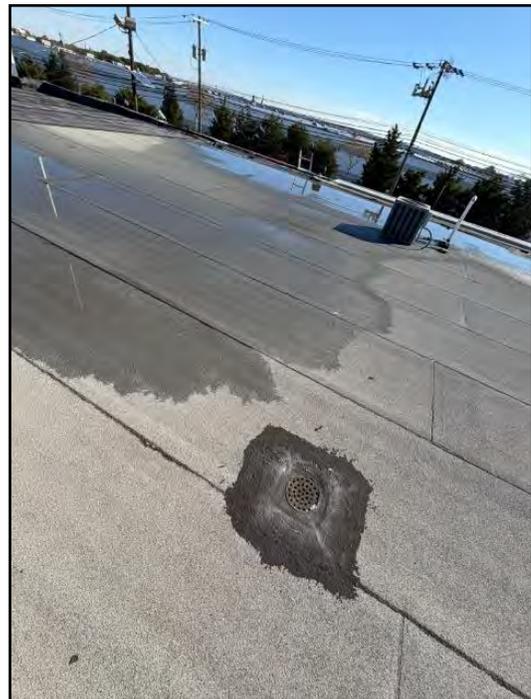
93. Drains not at low points
