# Your Inspection Report

Thursday, October 23, 2025

Smart Choice Inspections LLC  
173 Ridge Road, Suite H1  
Cedar Grove, NJ 07009

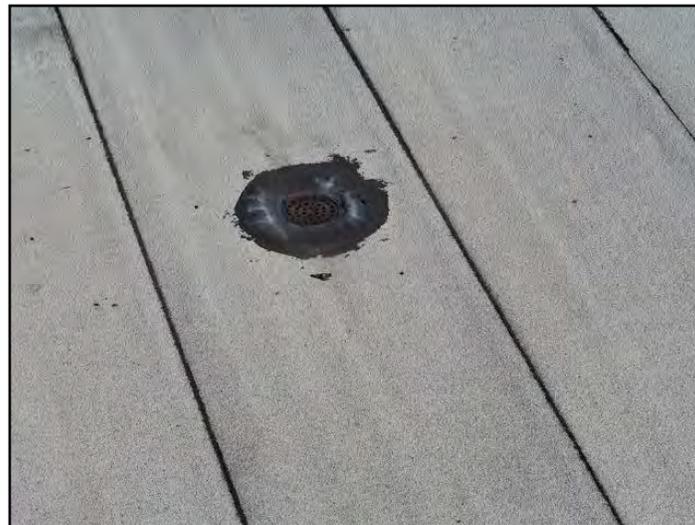
18. Condition: • [Strainer missing](#)

interior flat roof drains clogged with debris can cause water ponding, leading to: shortened roof life, possible freeze/thaw damage, additional weight/roof sag and significant water infiltration if a leak occurs

94. Strainer missing

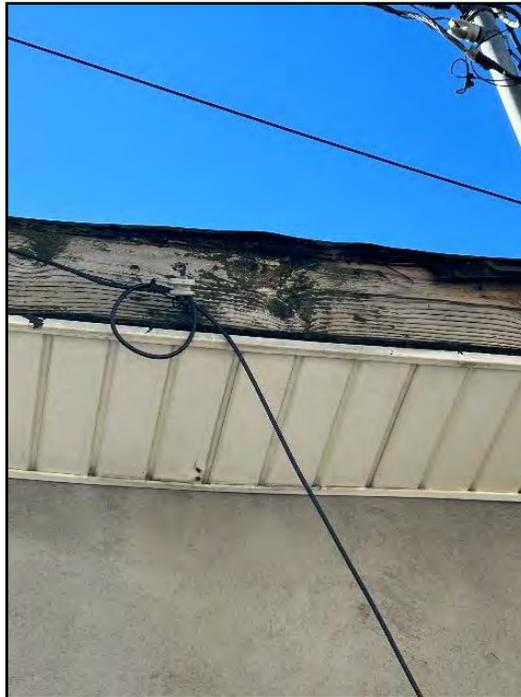
19. Condition: • [Rot](#)

95. Rot

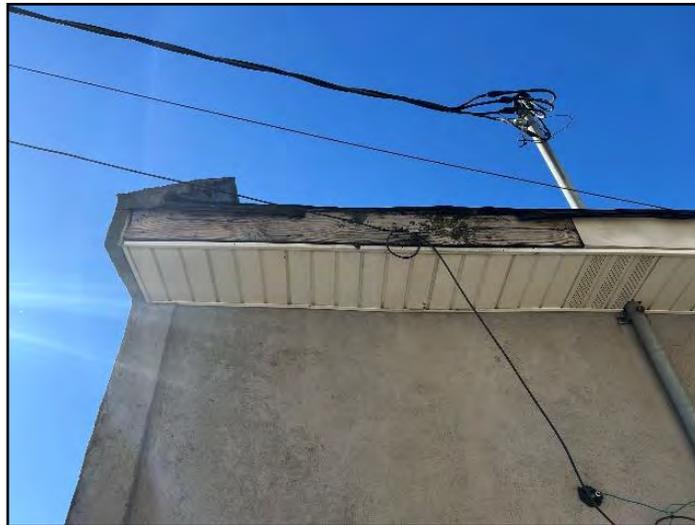
20. Condition: • [Loose or missing pieces](#)

96. Loose or missing pieces

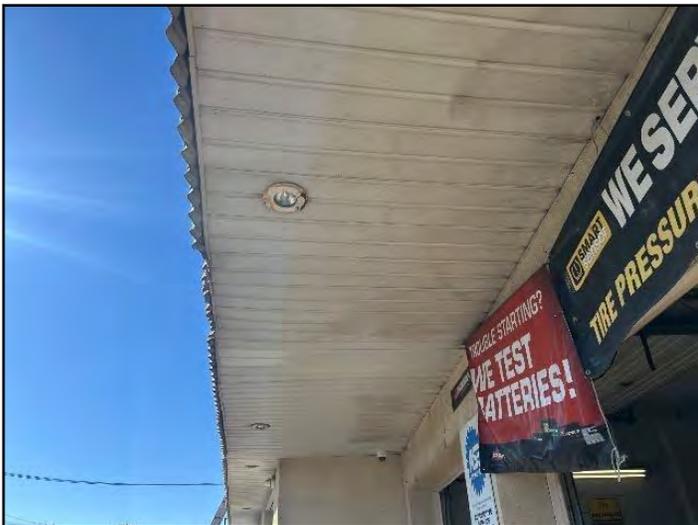
21. Condition: • Buckled soffit covers

97. Buckled soffit covers

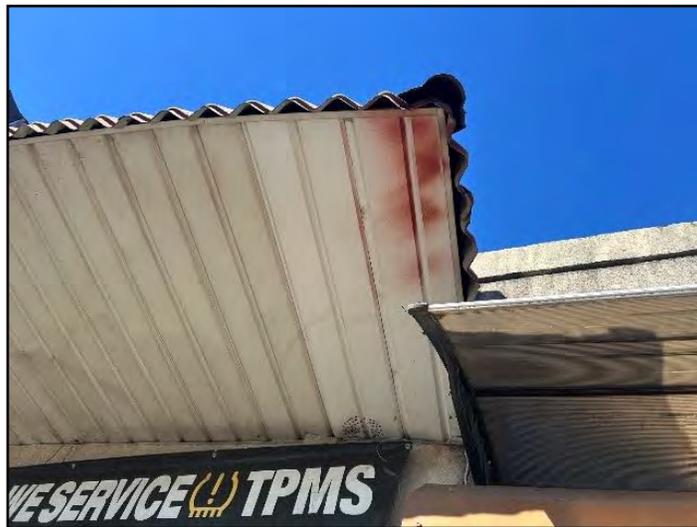
99.

22. Condition: • Paint needed

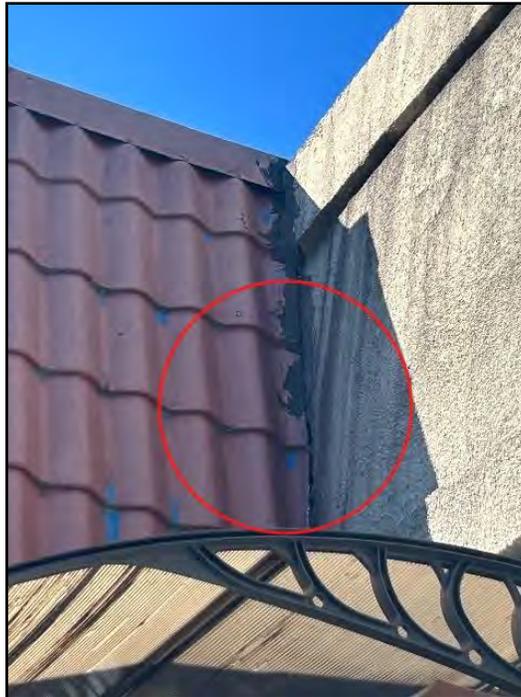
23. Condition: • [Moisture penetration](#)

100. Moisture penetration

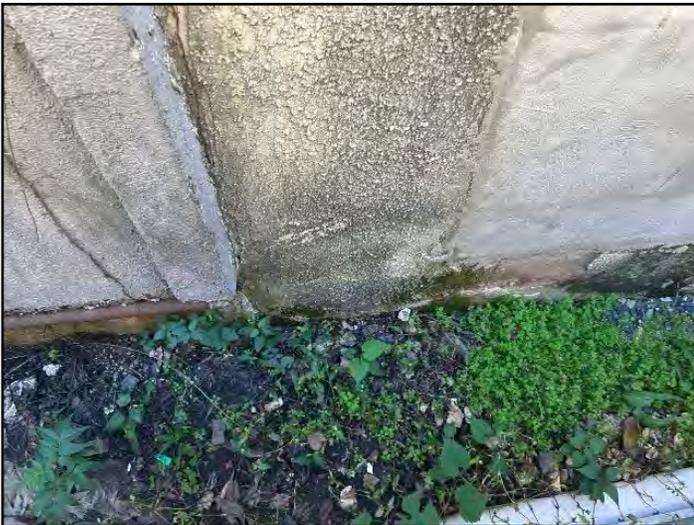
24. Condition: • [Moisture penetration](#)

101. Moisture penetration

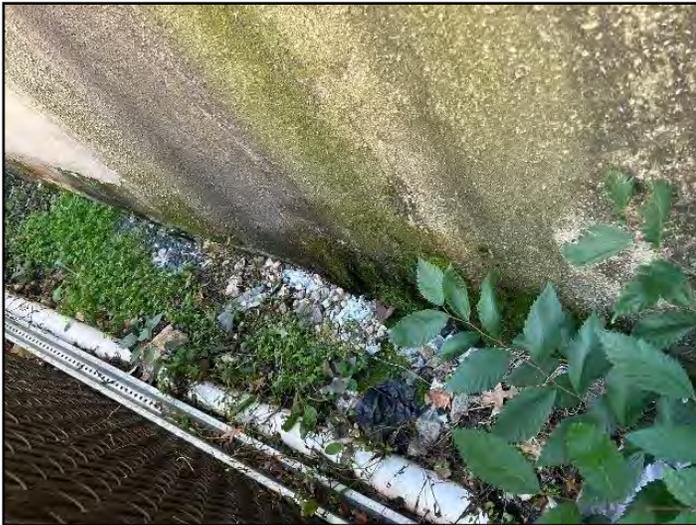
103. Moisture penetration

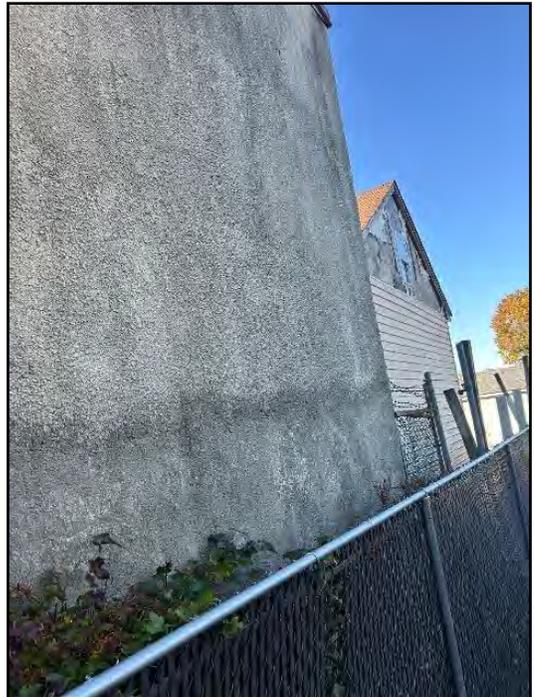
104. Moisture penetration

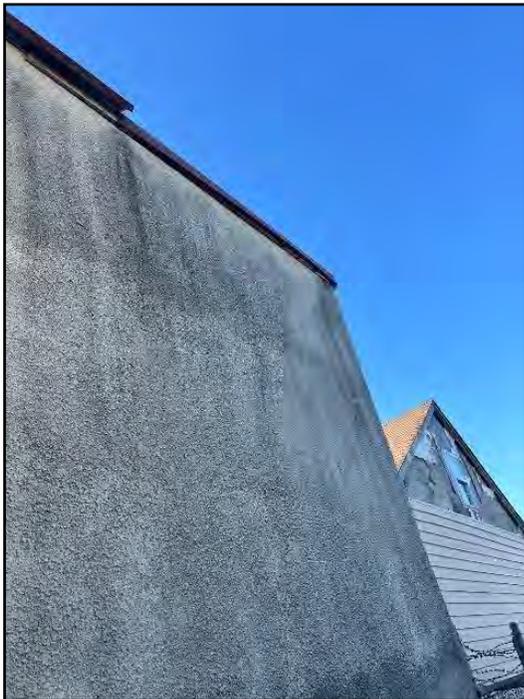
105. Moisture penetration

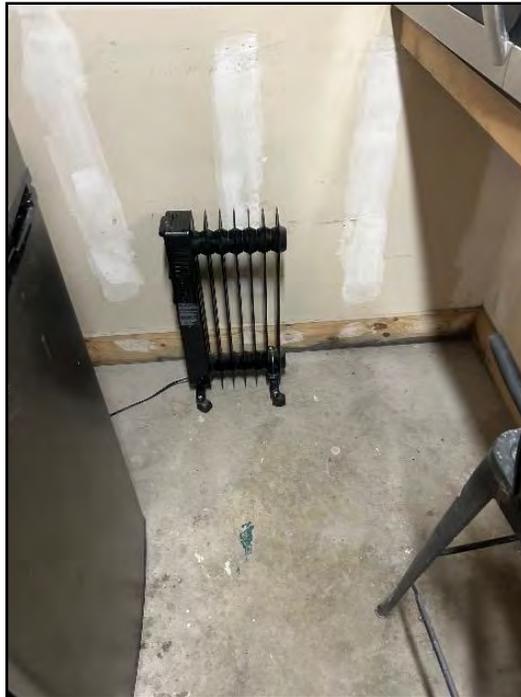
107. Moisture penetration

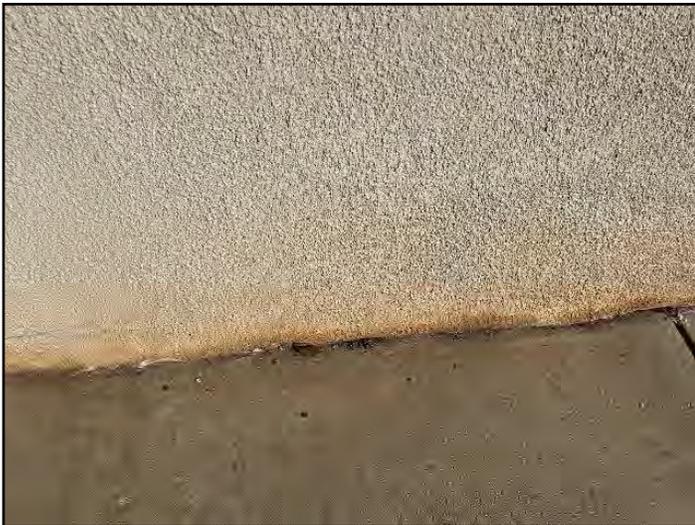
25. Condition: • [Moisture penetration](#)

108. Moisture penetration

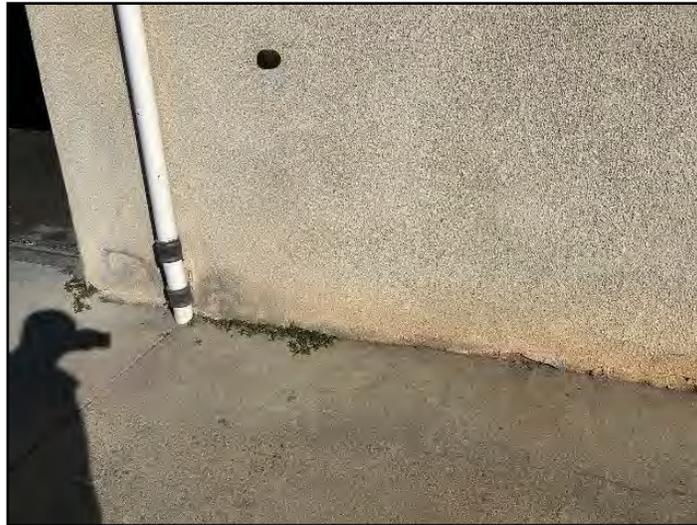
110. Moisture penetration

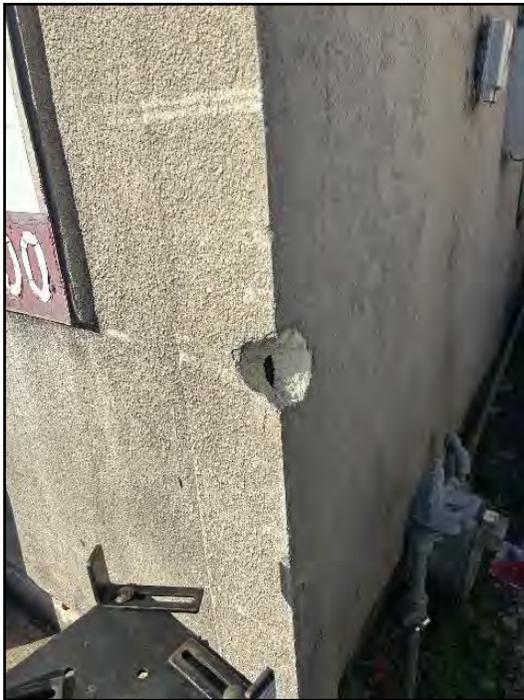
26. Condition: • [Mechanical damage](#)

111. Mechanical damage

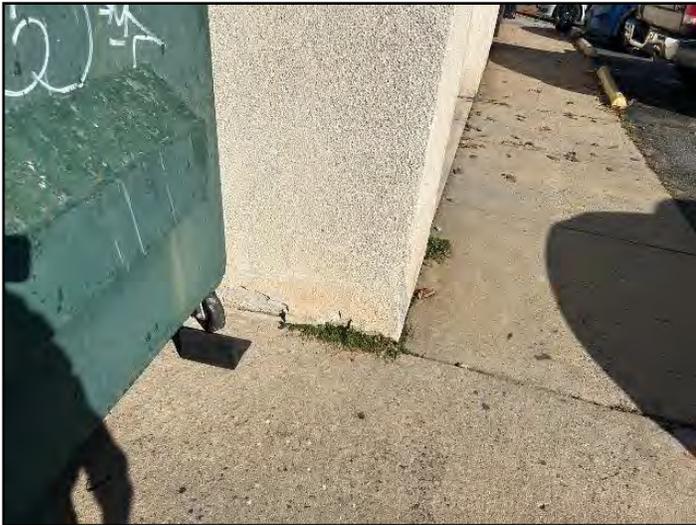
27. Condition: • [Mechanical damage](#)

113. Mechanical damage

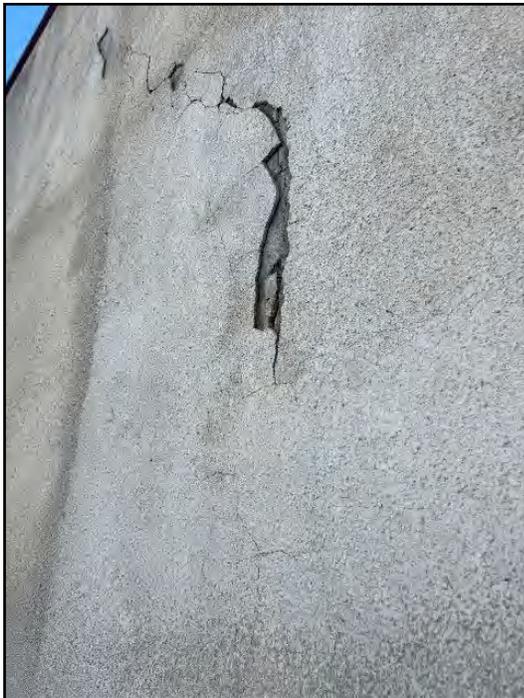
28. Condition: • [Mechanical damage](#)

115. Mechanical damage

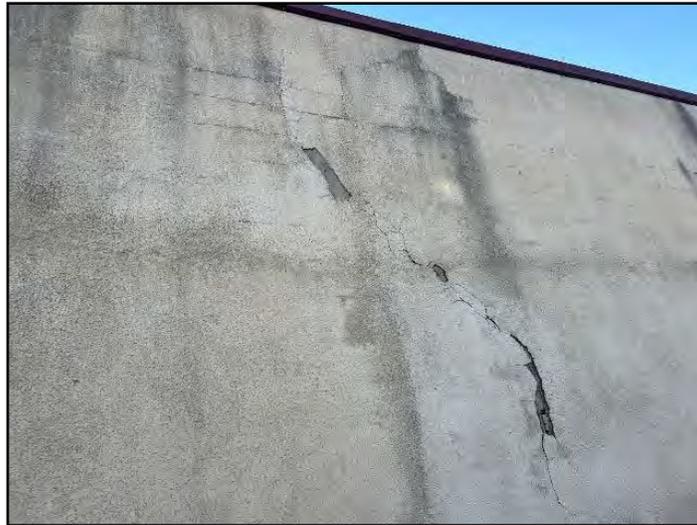
117. Mechanical damage

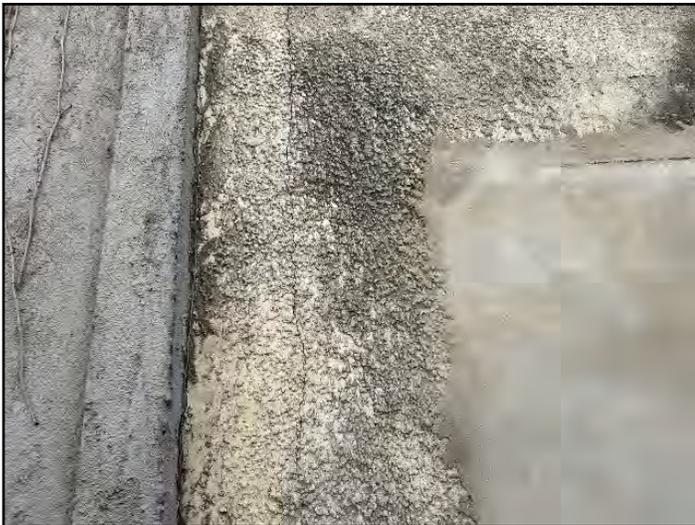
29. Condition: • [Cracked](#)

118. Cracked

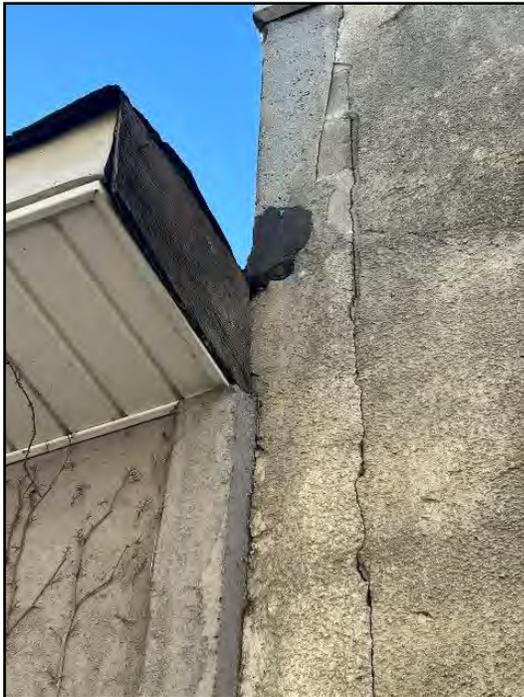
120. Cracked

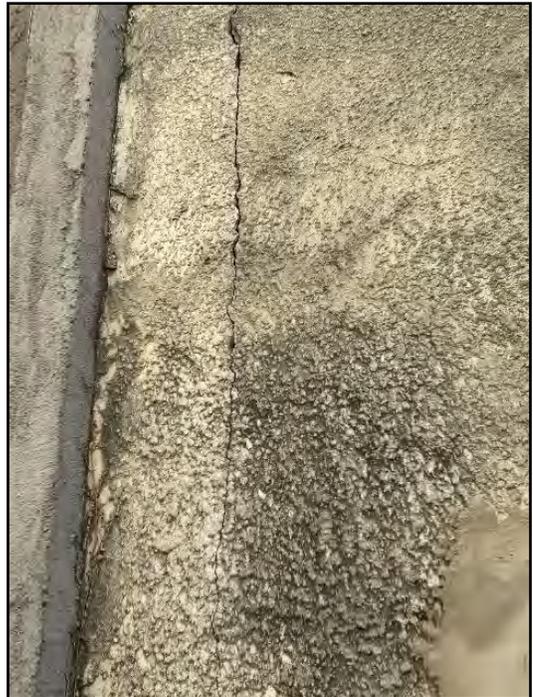
121. Cracked

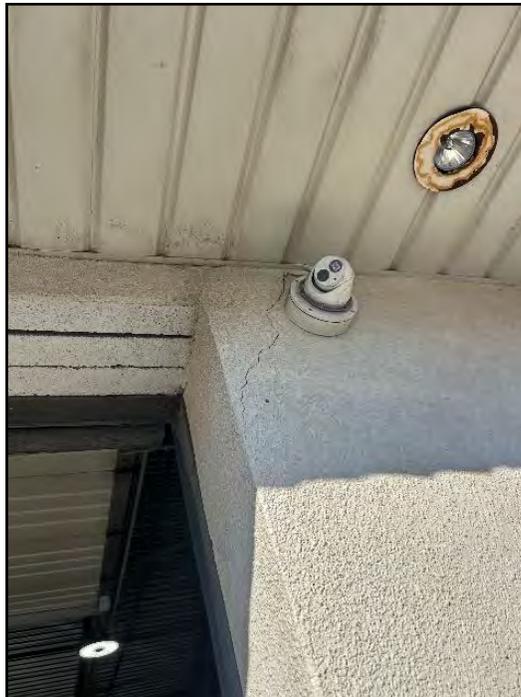
30. Condition: • [Cracked](#)

122. Cracked

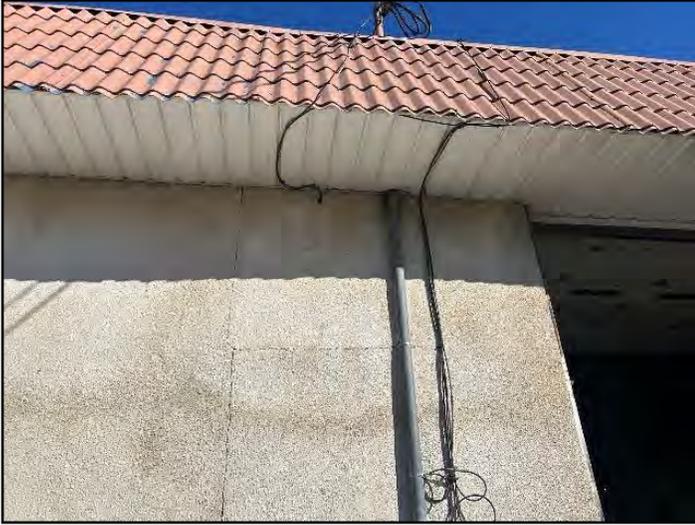
31. Condition: • [Cracked](#)

123. Cracked

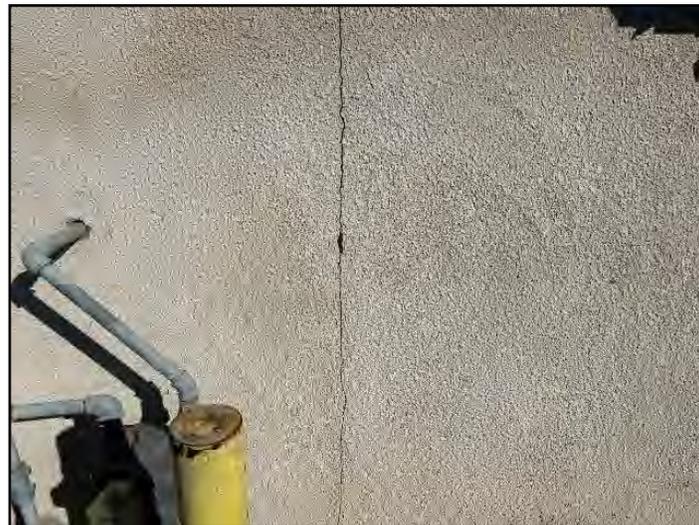
125. Cracked

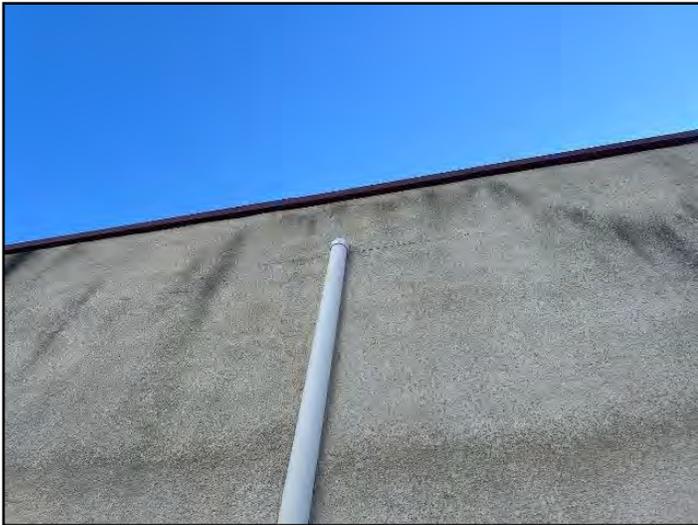
32. Condition: • [Cracked](#)

126. Cracked

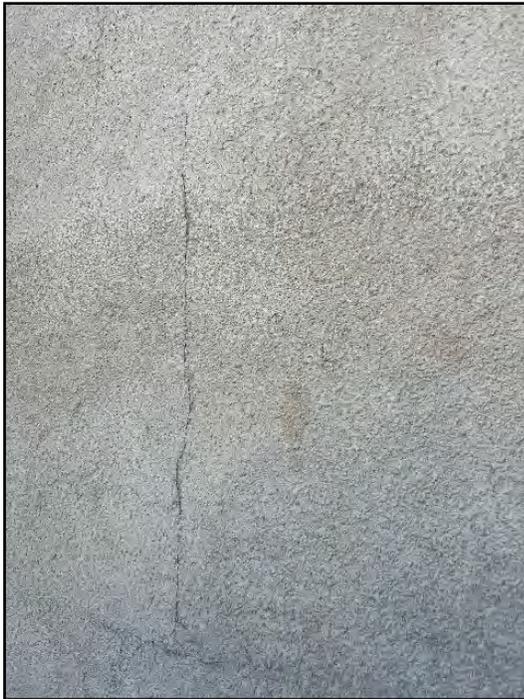
130. Cracked

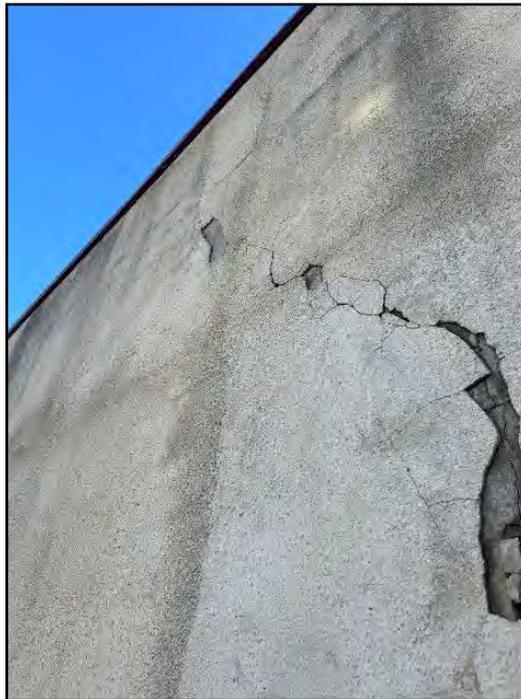
132. Cracked

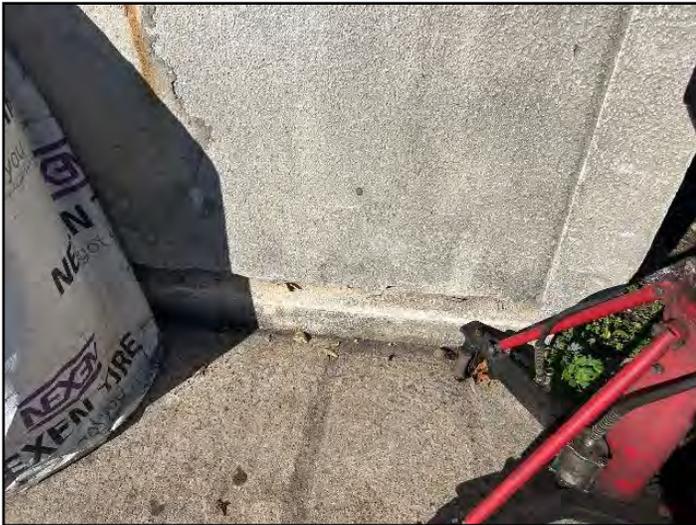
33. Condition: • [Crumbling](#)

133. Crumbling

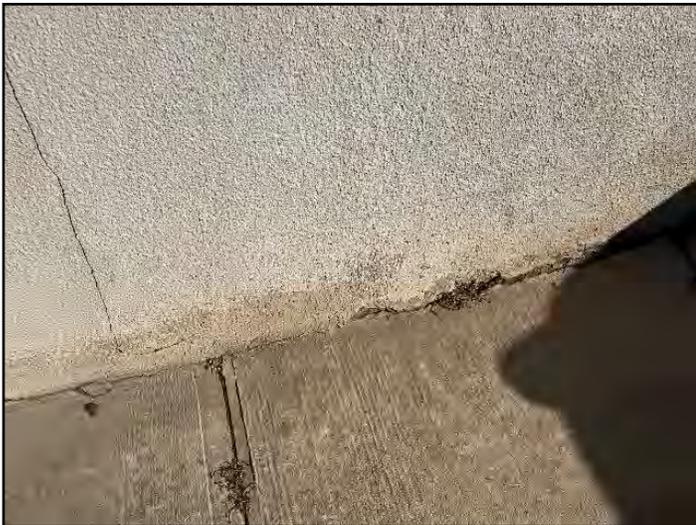
34. Condition: • [Crumbling](#)

135. Crumbling

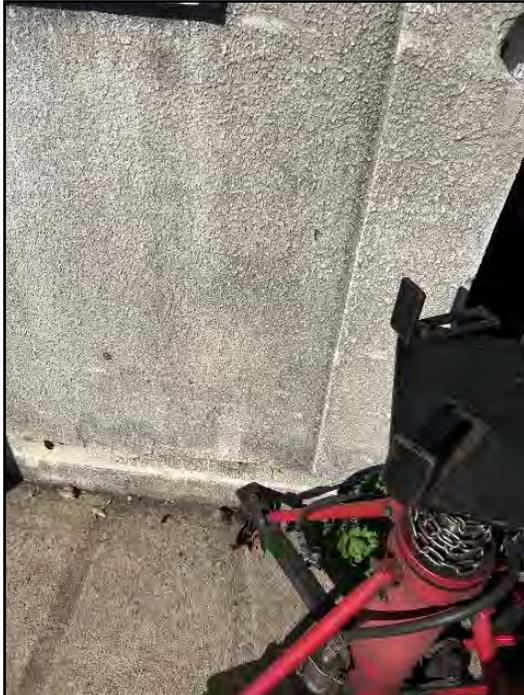
35. Condition: • [Too close to grade](#)

**137.** *Too close to grade*

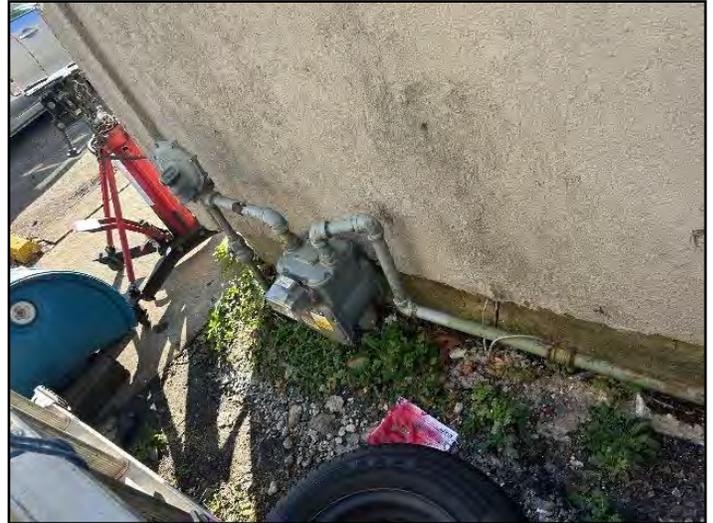
Implication(s): Chance of water damage to structure, finishes and contents | Material deterioration

**138.** *Too close to grade*

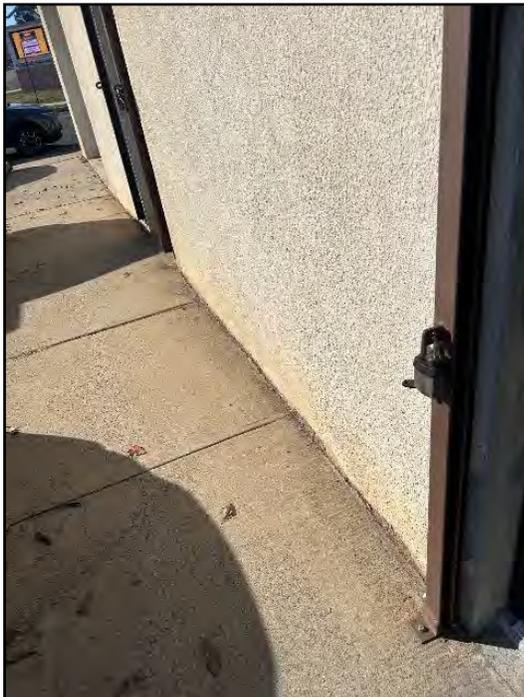
**139.** *Too close to grade*

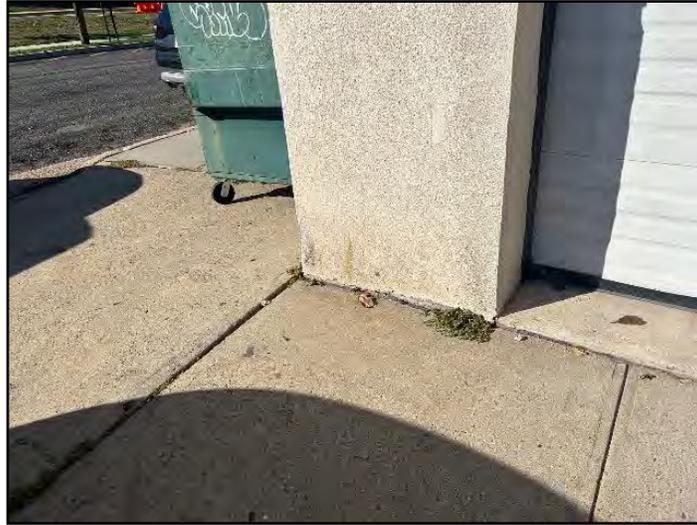
141. Too close to grade

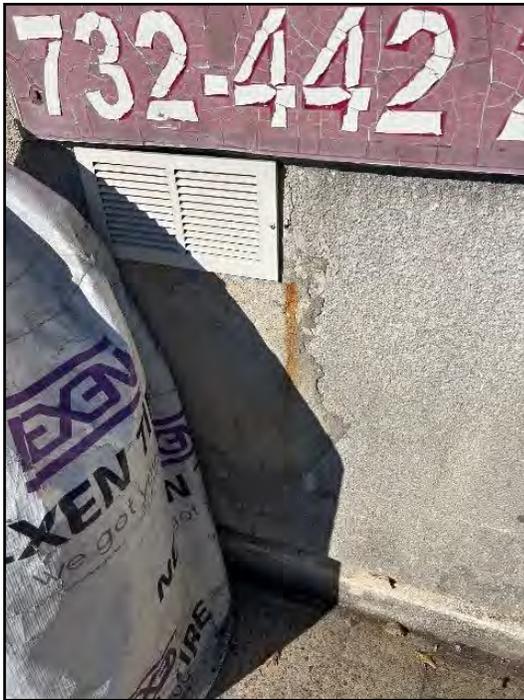
36. Condition: • Patched

Implication(s): Shortened life expectancy of material

142. Patched

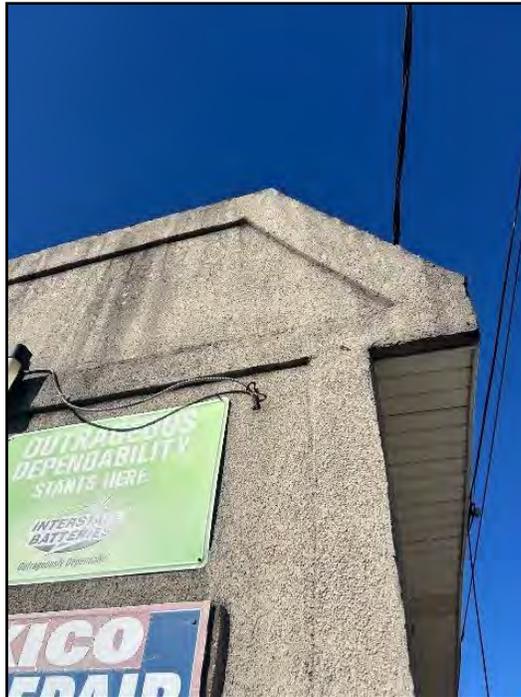
37. Condition: • Stained

144. Stained

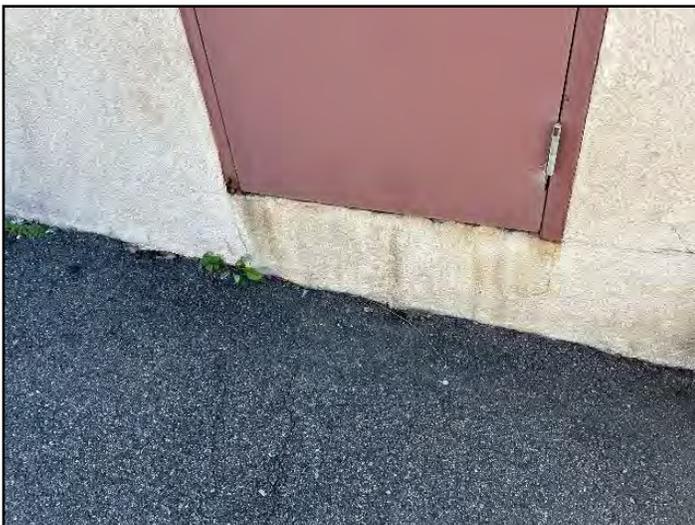
38. Condition: • [Rust](#)

Implication(s): Chance of damage to finishes and structure

145. Rust

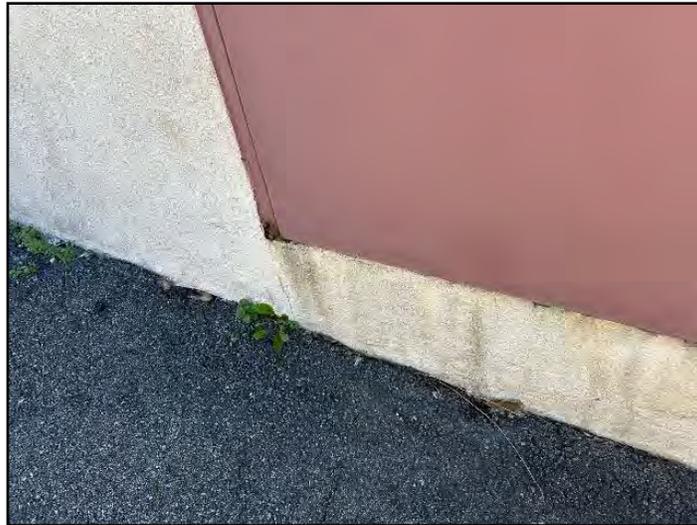
147. Rust

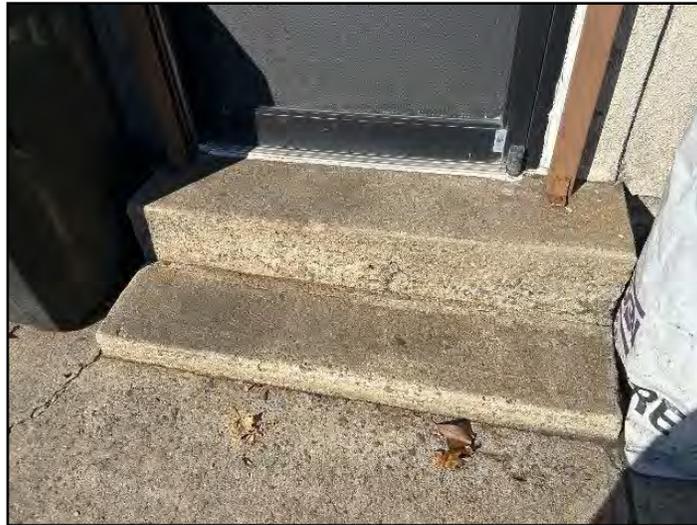
40. Condition: • [Masonry or concrete spalling](#)

Implication(s): Chance of damage to structure | Material deterioration | Trip or fall hazard

149. Masonry or concrete spalling

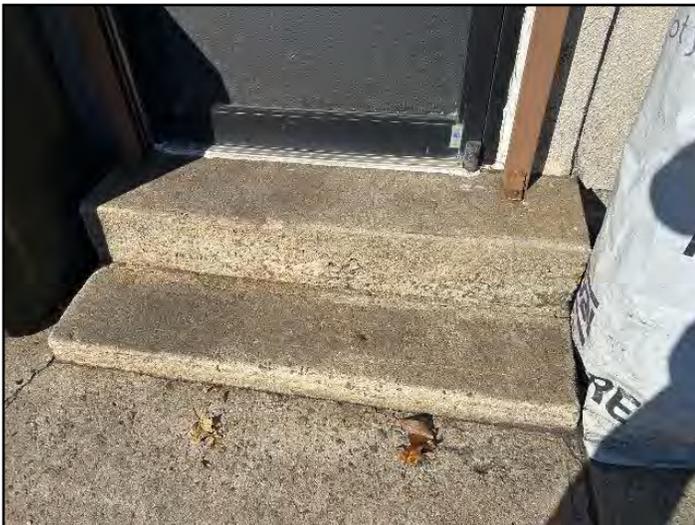
42. Condition: • [Landings missing or undersized](#)

Implication(s): Trip or fall hazard

150. Landings missing or undersized

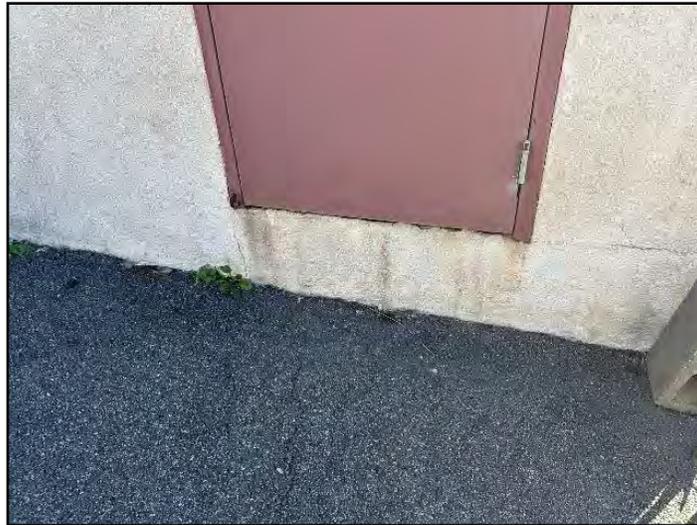
43. Condition: • [Landings missing or undersized](#)

Implication(s): Trip or fall hazard

152. Landings missing or undersized

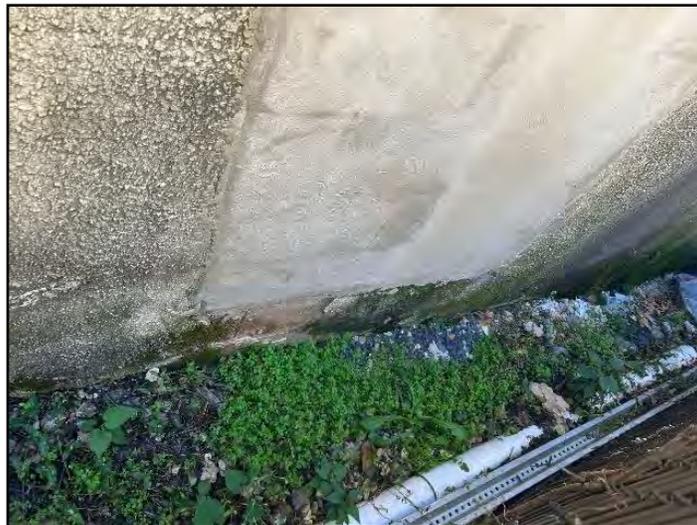
44. Condition: • [Water penetration](#)

Implication(s): Chance of water damage to structure, finishes and contents

153. Water penetration

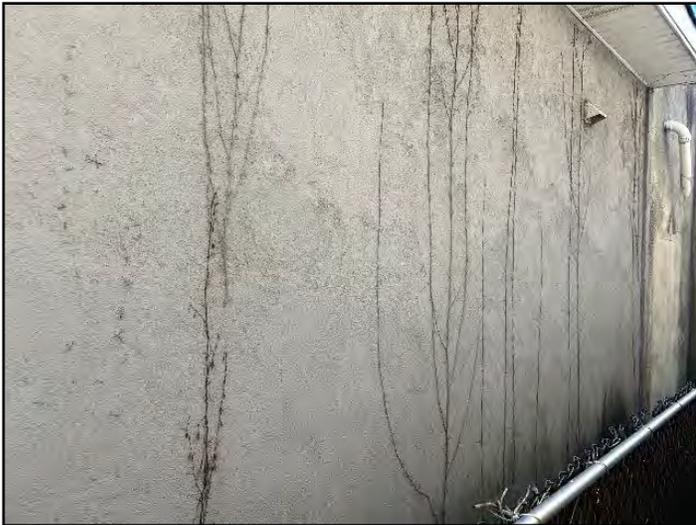
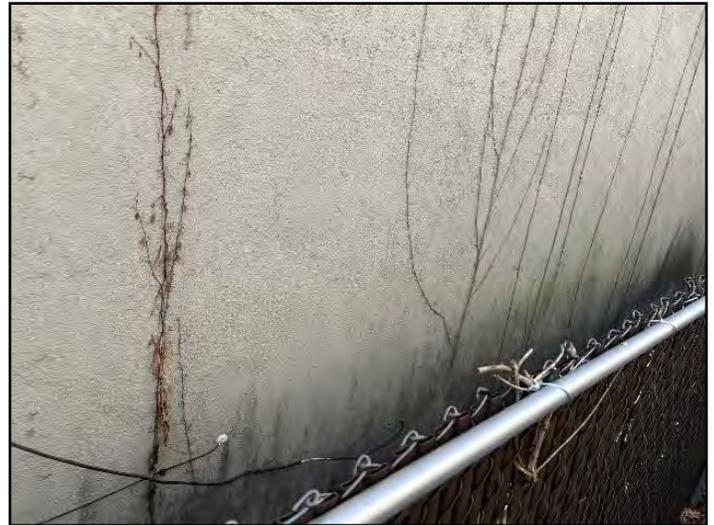
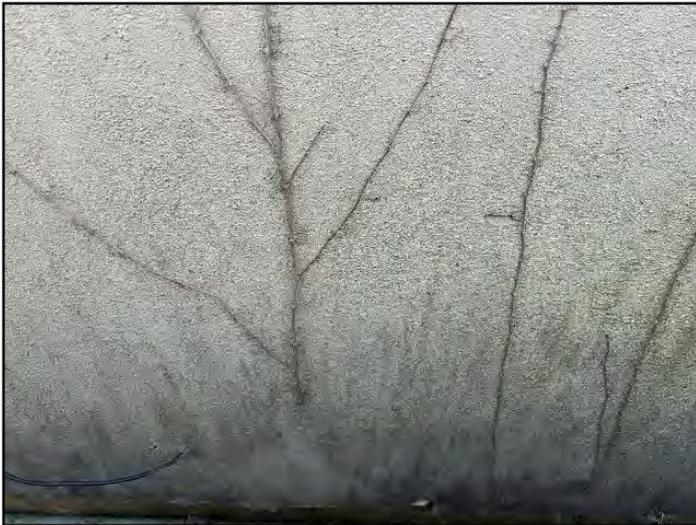
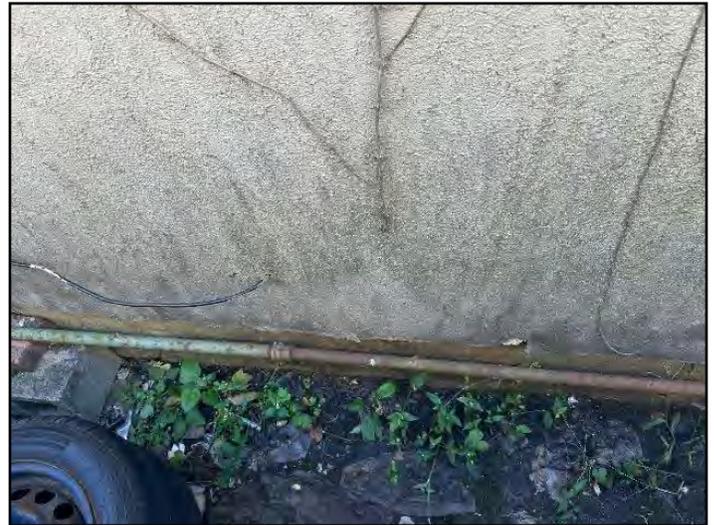
45. Condition: • Vines on building

Implication(s): Chance of damage to finishes | Chance of pests entering building

154. Vines on building

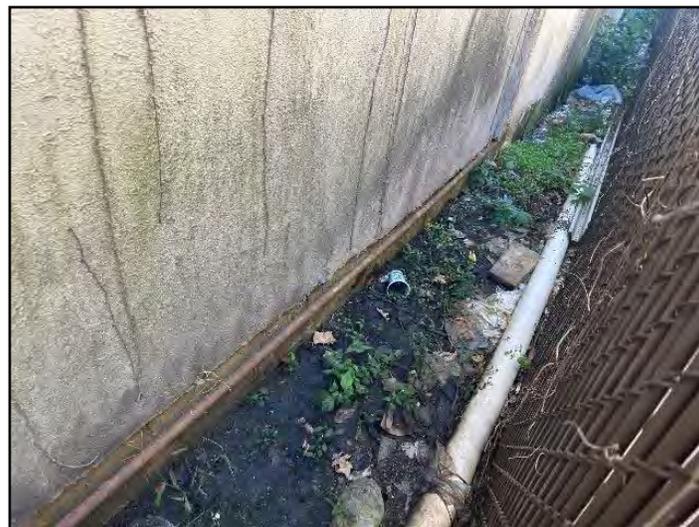
46. Condition: • [Improper slope or drainage](#)

Implication(s): Chance of water damage to structure, finishes and contents

Walk/patio sloping towards house

158. Improper slope or drainage

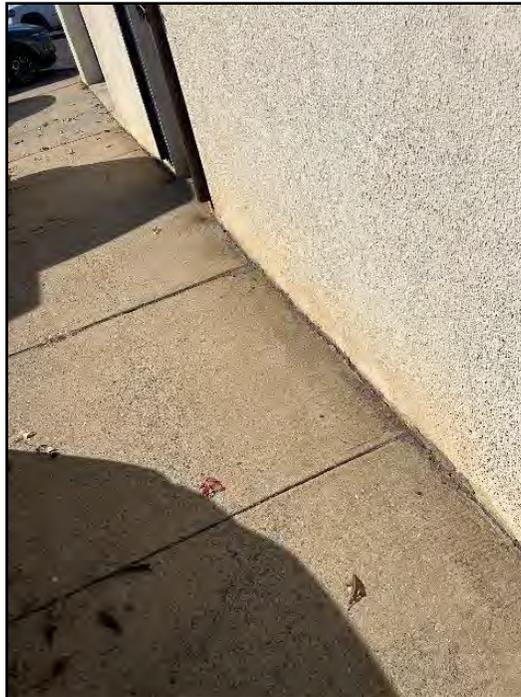
47. Condition: • [Improper slope or drainage](#)

Implication(s): Chance of water damage to structure, finishes and contents

159. Improper slope or drainage

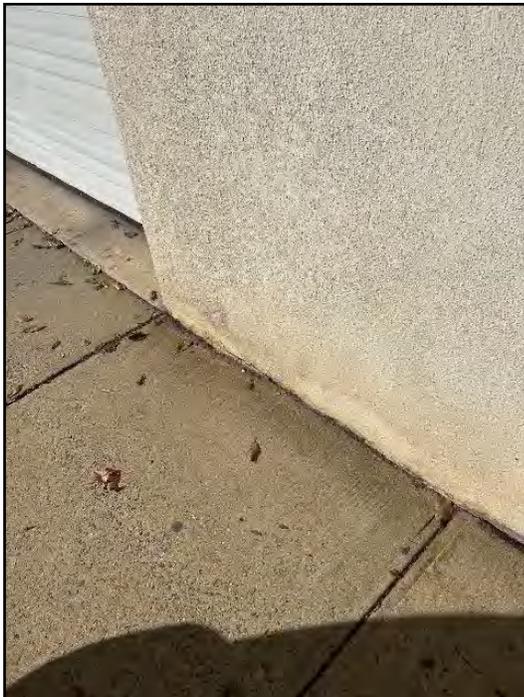
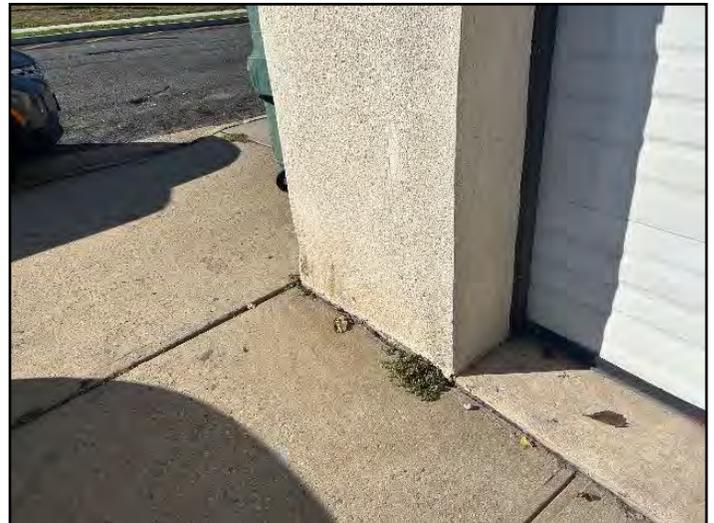
48. Condition: • [Unsealed gap at building](#)

Implication(s): Chance of water damage to structure, finishes and contents

160. Unsealed gap at building

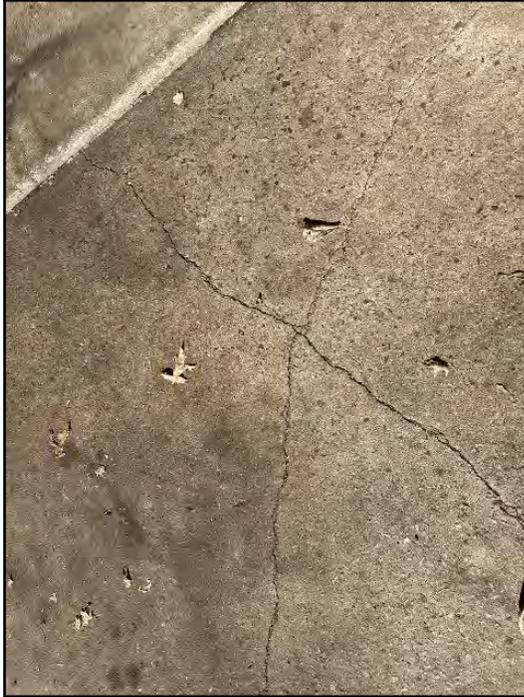
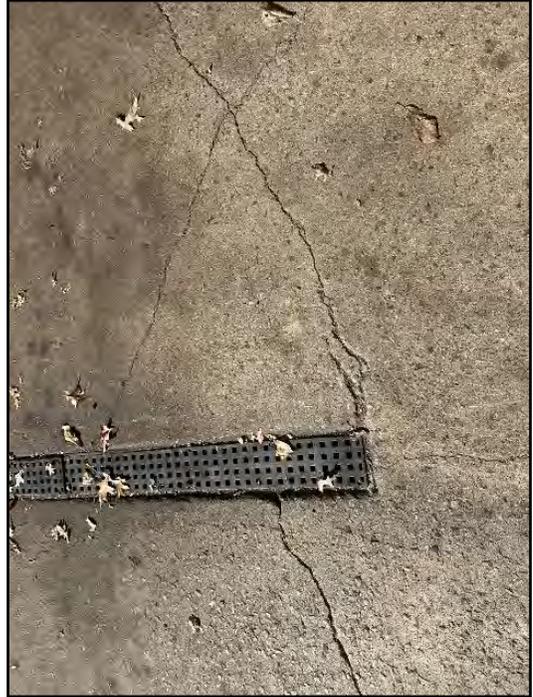
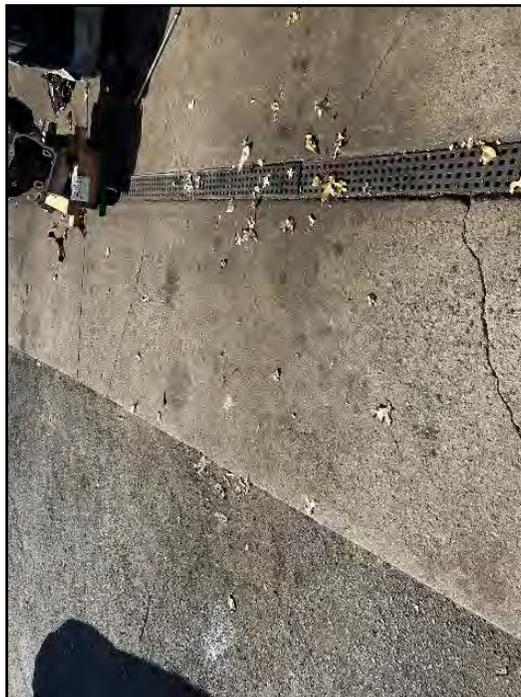
49. Condition: • [Cracked or damaged surfaces](#)

Implication(s): Trip or fall hazard

162. Cracked or damaged surfaces

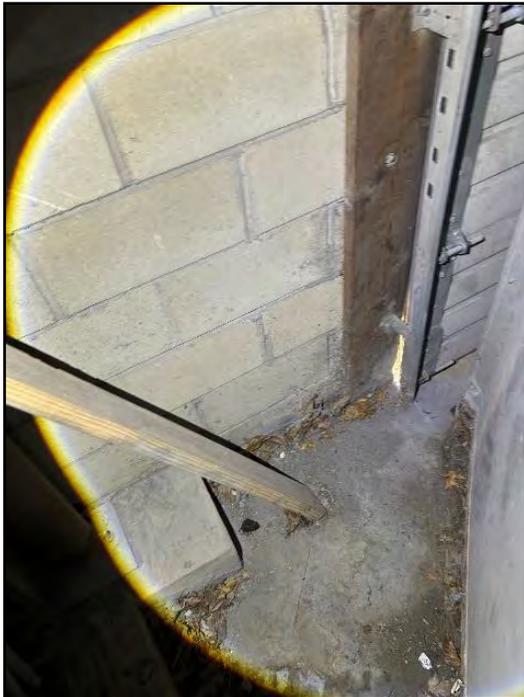
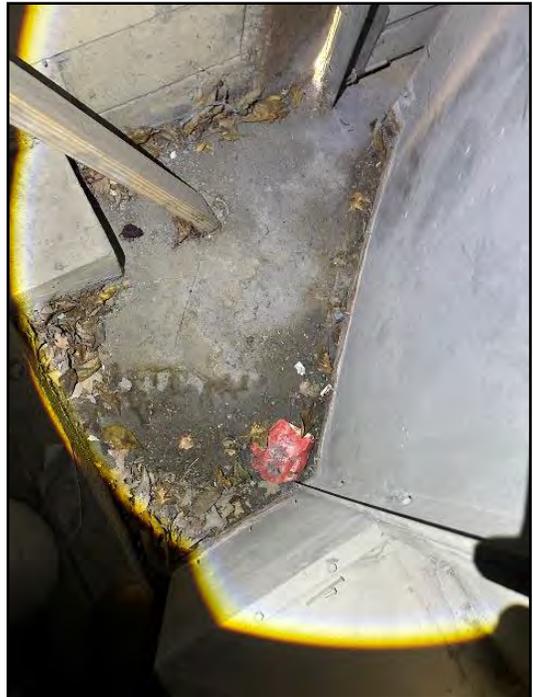
50. Condition: • Gaps around door when closed.

165. Gaps around door when closed.

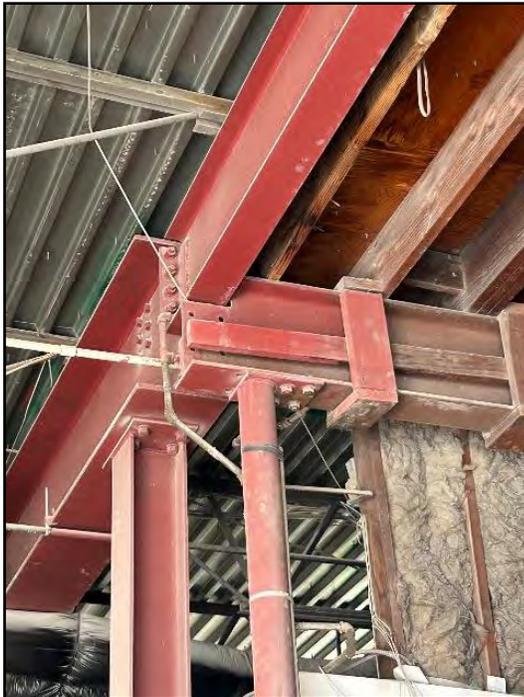
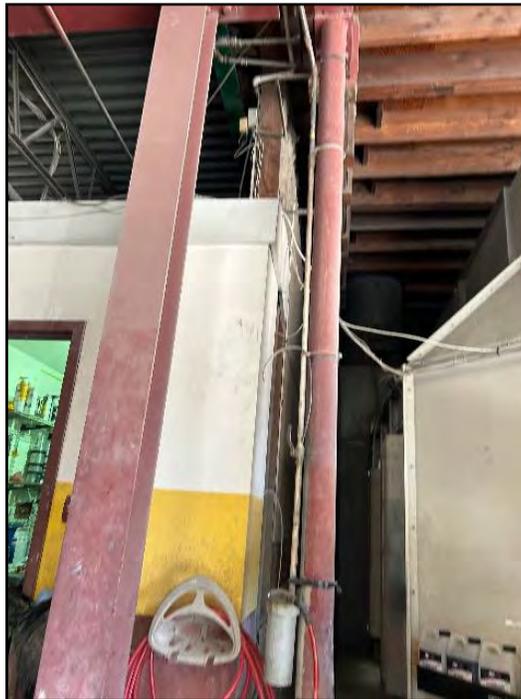
- 51. Condition:** • [Buckling](#)

**Implication(s):** Weakened structure | Chance of structural movement

167. Buckling

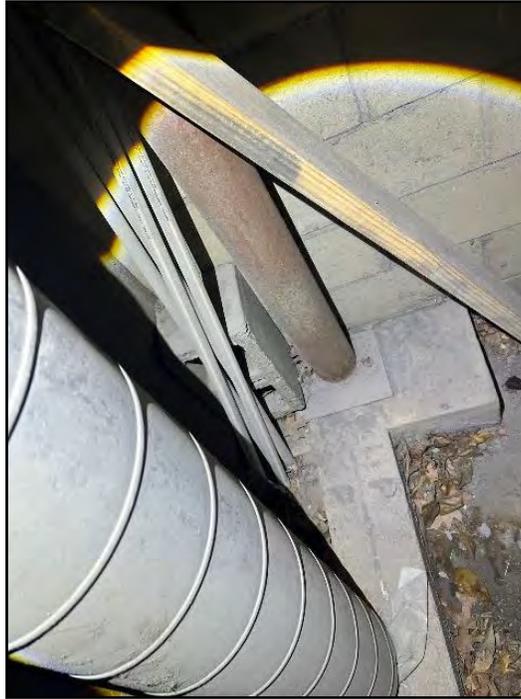
**Location:** Near garage door of painting area

53. Condition: • Improper support column

170. *Improper support column*

Recommend attaching column to a proper footing

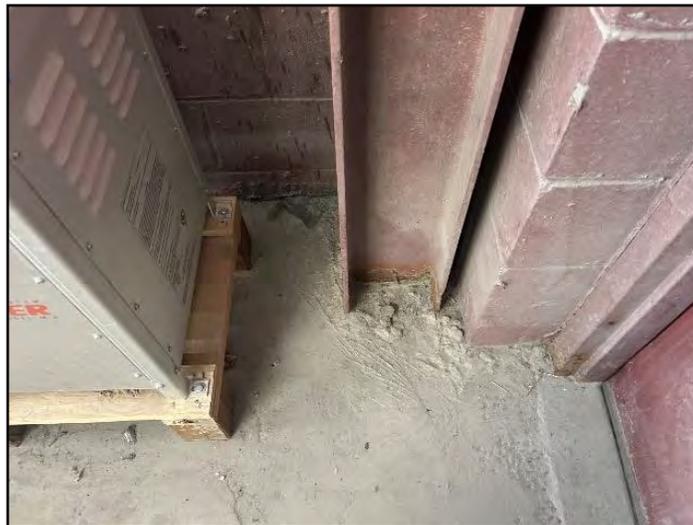
**54. Condition:** • Rust

**Implication(s):** Weakened structure, Chance of structural movement

171. *Rust*

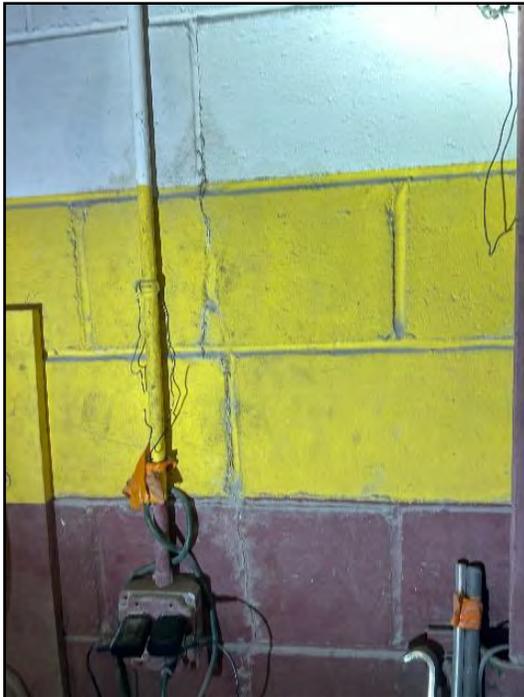
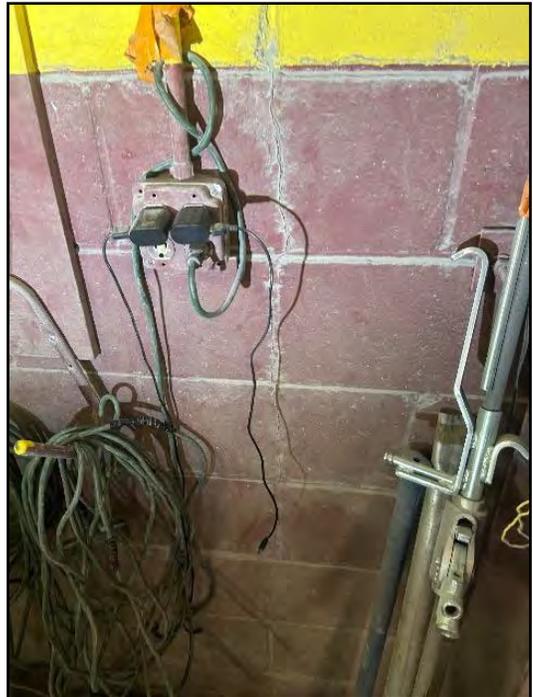
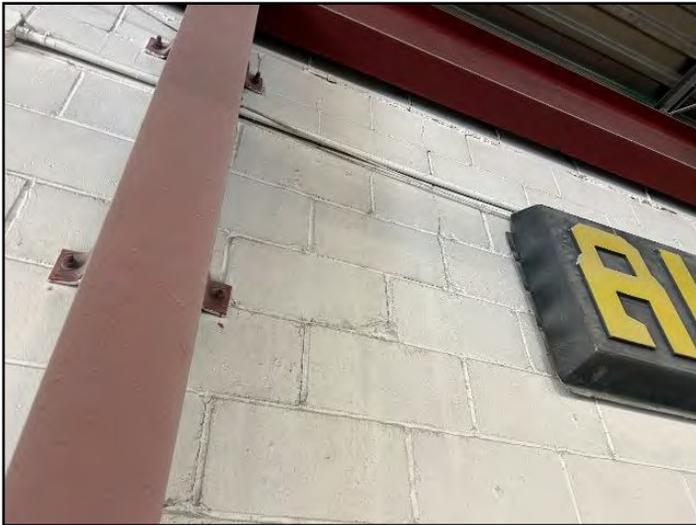
56. Condition: • [Cracked](#)

Implication(s): Chance of water damage to structure, finishes and contents | Weakened structure

174. Cracked
