# Your Inspection Report

Thursday, October 23, 2025

Smart Choice Inspections LLC  
173 Ridge Road, Suite H1  
Cedar Grove, NJ 07009

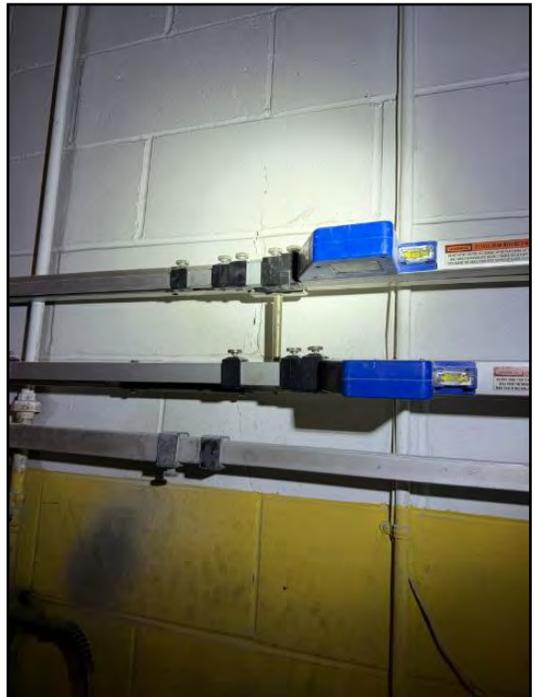
181. Cracked

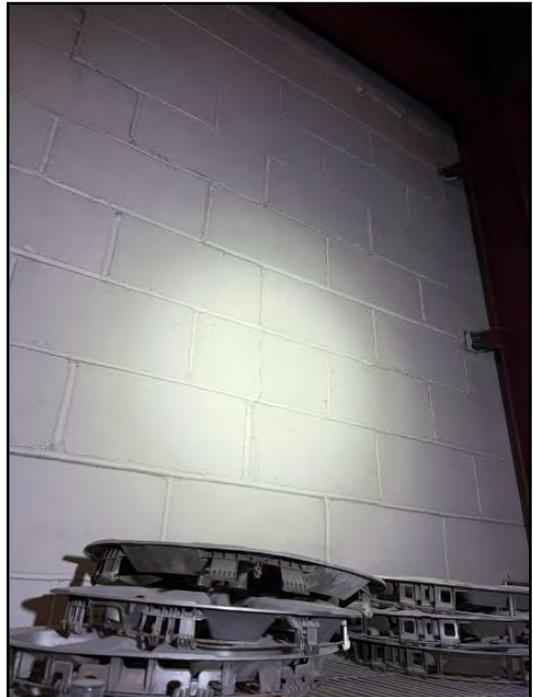
183. Cracked

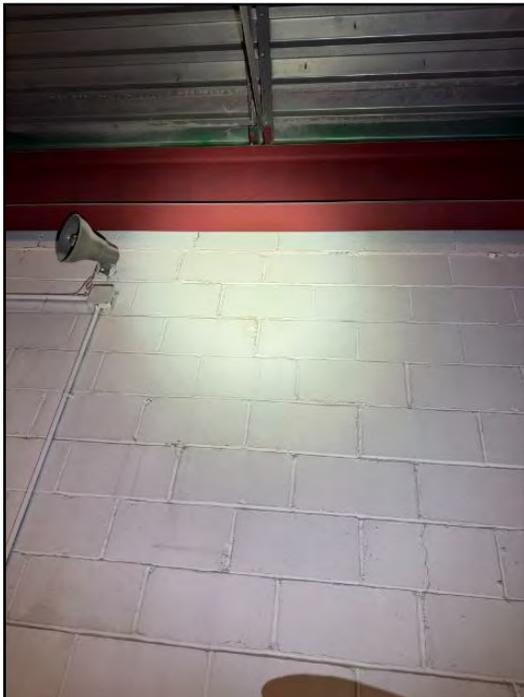
184. Cracked

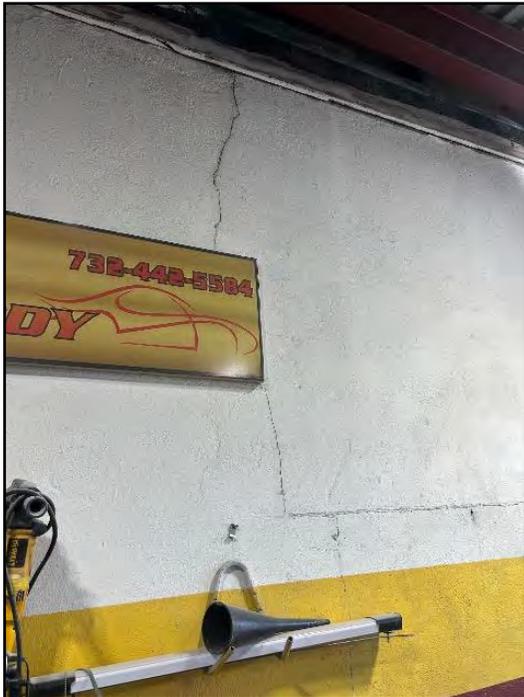
57. Condition: • [Cracked](#)

Implication(s): Chance of water damage to structure, finishes and contents | Weakened structure

186. Cracked

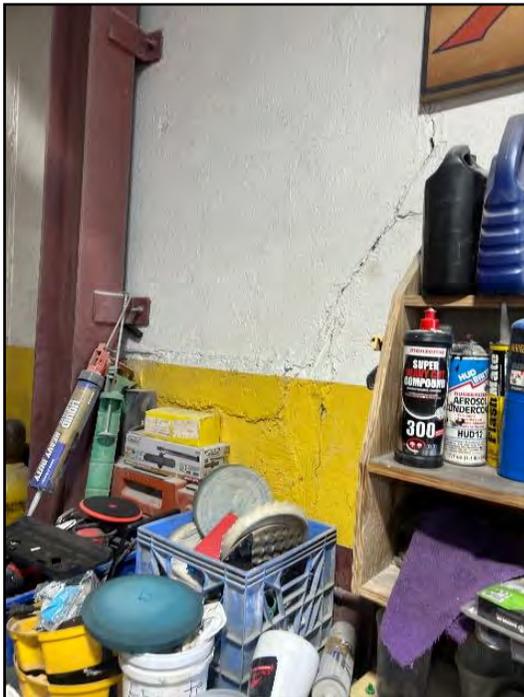
188. Cracked

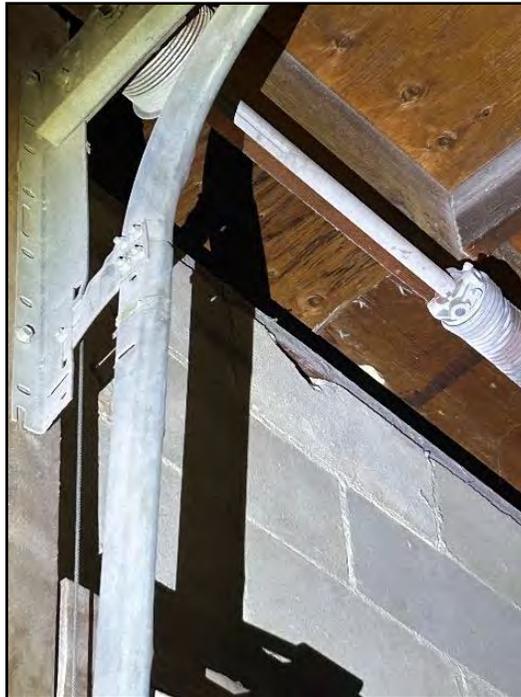
58. Condition: • [Spalling, crumbling or broken material](#)

Implication(s): Weakened structure | Chance of structural movement

Location: Above garage door

190. Spalling, crumbling or broken material

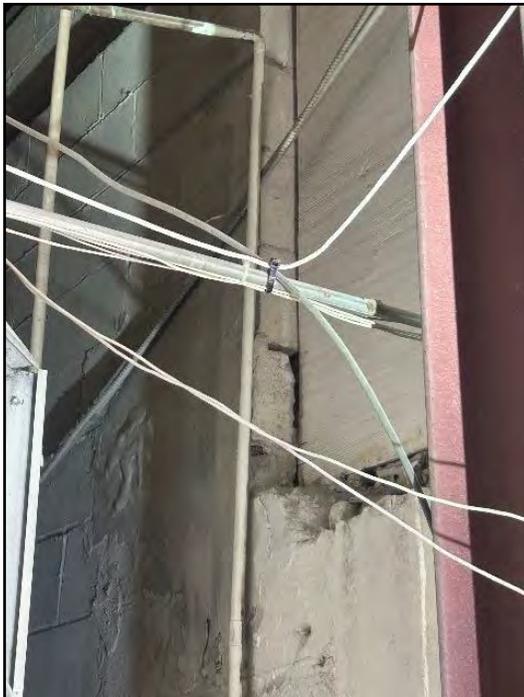
59. Condition: • [Spalling, crumbling or broken material](#)

Implication(s): Weakened structure | Chance of structural movement

191. Spalling, crumbling or broken material

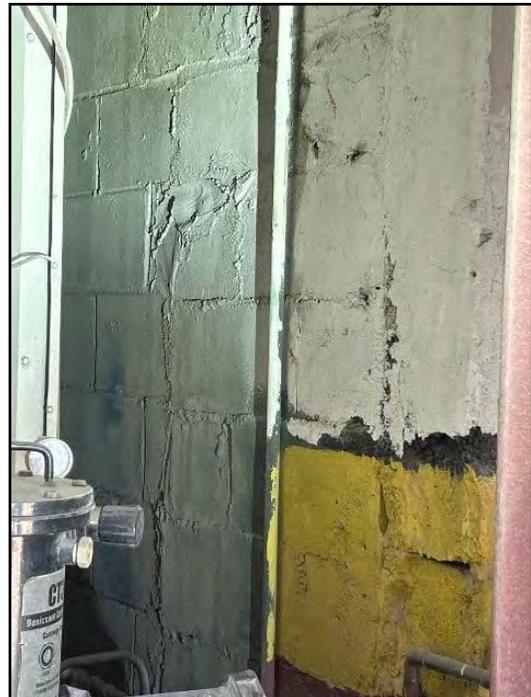
192. Spalling, crumbling or broken material

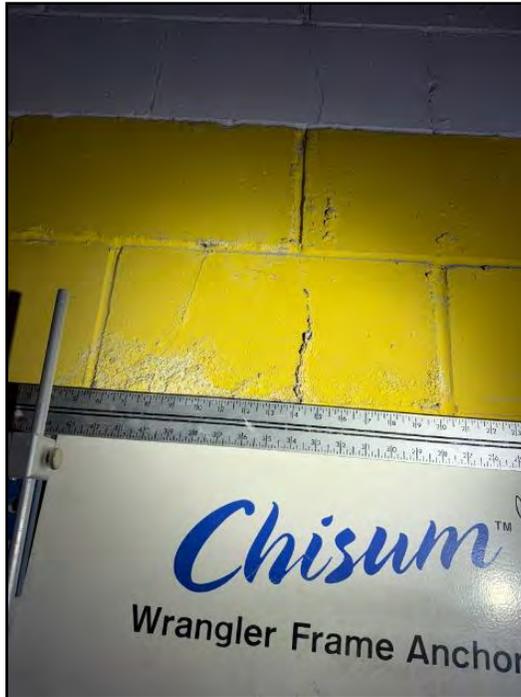
60. Condition: • Efflorescence

193. Efflorescence

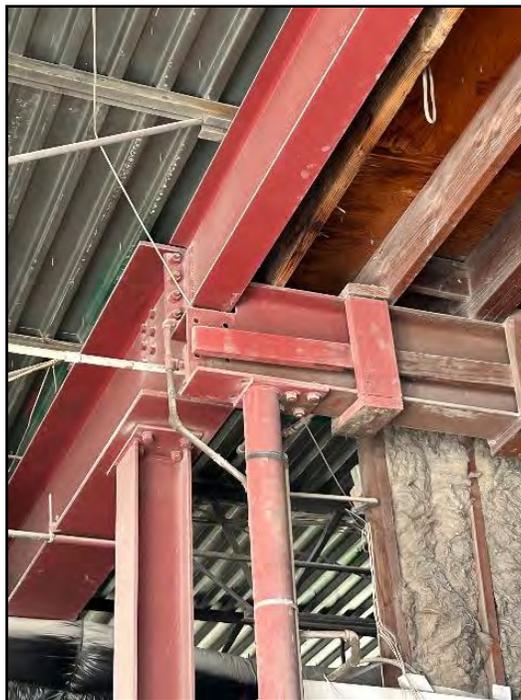
61. Condition: • [Notches or holes](#)

Implication(s): Weakened structure | Chance of structural movement

194. Notches or holes

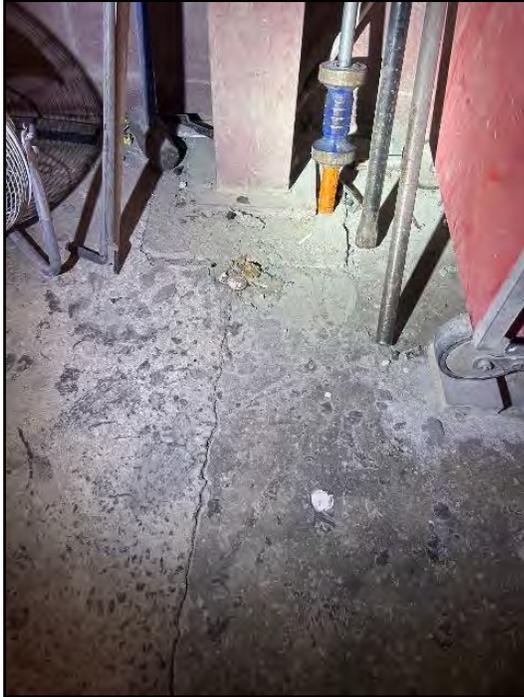
62. Condition: • [Cracked](#)

Implication(s): Chance of water damage to structure, finishes and contents | Trip or fall hazard

195. Cracked

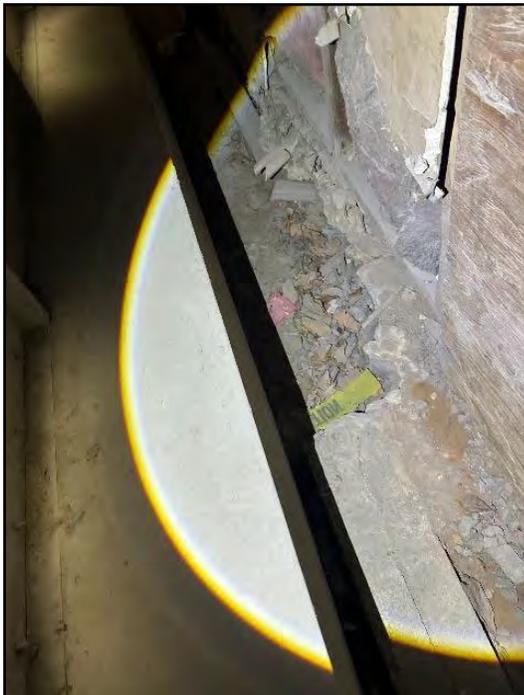
63. Condition: • [Spalling](#)

Implication(s): Chance of water damage to structure, finishes and contents | Shortened life expectancy of material

197. Spalling

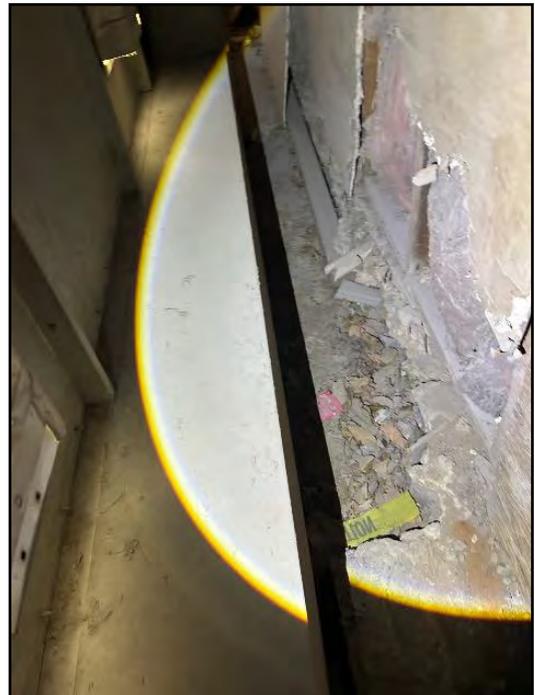
198. Spalling

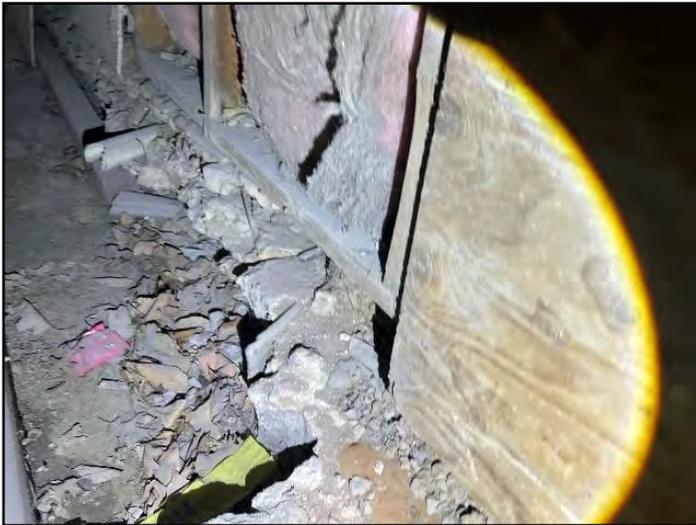
199. Spalling

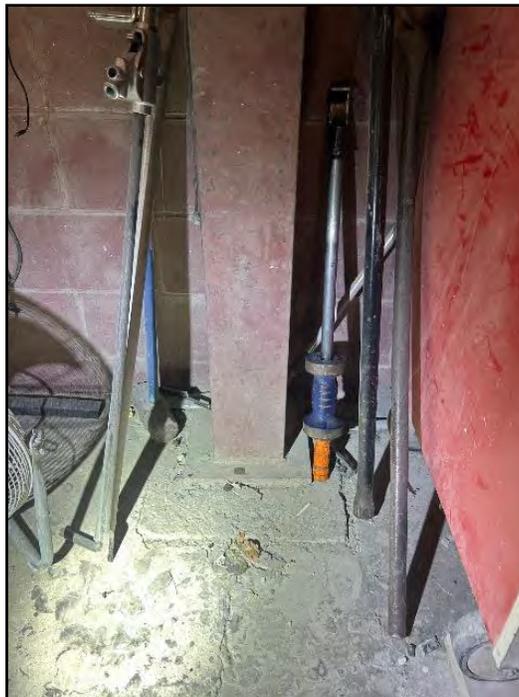
64. Condition: • [Settled](#)

Implication(s): Chance of water damage to structure, finishes and contents | Loss of proper slope for drainage | Trip or fall hazard

201. Settled

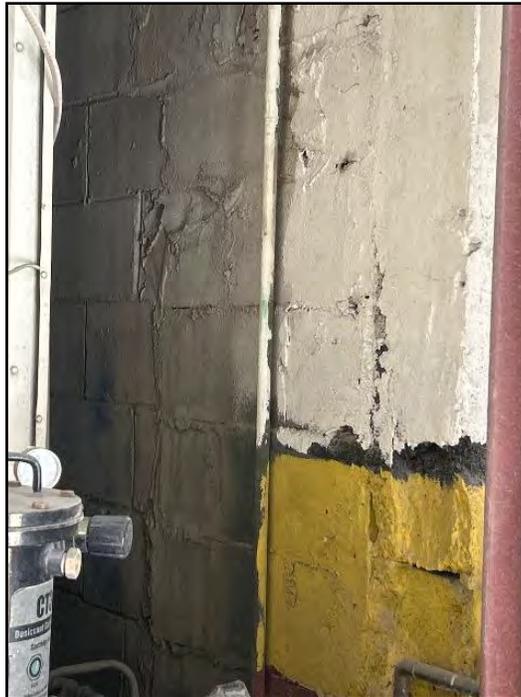
65. Condition: • [Prior repairs](#)

Implication(s): Weakened structure

202. Prior repairs

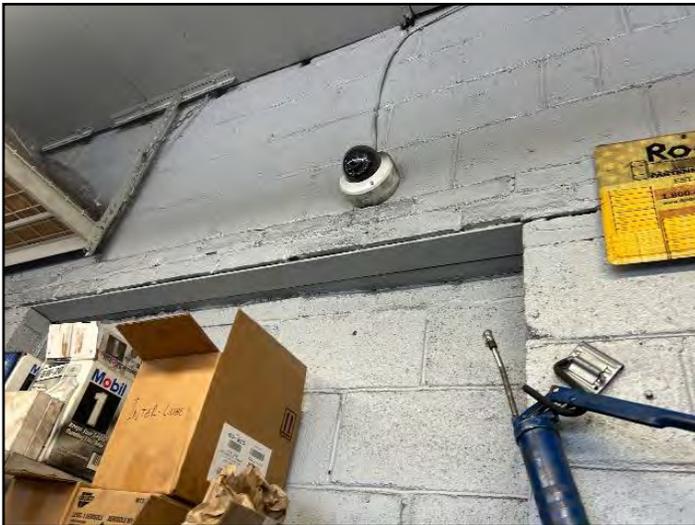
66. Condition: • [Cracked](#)

Implication(s): Weakened structure

203. Cracked

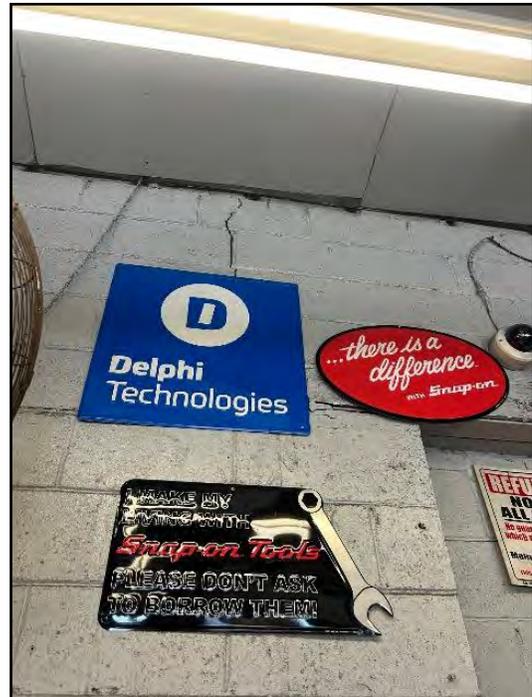
204. Cracked

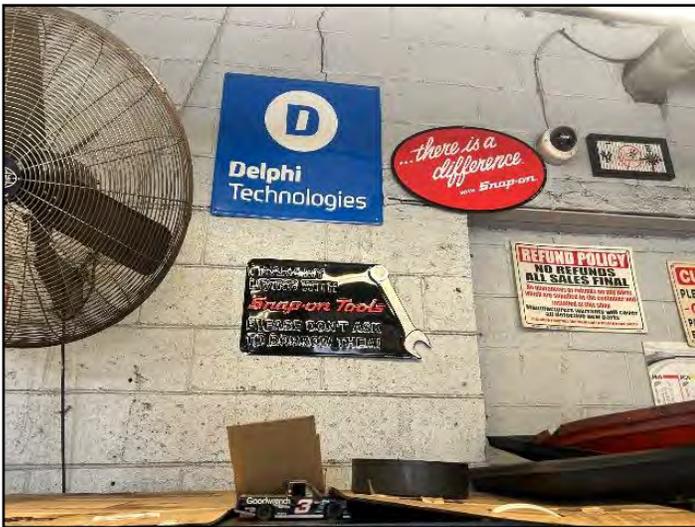
205. Cracked

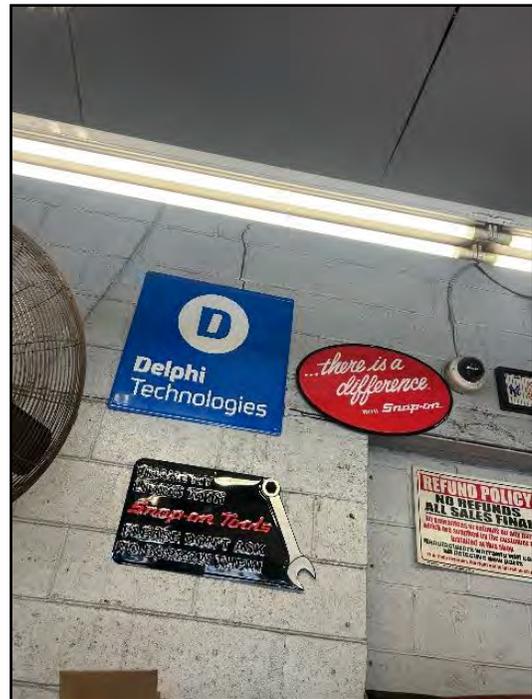
206. Cracked

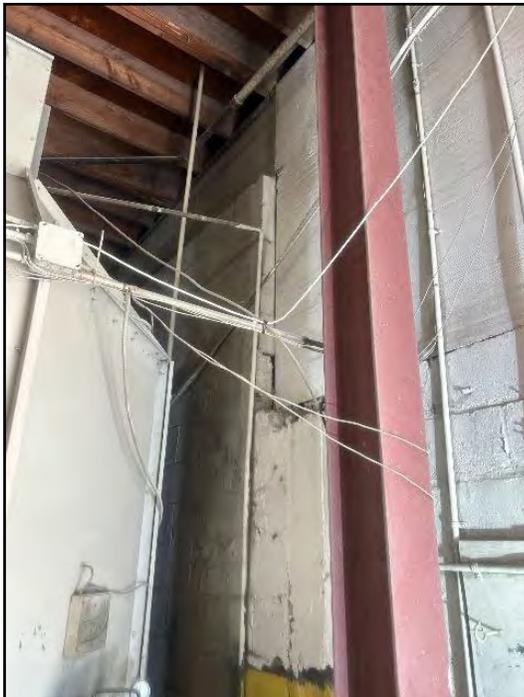
67. Condition: • [Bowling, leaning or bulging](#)

Implication(s): Weakened structure | Chance of structural movement

207. Bowling, leaning or bulging

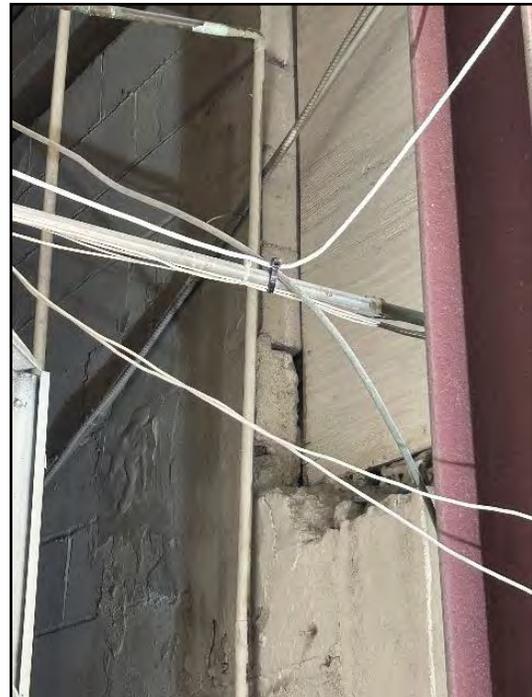
208. Bowling, leaning or bulging

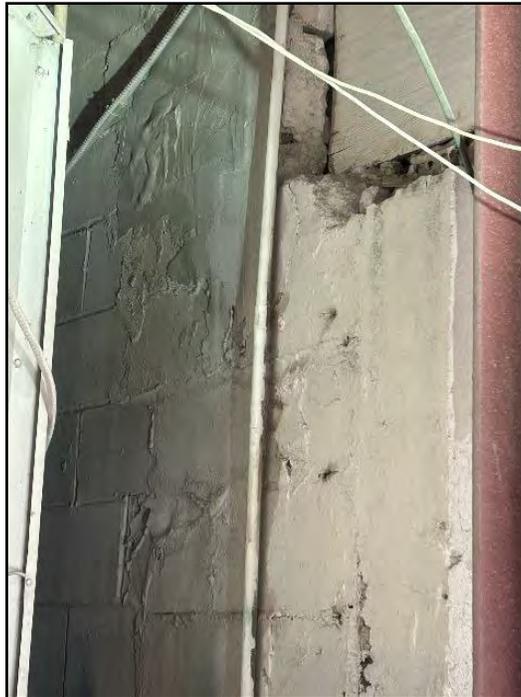
209. Bowing, leaning or bulging

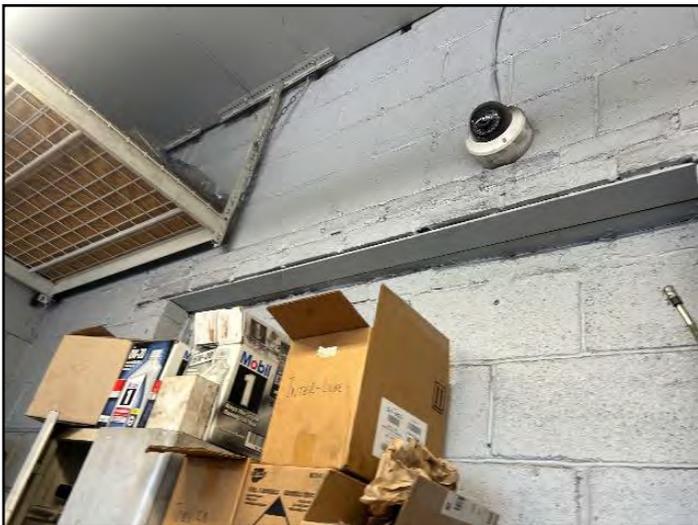
**68. Condition:** • [Lintels sagging](#)

Structural cracks have begun to form on foundation wall due to sagging lintel. Recommend addressing the cracks and replacing lintel.

**Implication(s):** Weakened structure | Chance of structural movement

210. Lintels sagging

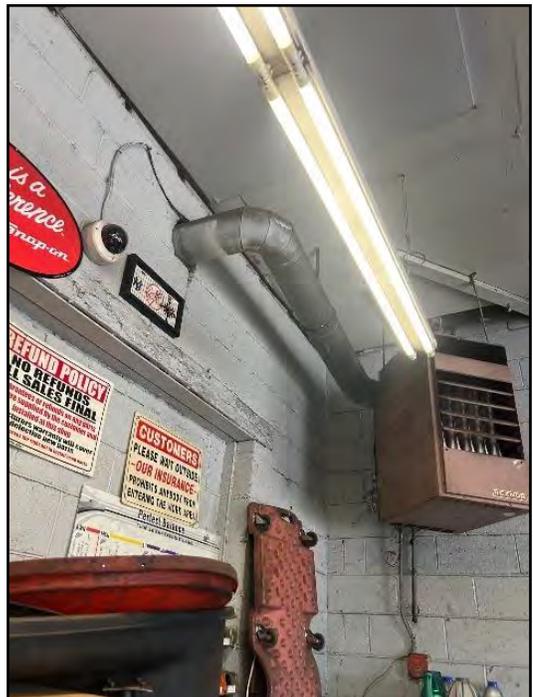
211. Lintels sagging

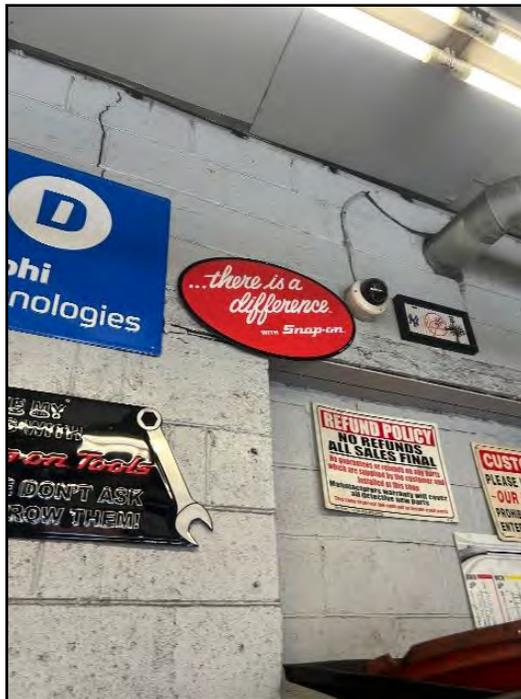
212. Lintels sagging

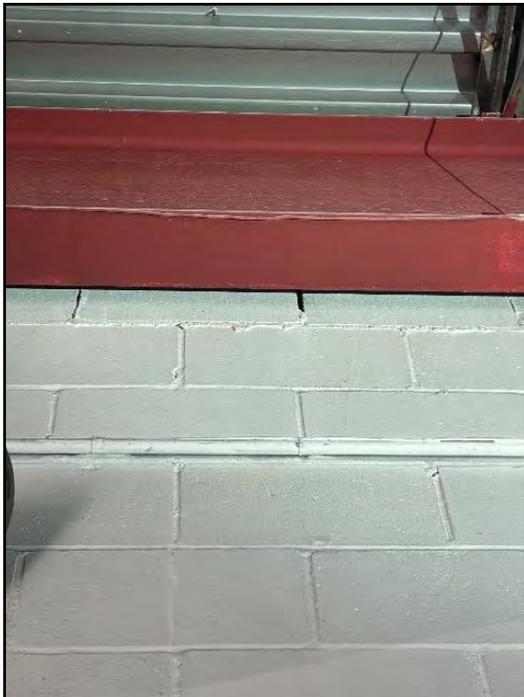
69. Condition: • [Mortar deteriorating](#)

Implication(s): Weakened structure | Chance of structural movement

213. Mortar deteriorating

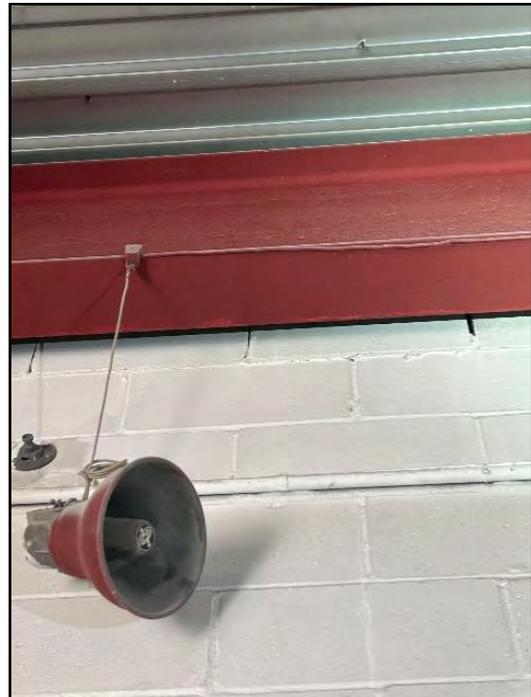
214. Mortar deteriorating

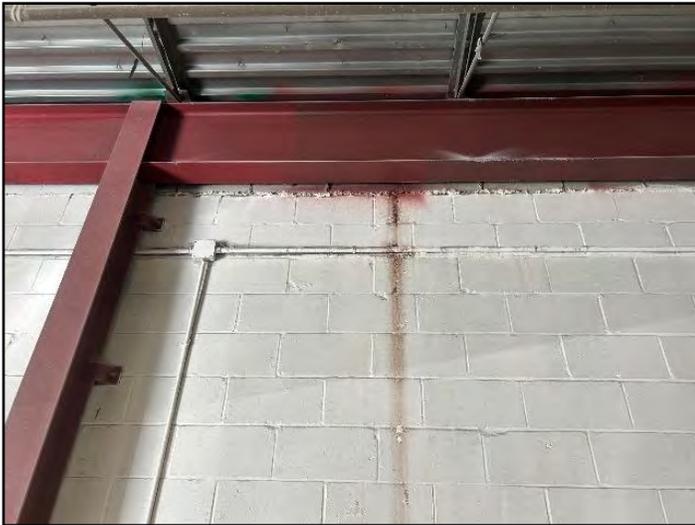
215. Mortar deteriorating

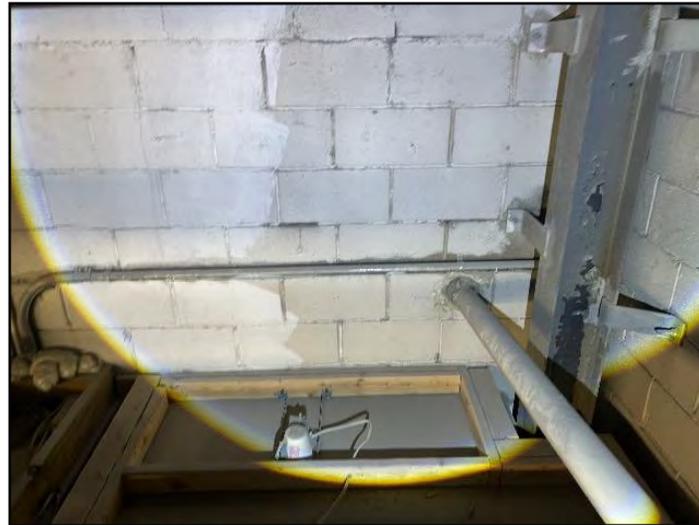
217. Mortar deteriorating

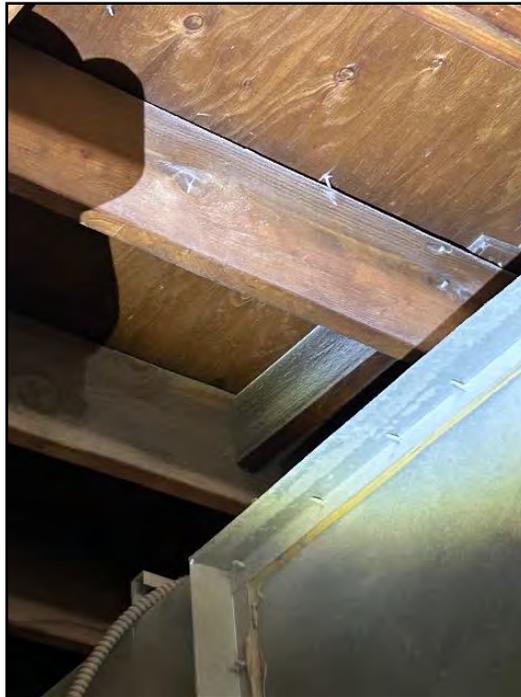
70. Condition: • Sag

218. Sag

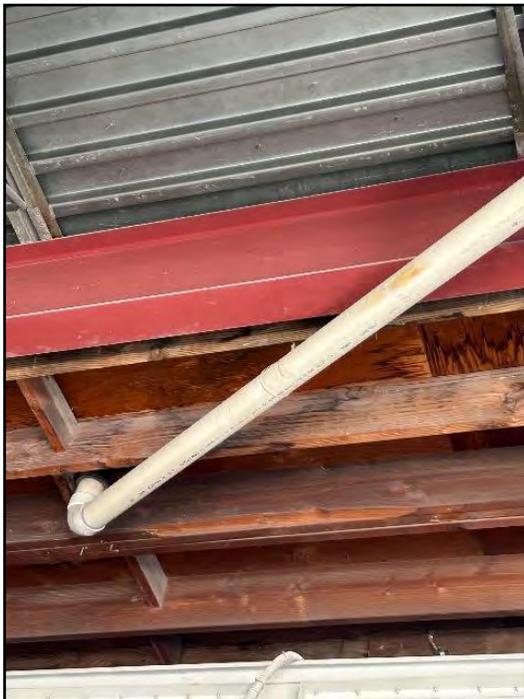
71. Condition: • Water stains

219. Water stains

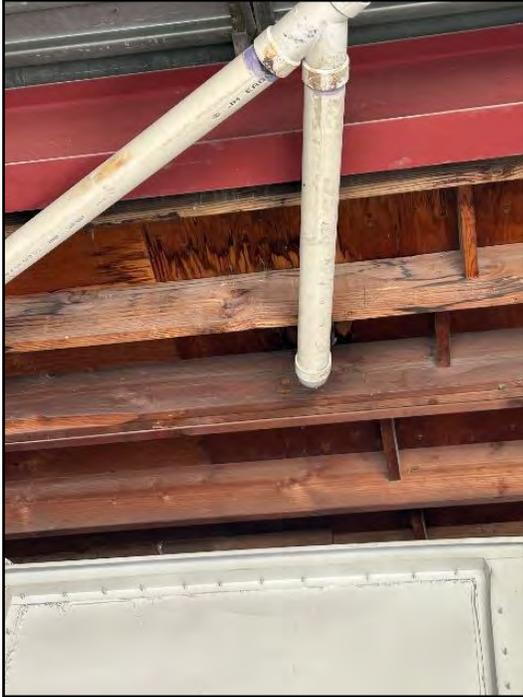
72. Condition: • [Water stains](#)

**Implication(s):** Material deterioration

**221.** *Water stains*

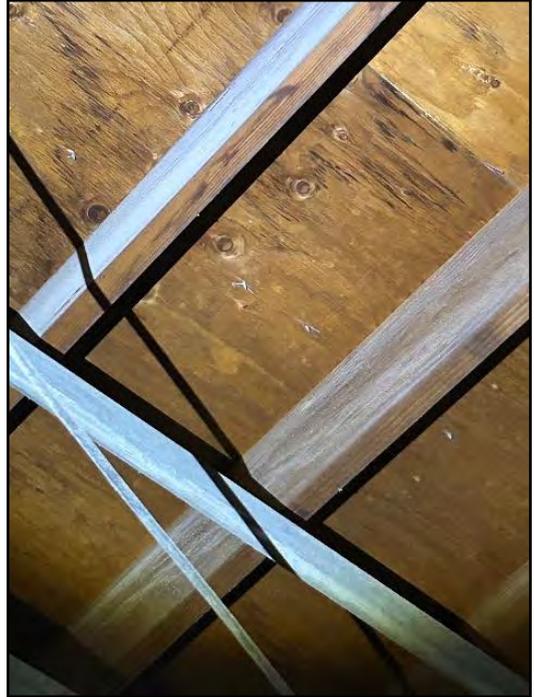
**222.** *Water stains*

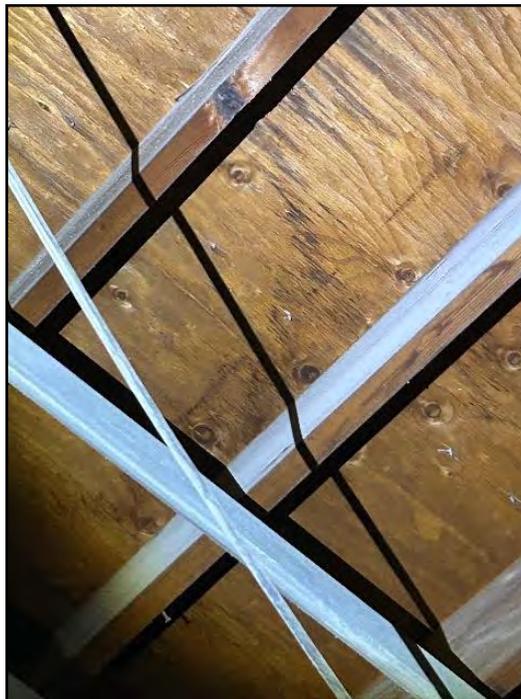
**223.** *Water stains*

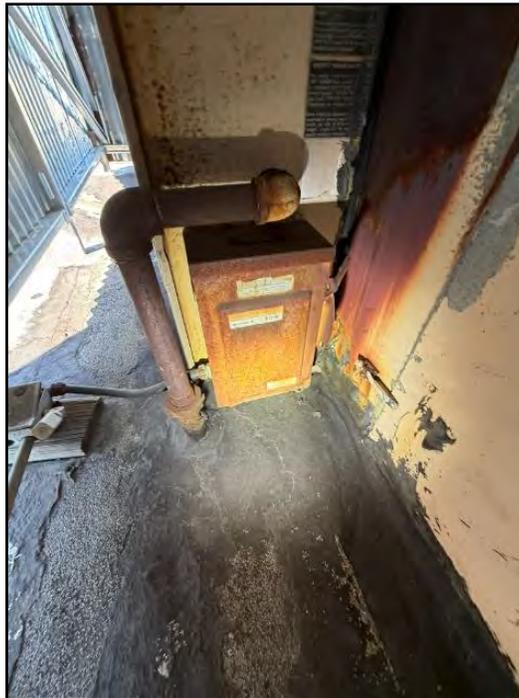
**73. Condition:** • [Rust](#)

**Implication(s):** Electric shock | Increased fire hazard

**Location:** Roof

224. Rust

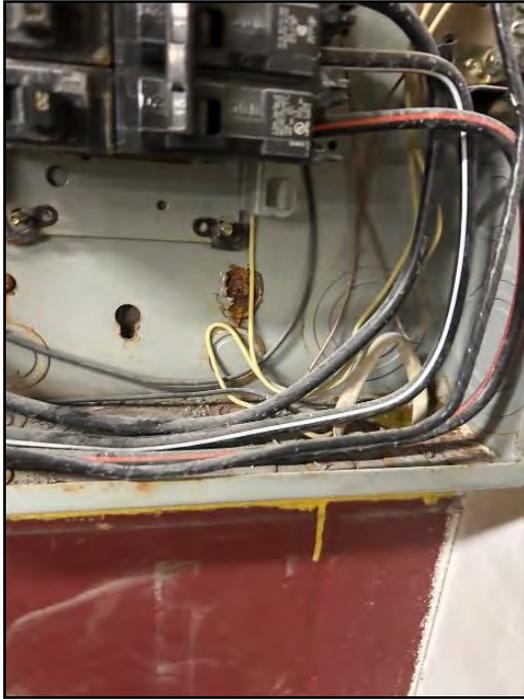
**74. Condition:** • [Rust or water in panel](#)

Corroded components observed during inspection of three phase distribution panel. Recommend hiring a licensed electrician to replace distribution panel. Also recommend for moisture issue in regards to downspout to be mitigated to ensure that this area does not remain an issue for future panels. Safety and fire hazard.

**Implication(s):** Electric shock | Fire hazard

225. Rust or water in panel

**Task:** Replacement

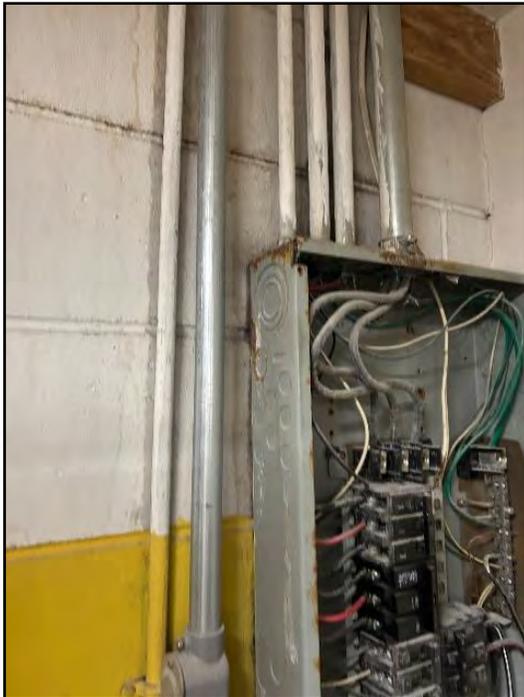
231. Inappropriate mounting surface

75. Condition: • [Inappropriate mounting surface](#)

Implication(s): Fire hazard

in many jurisdictions, the panel support (or back-up) must be a non-combustible material such as drywall

plywood or wood planking were commonly used for panel support in older installations

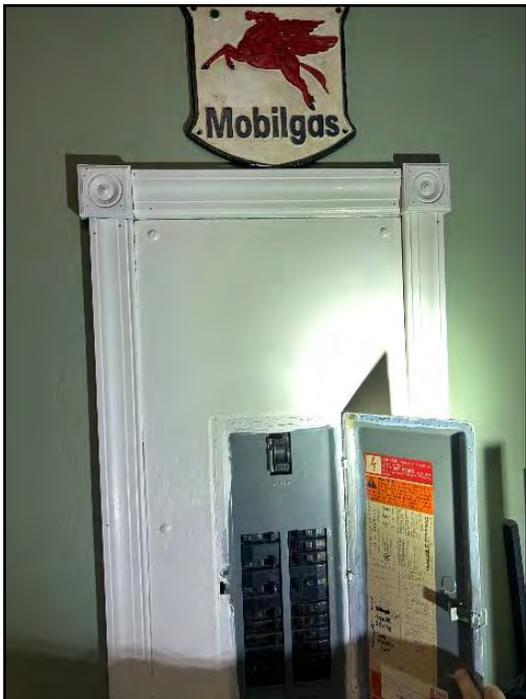
234. Poor access

76. Condition: • [Poor access](#)

Implication(s): Difficult to service

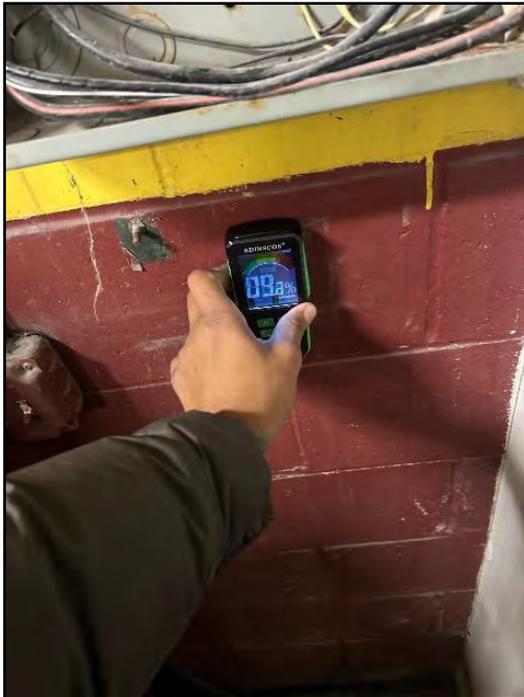
236. Poor location

77. Condition: • [Poor location](#)

Implication(s): Difficult to service

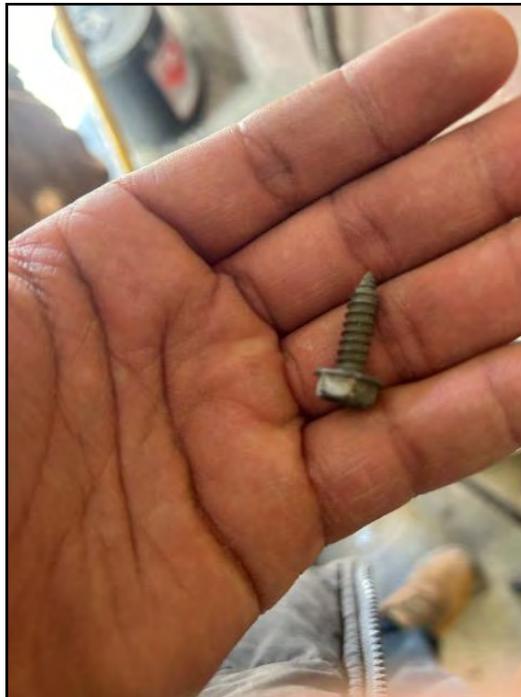
238. Wrong Fasteners

**78. Condition:** • Wrong Fasteners

Recommend securing panel cover with electrical screws. Screws with a tip can easily damage wires inside the panel.

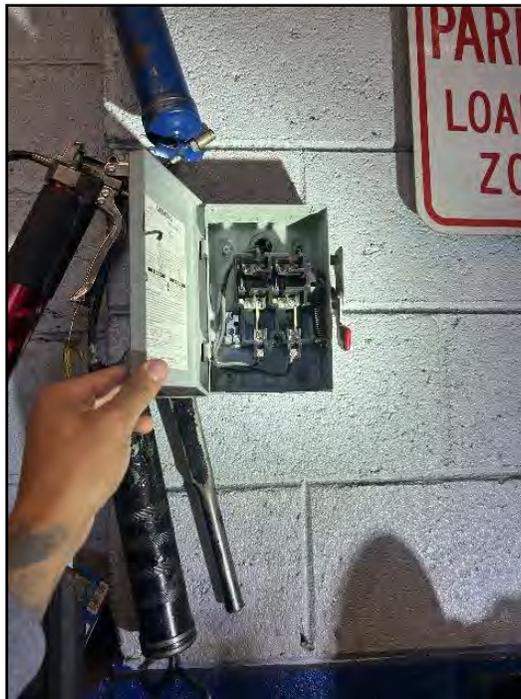
241. No fuses or breakers for subpanel (pony...

**80. Condition:** • [No fuses or breakers for subpanel \(pony panel\)](#)

Copper wiring was installed in place of the required tube fuses, which eliminates overcurrent protection and creates a significant safety hazard.

**Implication(s):** Electric shock | Fire hazard

**Location:** Auto mechanic shop

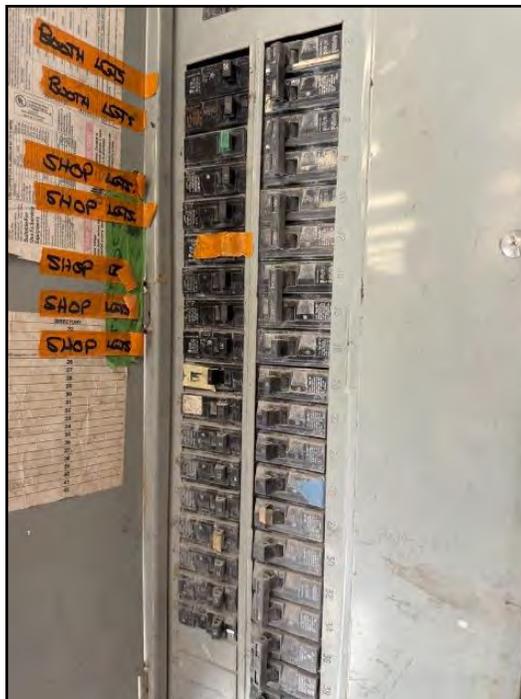
242. Loose breakers or fuses

81. Condition: • [Loose breakers or fuses](#)

Implication(s): Electric shock | Fire hazard

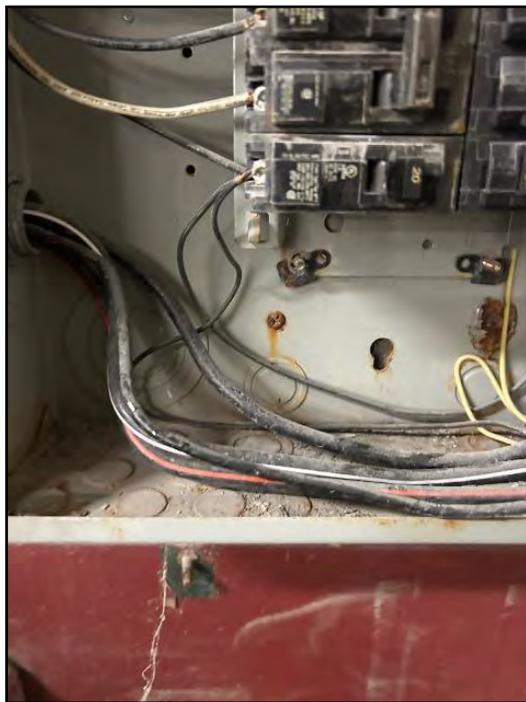
243. Double taps

82. Condition: • [Double taps](#)

Implication(s): Fire hazard

Location: Various

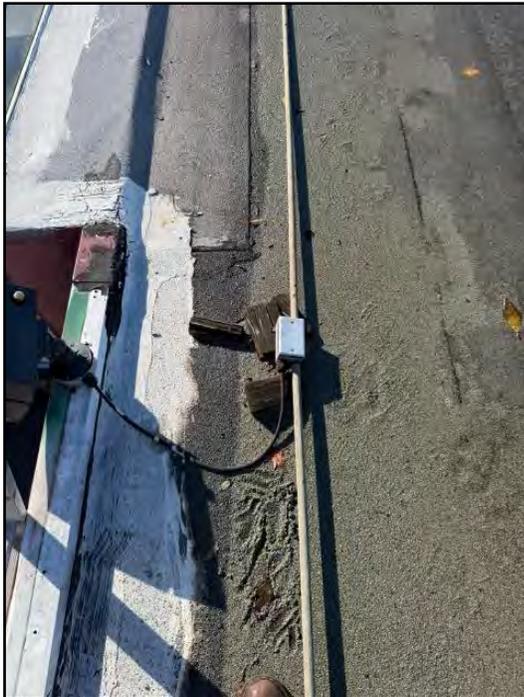
246.

**84. Condition:** • Conduit is missing multiple clamps to secure it to the roof.

**Location:** Roof

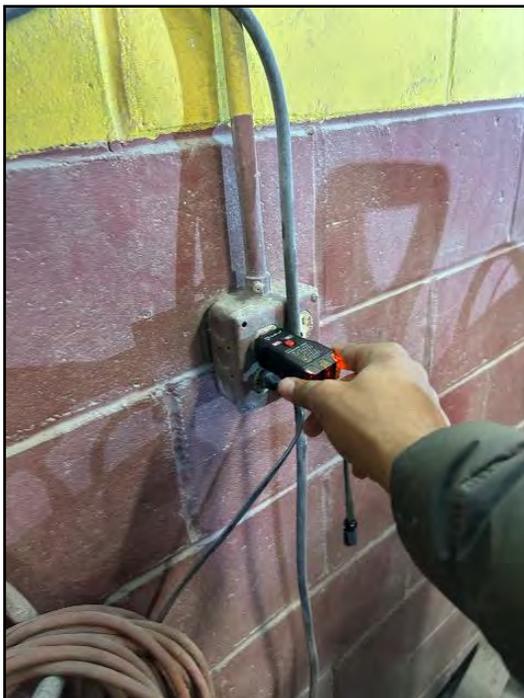
248. Loose

85. Condition: • [Loose](#)

Implication(s): Electric shock | Fire hazard

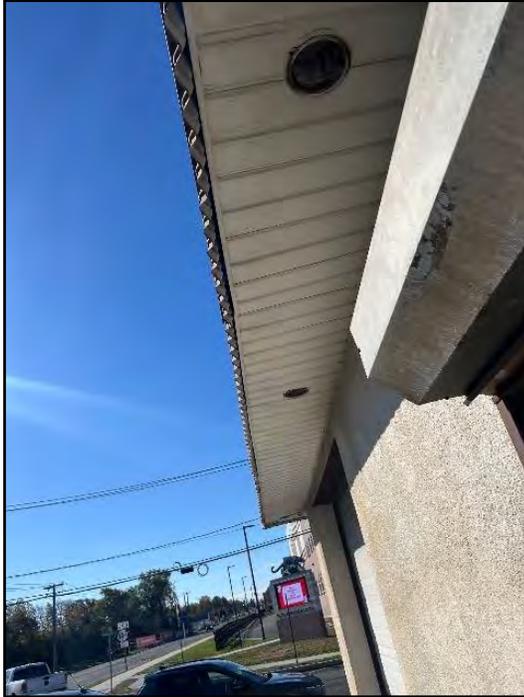
250. Missing

86. Condition: • [Missing](#)

Implication(s): Inadequate lighting

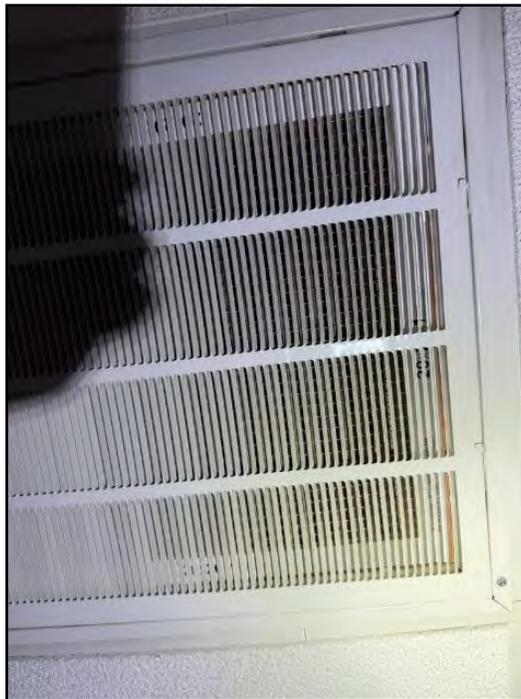
260. Dirty

88. Condition: • [Dirty](#)

Implication(s): Increased heating costs | Reduced comfort

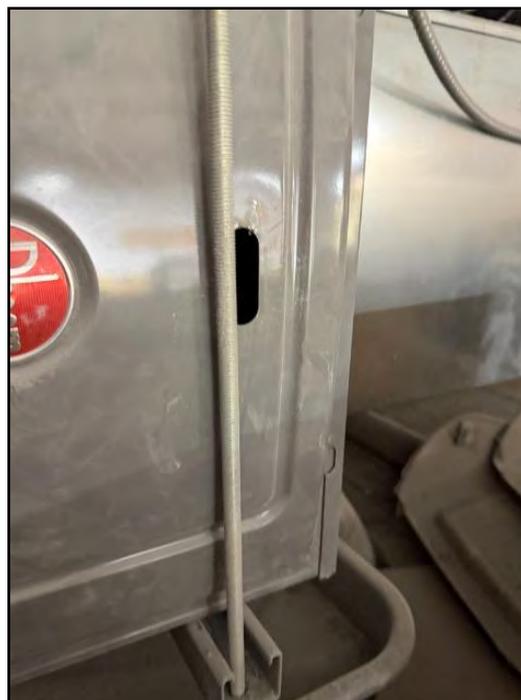
263. Air leakage entering from return side

**90. Condition:** • Air leakage entering from return side

**Implication(s):** Openings found on the return side (before the blower) can pull back gases and pollutants from the utility area, INTO the supply side. These pollutants can include carbon monoxide.

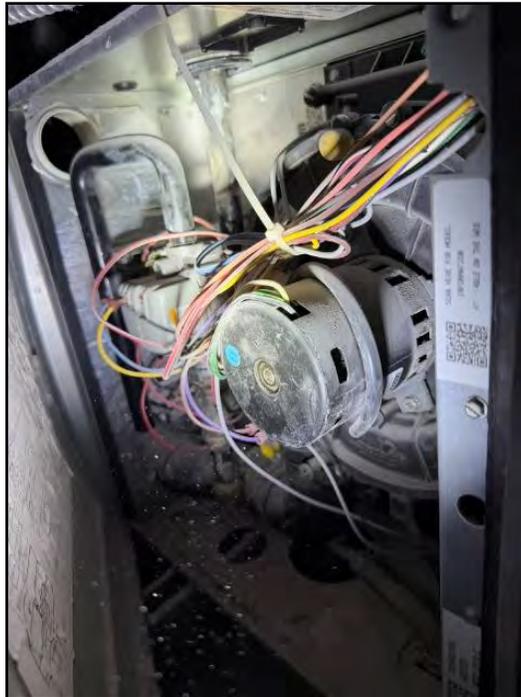
265. *Dirt or soot*

**92. Condition:** • [Dirt or soot](#)

The intake appears to be pulling in air from the body shop, drawing in paint and filler dust into the unit. This can cause internal components to deteriorate prematurely, restrict airflow, and affect overall performance. It is recommended to reroute the intake to draw clean air from an uncontaminated area and to have the unit inspected and serviced to prevent further damage.

**Implication(s):** Equipment not operating properly | Increased heating costs | Reduced comfort

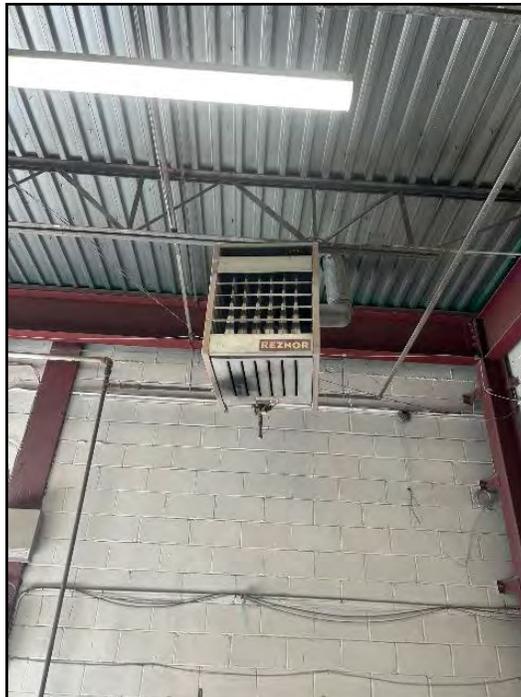
266.

93. **Condition:** • Currently inoperative, however, unit is in working condition

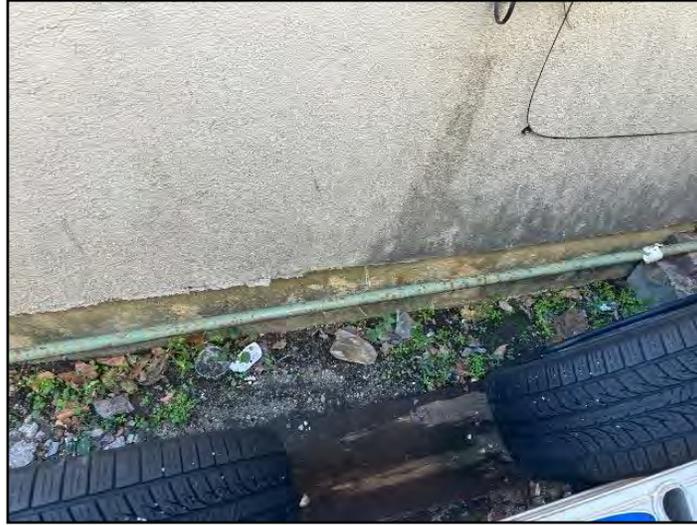
**267.** *Rust*

94. **Condition:** • [Rust](#)

**Implication(s):** Fire or explosion

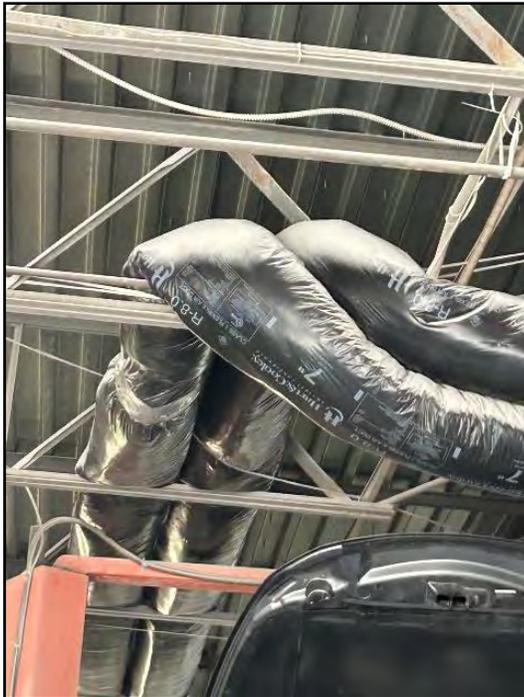
269. *Obstructed or collapsed*

96. Condition: • [Obstructed or collapsed](#)

Implication(s): Increased cooling costs | Reduced comfort

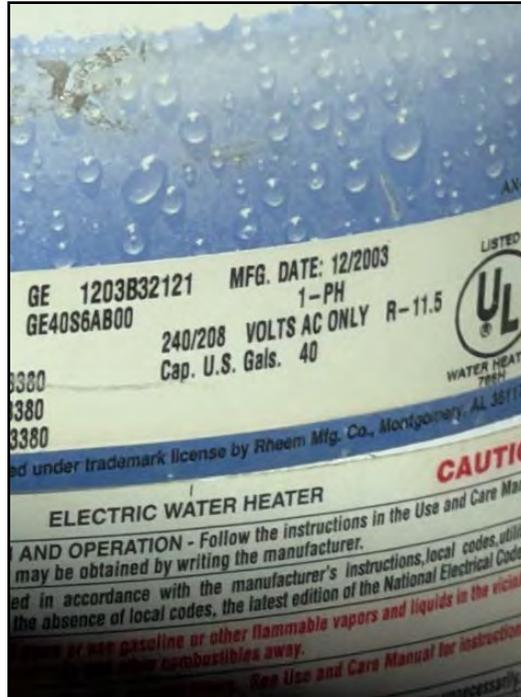
272. Past life expectancy

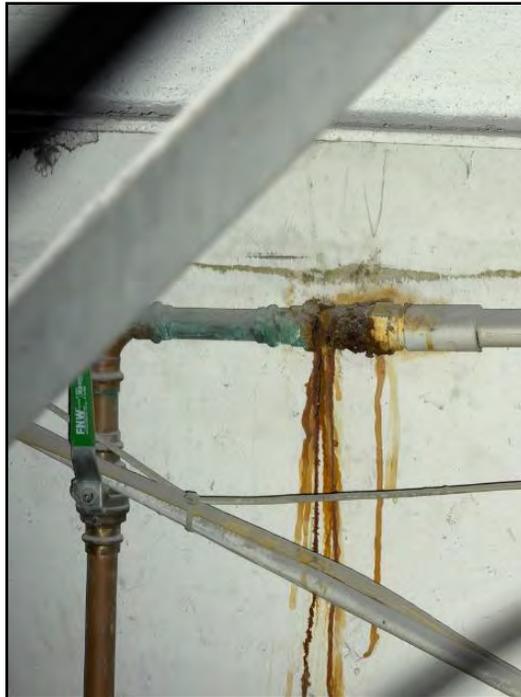
273. Leak

97. Condition: • [Leak](#)

Implication(s): Chance of water damage to structure, finishes and contents | System inoperative

Location: Seen above office space

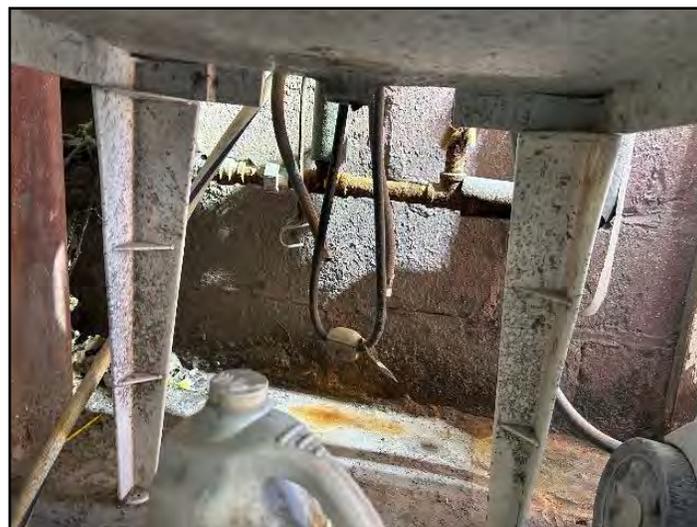
274. Rust

98. Condition: • [Rust](#)

Implication(s): Chance of water damage to structure, finishes and contents | Leakage | Reduced system life expectancy | Equipment failure

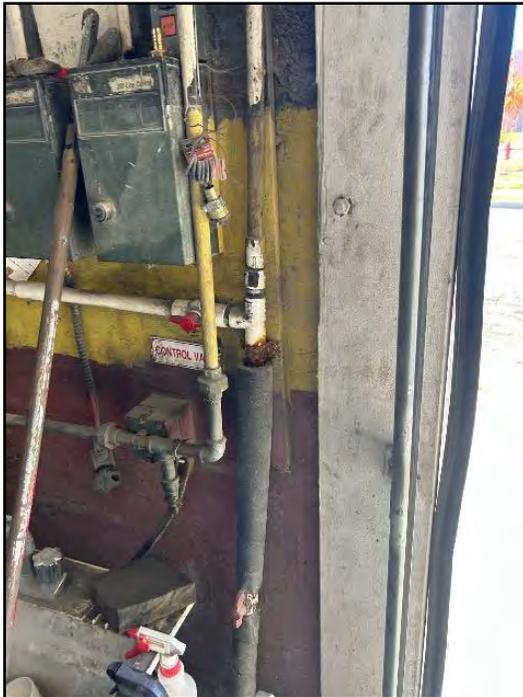
275. Corrosion

99. Condition: • Corrosion

Implication(s): Chance of water damage to structure, finishes and contents | Leakage | Reduced system life expectancy | Equipment failure

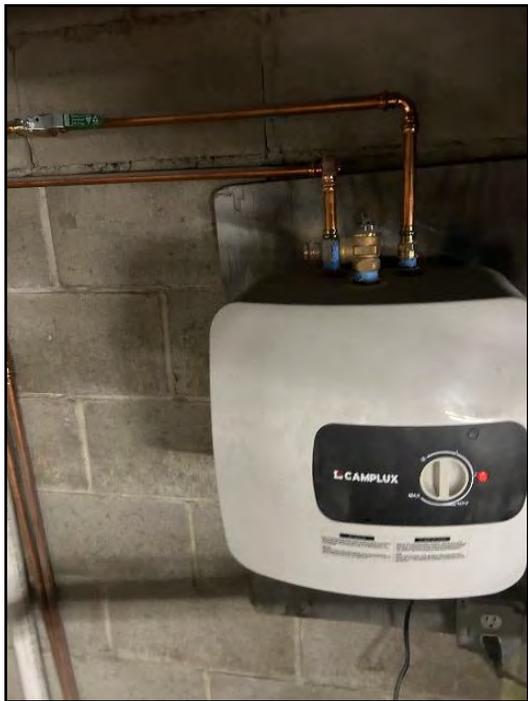
277. Discharge tube missing

101. Condition: • [Discharge tube missing](#)

Implication(s): Scalding
