# Your Inspection Report

Thursday, October 23, 2025

Smart Choice Inspections LLC  
173 Ridge Road, Suite H1  
Cedar Grove, NJ 07009

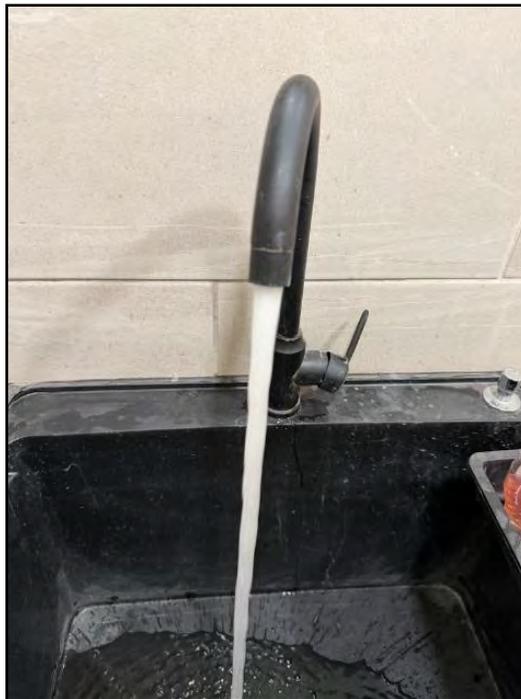
279. Drip, leak

103. Condition: • [Drip, leak](#)

Implication(s): Chance of water damage to structure, finishes and contents

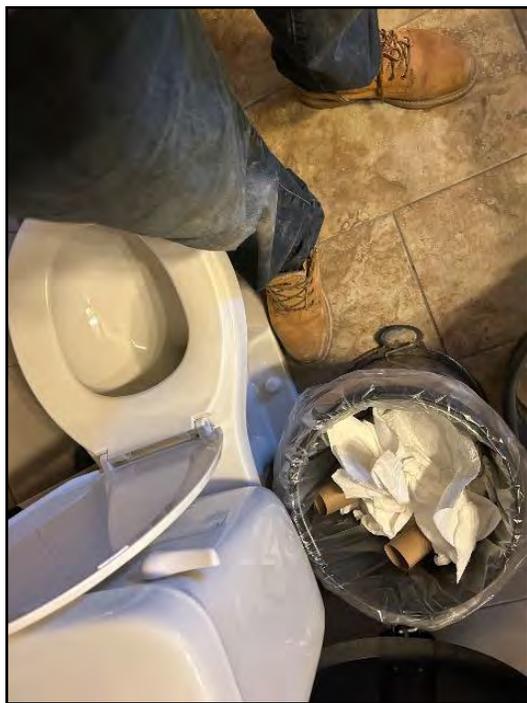
280. Loose

104. Condition: • [Loose](#)

Implication(s): Chance of water damage to structure, finishes and contents | Sewage entering the building | Possible hidden damage

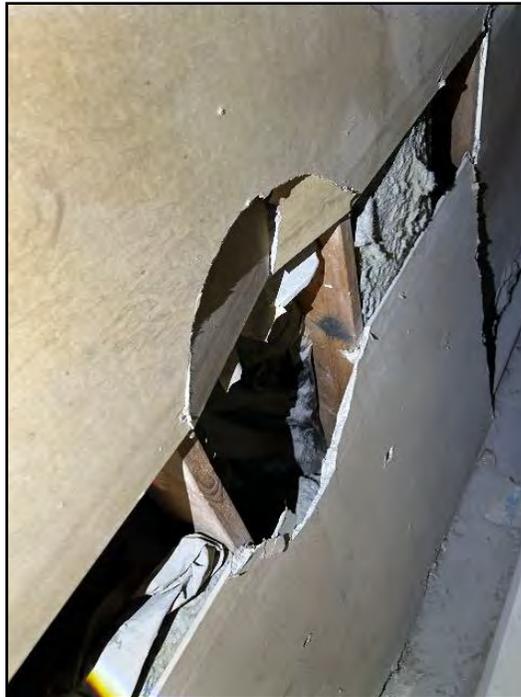
288. Damage

**106. Condition:** • Damage

**Implication(s):** Damage or physical injury due to falling materials

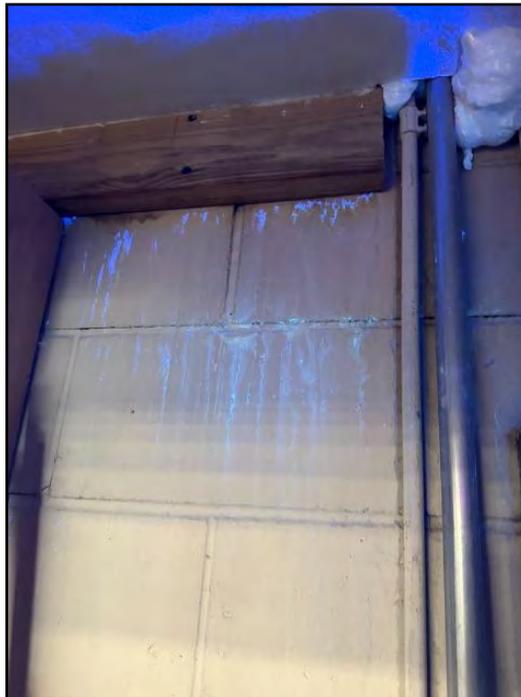
295. Active water leak detected

**107. Condition:** • Active water leak detected

Moisture was detected in the masonry block wall, and visible water stains were also observed.

It is suspected that the water is originating from an improperly discharged downspout connected to the flat roof gutter system.

**Implication(s):** Chance of movement, Rot, Leakage

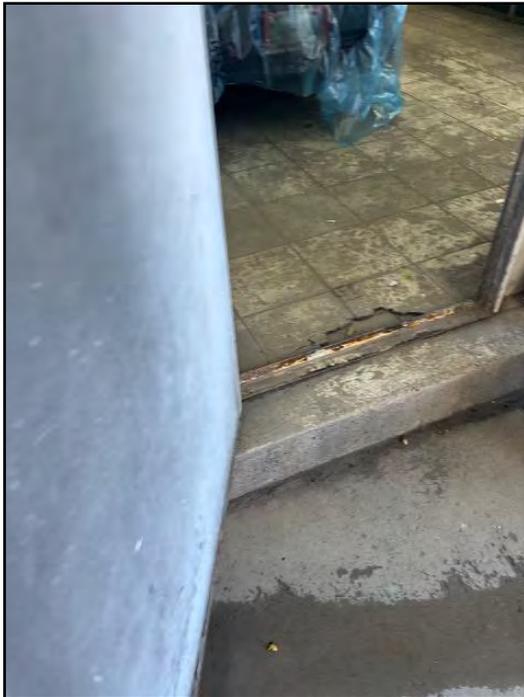
296. Tiles broken

108. Condition: • [Tiles broken](#)

Implication(s): Trip or fall hazard

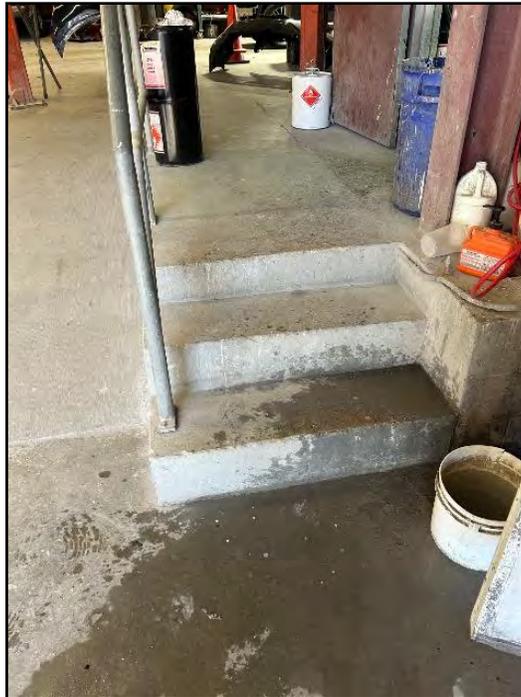
299.

**109. Condition:** • Rise and run not uniform

**Implication(s):** Trip hazard

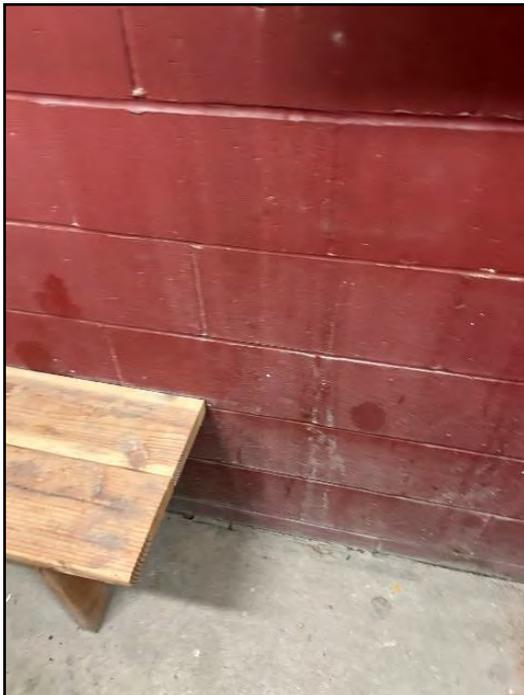
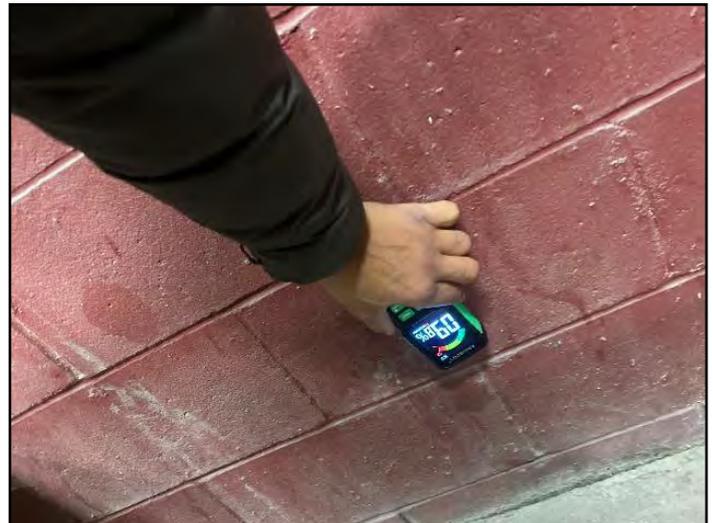
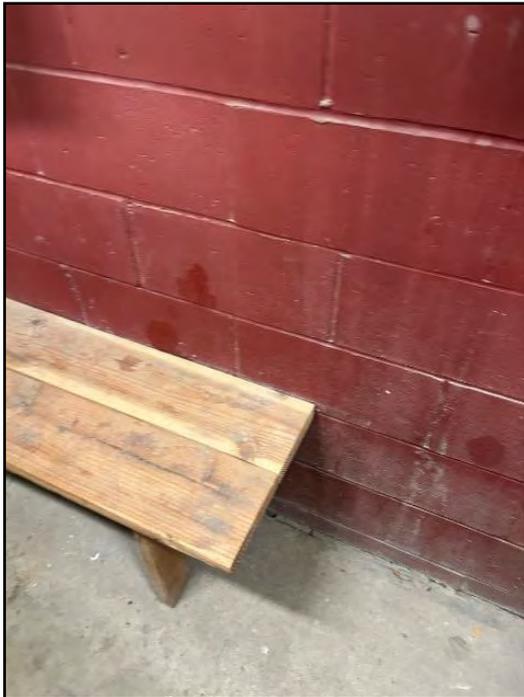
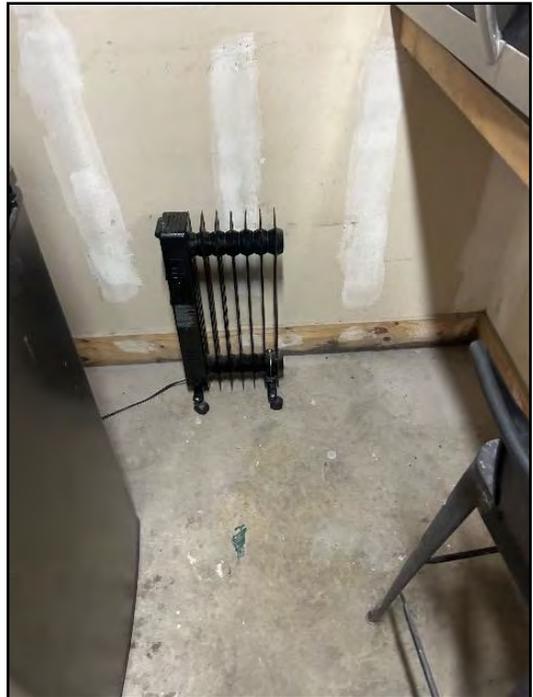
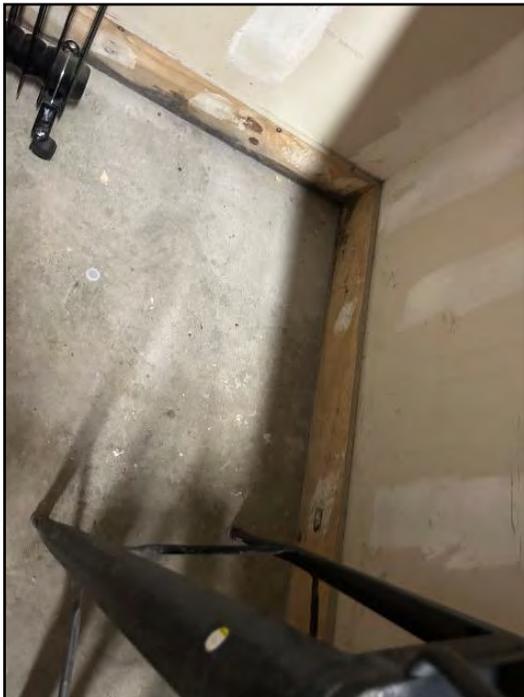
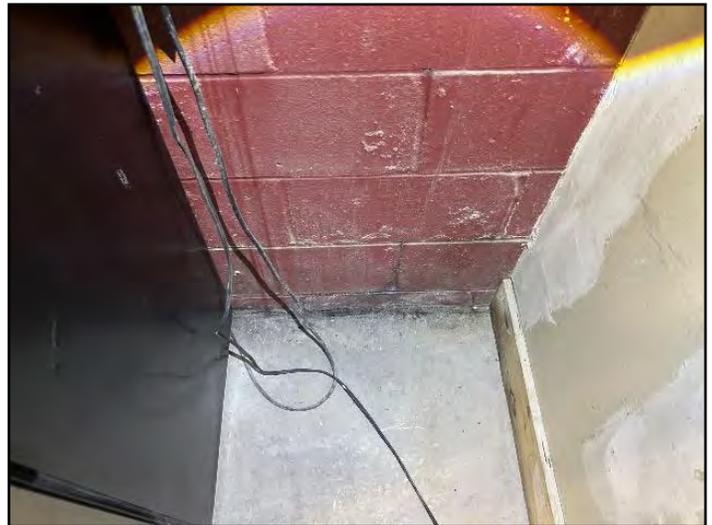
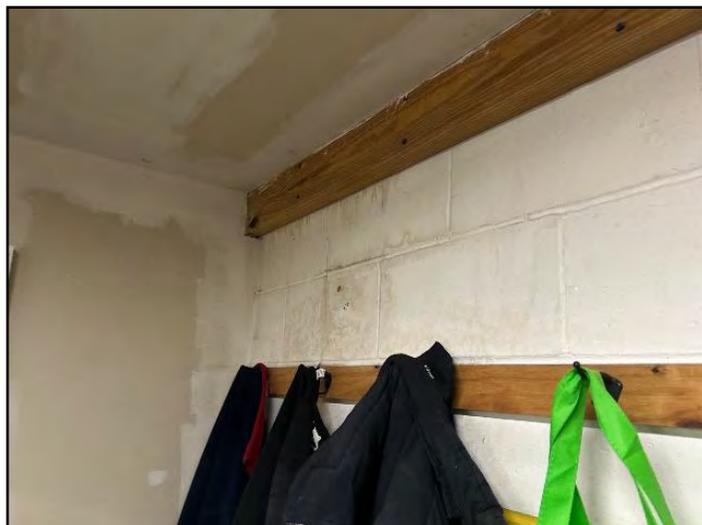
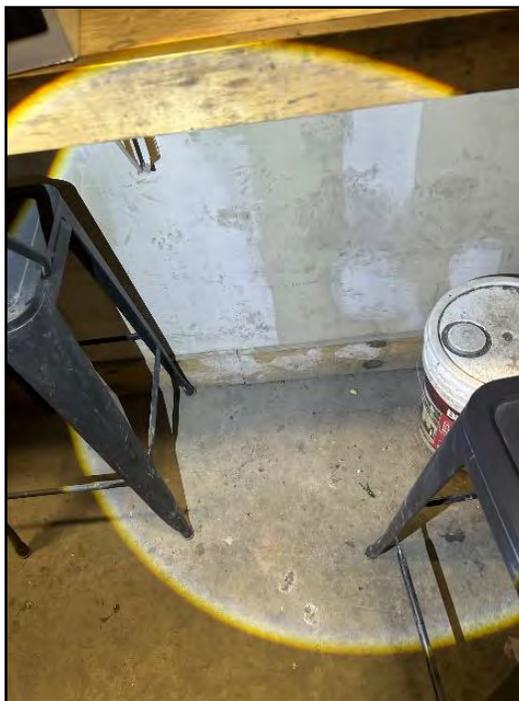
**110. Condition:** • Mold

**Implication(s):** Health hazard

**Location:** Kitchenette
